UNIVERSITY COLLEGE CORK

WIND ENERGY

# Kilgarvan Wind Farm Visit 28-10-2015

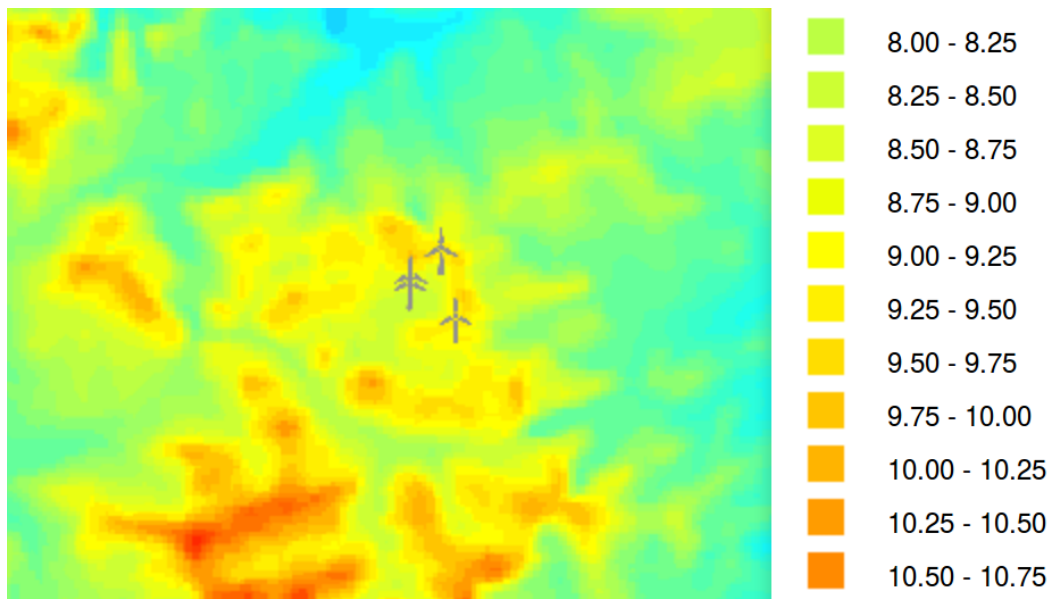
Figure 1: Wind speed at 75m - SEAI Wind Atlas - Kilgarvan Area

According to the SEAI Wind Atlas [3], the area has some of the best onshore wind conditions in Ireland. Average wind speeds at 75m height are between 8 - 10 m/s. The wind conditions are also relatively consistent, with a Weibull k modulus of 2 - 2.5.

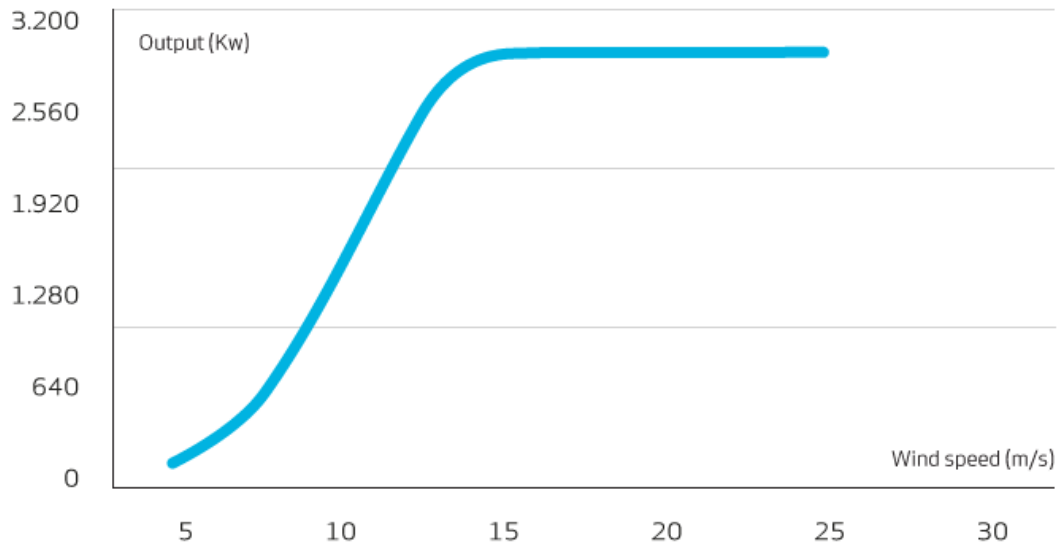
Figure 2: Vestas V90 Power Curve

Figure 2 shows the power curve of the Vestas V90. This shows the cut in, cut out and rated wind speeds for the turbine.

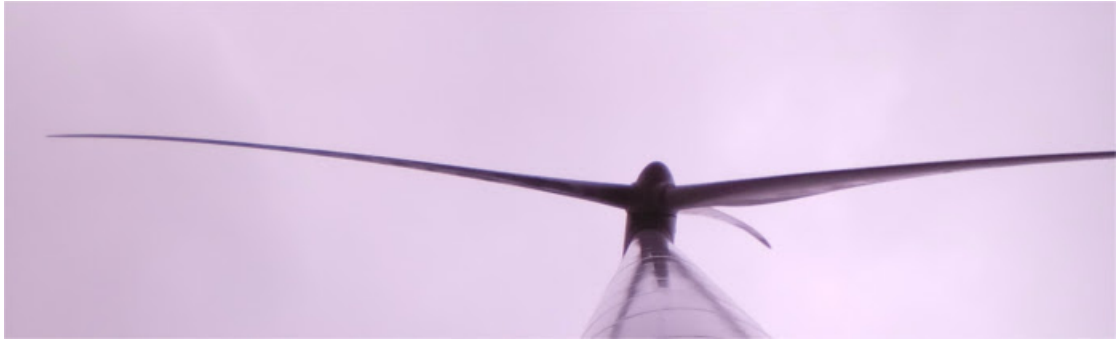
Figure 3: Vestas V90 Rotor

The blades on the Vestas machines appear to be swept back significantly. The Nordex blades appear straighter. There was a noticeable twist along the length of the blades. This twist is designed in to accommodate the change in apparent wind speed along the length of the blades. Figure 3 shows Vestas rotor. Note the swept back blades and twist of the blades.

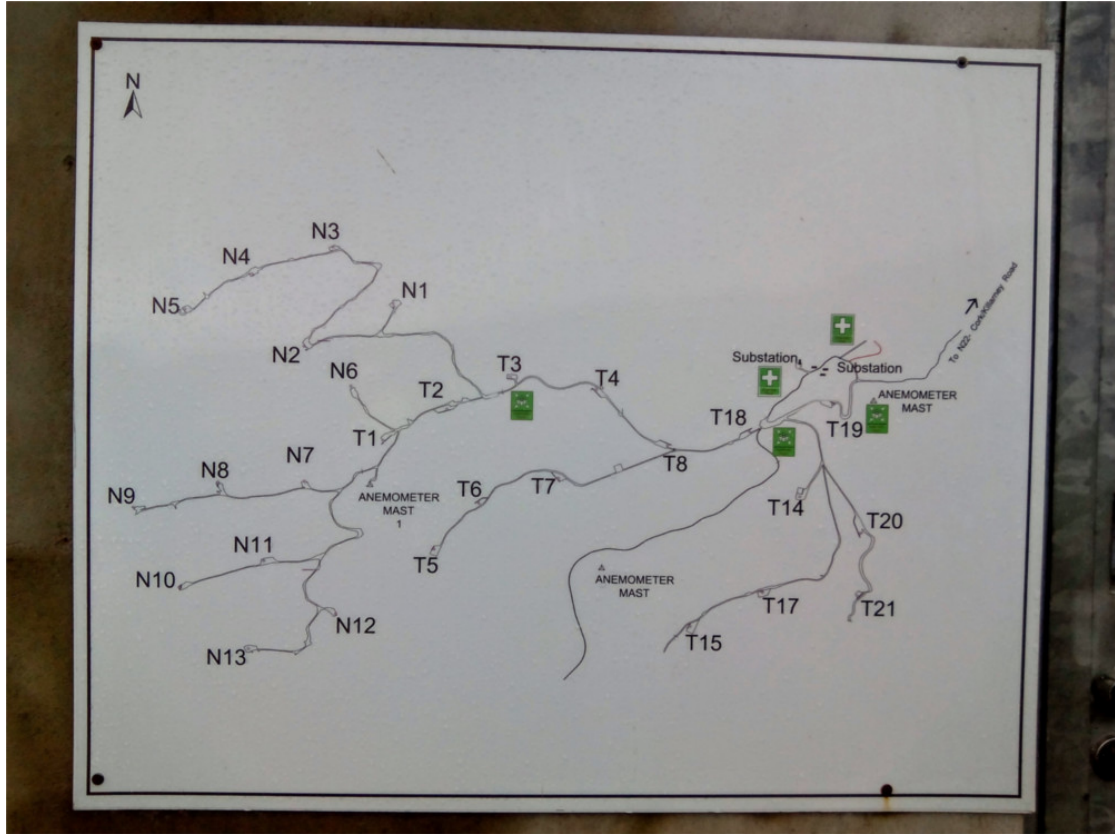
Figure 4: Farm Layout - N indicates Nordex, T indicates Vestas

There are three anemometer masts on the site. They are spread out to different areas and are at different elevations. The positions of the anemometers can be seen in figure 4.

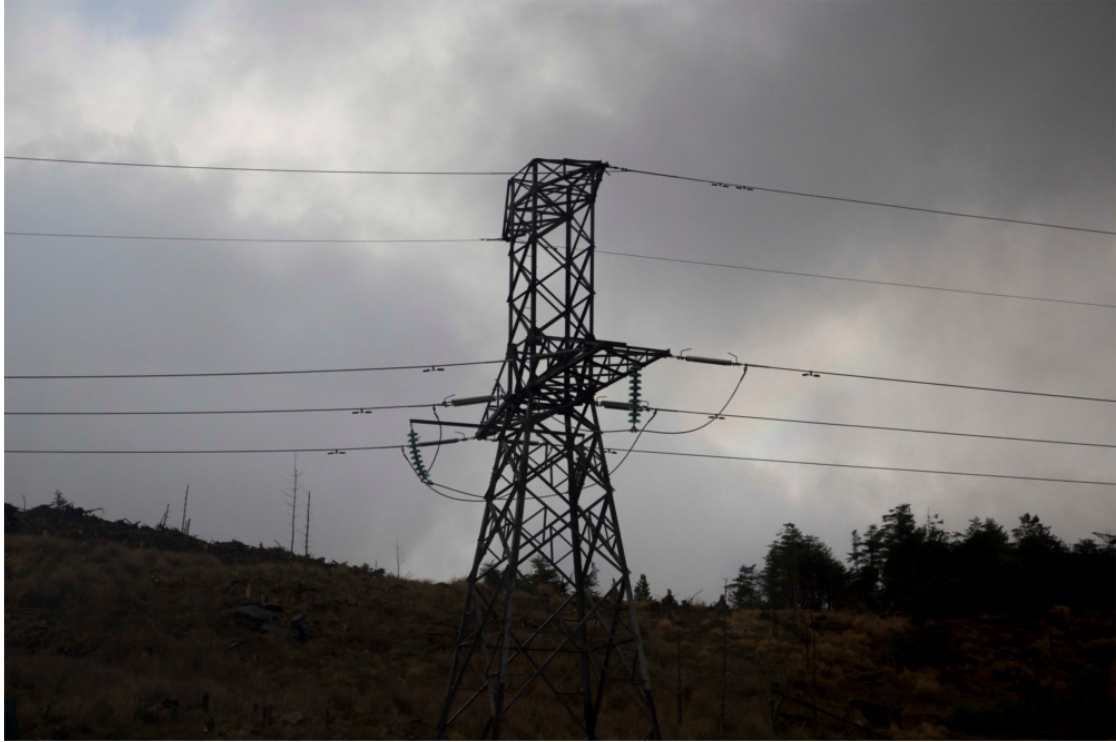
Figure 5: Pylon carrying 110kV electricity lines

The on-site grid between the turbines and the substation is not visible and can be assumed to use underground cables. The Brookfield substation is connected to the ESB substation with a series of wooden and metal pylons. The pylons, as shown in figure 5, carry five cables - one for each phase of the 3-phase electricity being generated, one ground cable and one communications fibre optic cable.
