Technical Service Bulletin: tsb100125

Released Date: 28-Nov-2001

Gear Cover Bushing Installation Instructions

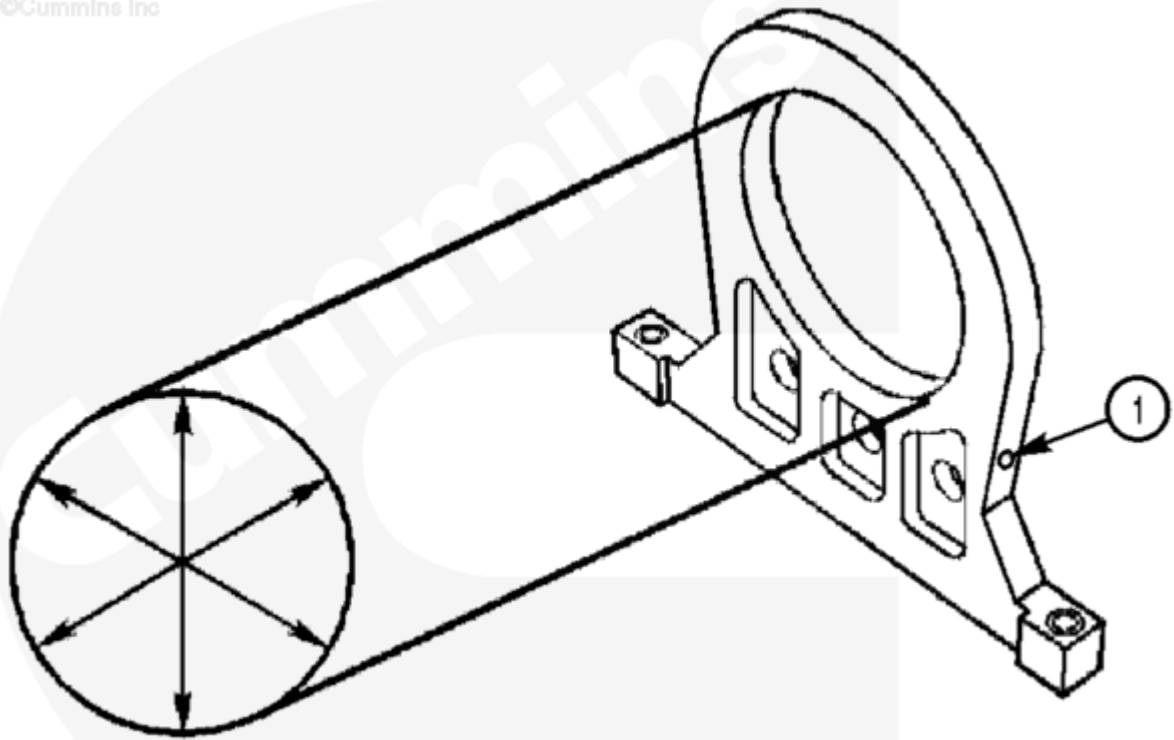
01600233

The grease fitting (1) has been moved to the lower left-bank side of the trunnion.

Fig. 1, Front Support Trunnion with New Grease Fitting Location (1)

To fit this trunnion to engines using the previous design, you **must** change the wear sleeve fitted to the front gear cover. The new wear sleeve, Part Number 4065741, has different dimensions and uses a harder material.
