UNIVERSITY COLLEGE CORK

WIND ENERGY

# Kilgarvan Wind Farm Visit 28-10-2015

# 1 Site Description

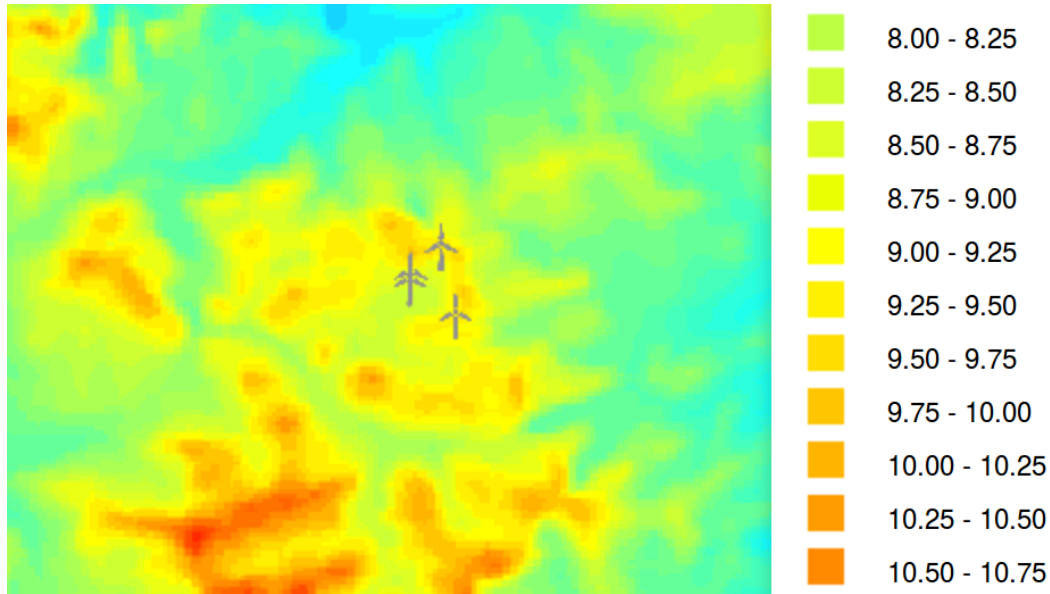
Wind speed at 75m - SEAI Wind Atlas - Kilgarvan Area

According to the SEAI Wind Atlas [1], the area has average wind speeds at 75m height of 8 - 10  $\text{ms}^{-1}$ .

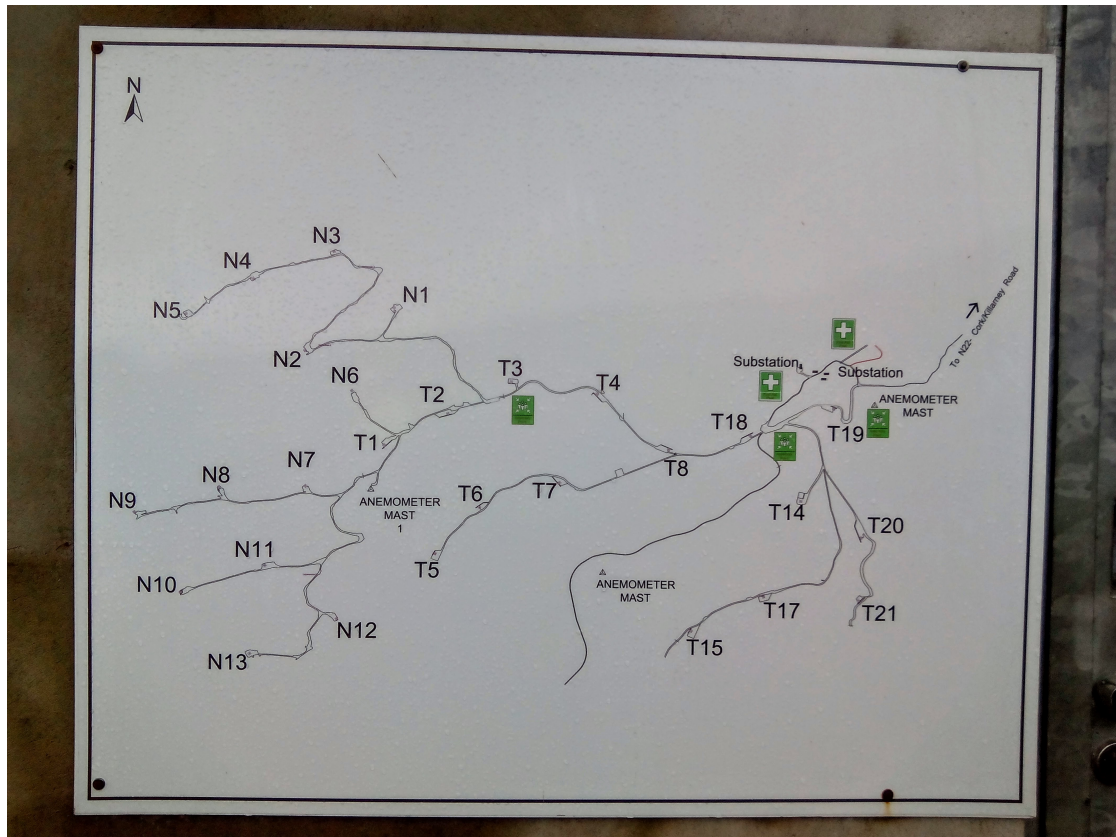
Layout of the wind farm. N indicates a Nordex turbine, T indicates a Vestas machine

Some machines are in better sites than others. Some machines are located in depressions, or shadowed by the hillside if the wind is blowing in a particular direction. The power output of the turbines can vary significantly depending on their location. The worst performing machines only generate 40% of the power as the best performers. This is taken into account at the design stage.
