Technical Service Bulletin: tsb100216

Released Date: 14-Jul-2003

Introduction of New Fuel Filter Head Outlet Fitting with Check Valve for QSK45, QSK60, and QSK78 Engines

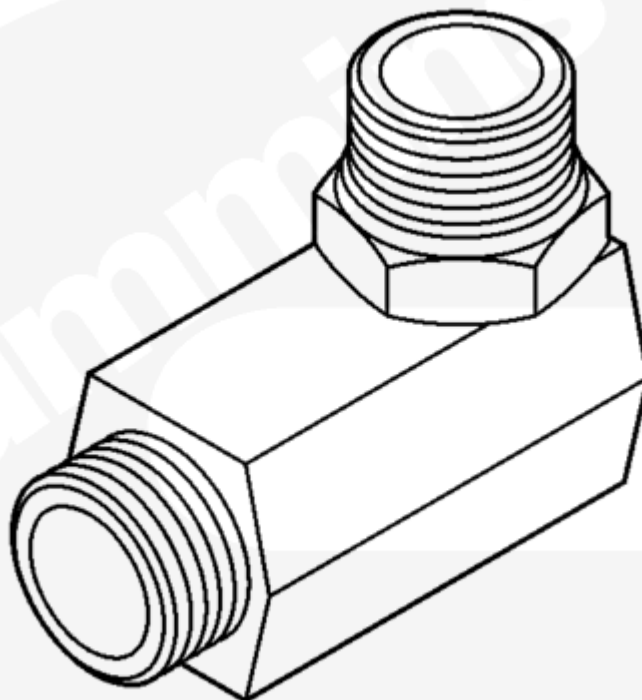
05600156

This Technical Service Bulletin introduces a new fuel filter head outlet fitting with an internal check valve, Part Number 4086602, for QSK45, QSK60, and QSK78 engines.

The new fuel filter head outlet fitting with an internal check valve can **only** be used with the new number 20 SAE size fuel line and the corresponding fuel pump inlet connection.

The hard starting failure mode is associated with the current fuel filter head outlet fitting. This is due to fuel in the fuel line draining back into the fuel filters. When this occurs, the engine will experience a hard starting condition. The check valve holds the fuel in the fuel line between the fuel filter head and the fuel pump.

The old fuel filter head outlet fitting, Part Number 3332349, is now being obsoleted and superseded to the new fuel filter head outlet fitting. The new fuel filter head outlet fitting with internal check valve was made an option for production at the Daventry Engine Plant in January 2003.
