Technical Service Bulletin: tsb100239

Released Date: 15-Oct-2003

New Cylinder Head Casting and Valve Rotator

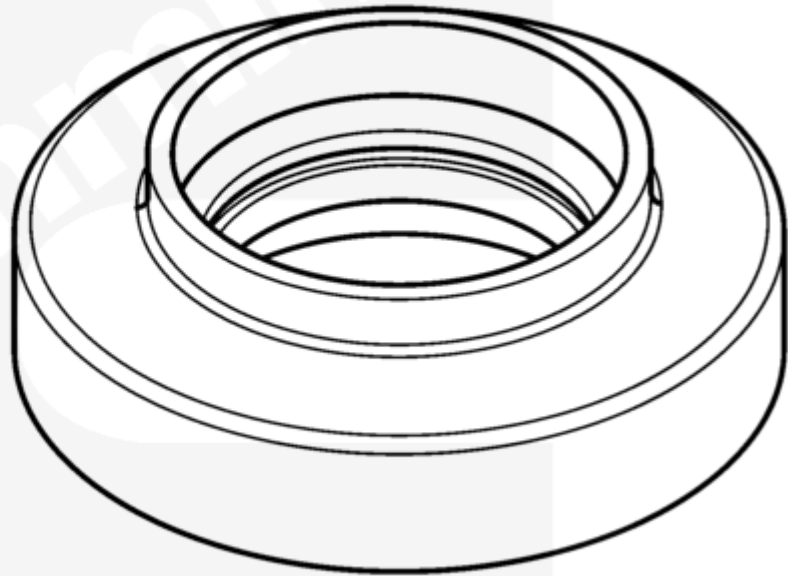
Figure 1 Old Type Valve Rotator.

Figure 1 shows the old type valve rotator, figure 2 shows the new type rotator.
