System in servicing - Servicing the system

Service concept for APV Centrifugal Pumps

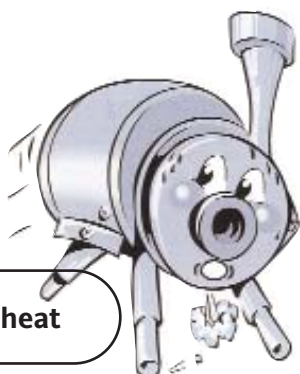
Vibrations and heat

- Pump unit vibratessee Item 1.e.
- Overheated motorsee Items 2.c., 2.d.

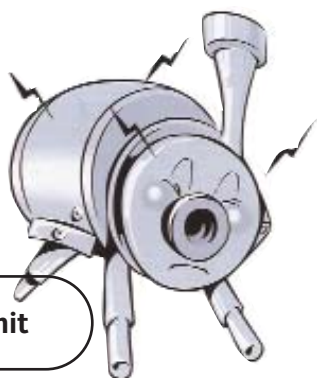
Noise in pump unit

- Screeching shaft sealsee Item 1.d.
- Scraping sound from pump housingsee Item 1.a.
- Knocking sounds from pump housingsee Items 1.b, 1.c
- Rumbling sounds from motorsee Items 2.a., 2.b., 2.c.
- Buzzing sound from motorsee Item 2.f.
- Rattling sounds from unitsee Item 2.g.

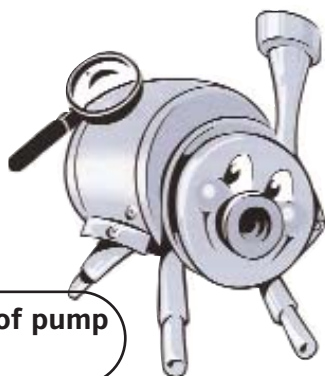
Visual inspection of pump unit

- Leaks from unitsee Item 3.
- Sedimentation of productsee Item 3.i
- Pump does not worksee Items 2.e., 3.j.
- Capacity problemssee Item 4

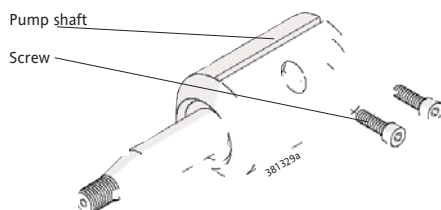
- 1.a. Metallic screeching sounds from the pump housing may have the following causes:
- a skewed or damaged impeller running against the pump housing and/or rear flange
 - the pump shaft is not firmly attached to the motor shaft with the prescribed torque
 - the pump shaft has not been properly adjusted in the axial direction after a new impeller has been fitted (see also Item 4.e)
 - the spring in the shaft seal may have been caught between the cone and the impeller when the seal was fitted (only on the W+ classic pump).
 - the pump housing is being pulled sideways by loads from the piping system
 - the motor bearings may be worn, making the motor shaft vibrate.

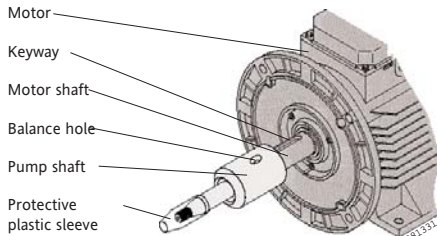
1.e: If the pump vibrates, it is because of an imbalance which can have the following causes:

- one of the vanes of the impeller is broken / deformed
- sporadic precipitation of the product on the impeller
- the balance hole on the pump shaft has not been correctly positioned over the keyway on the motor shaft
- The motor shaft has not been balanced with a keyway by the supplier
- a vane on the ventilator has broken off.

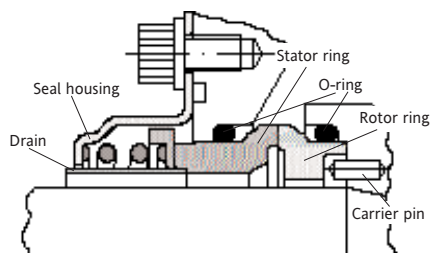
W+ series

3. a: If leaks can be traced around a newly replaced shaft seal, we can recommend

- tightening the screws around the seal flange to ensure that the seal surfaces between the seals are parallel.
- (W+ series) The carrier pin for the rotating part of the seal may be higher than the corresponding notch in the seal, which will mean that the wearing surfaces of the seal parts are not parallel. The rotating seal part must not be able to tilt when placed without the O-ring. The presence of foreign bodies will have the same effect. It can be seen clearly on the seal flange if the seal has not been placed correctly, since deep grooves are quickly formed in it, causing loss of spring tension and a leaky seal.

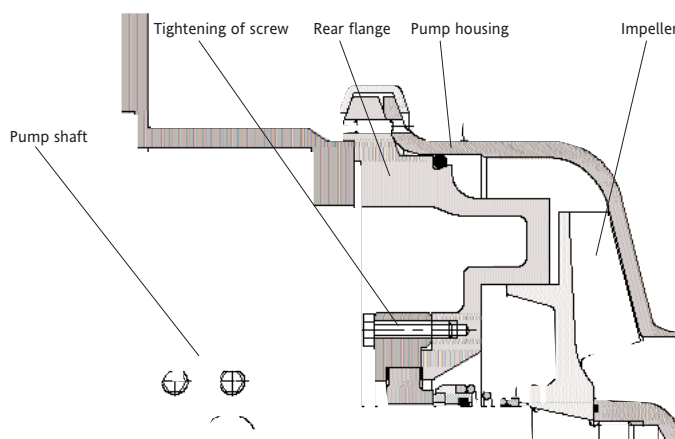
W - Classic Series

3. c: In the W classic type the spring around the seal may face the wrong way, break or twist around the shaft, for example if the pump has rotated against the prescribed direction. This can happen during start-up of the pump or during CIP running in the opposite flow direction.

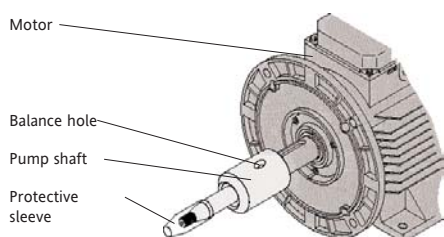
3. b: If a visual inspection shows that the edges have been knocked off the seal, this indicates that it has suffered physical damage. This usually happens during fitting of the rear flange on the intermediate flange, since this is where the static seal part has to be guided over the pump shaft and thus happens to strike the shaft.

APV recommends the use of a plastic protective sleeve as physical separation between the seal and the shaft.

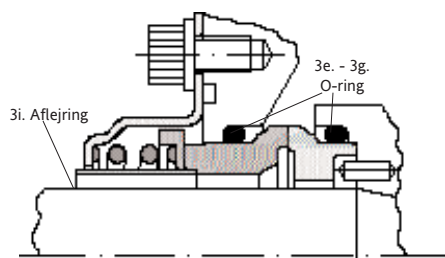
3. i: Normally one can find very small precipitations of the medium on the outside part of the shaft seal, because the smallest dry-matter particles in the fluid (around 0.001 mm in size) can pass the wearing surfaces of the shaft seal, after which the particles crystallize and accumulate as the fluid content evaporates.

APV recommends that you fit a shaft seal with water-flushing if such precipitation is unacceptable.
