Technical Service Bulletin: tsb100282

Released Date: 28-Jun-2004

New Direct Drive Fan Hub Washer

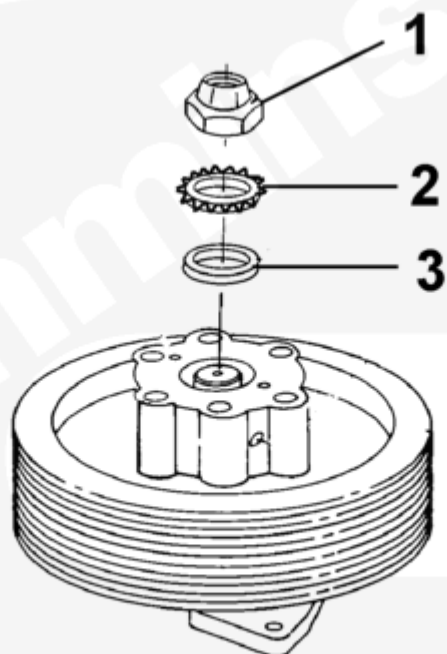
Figure 1.

This Technical Service Bulletin introduces a new hardened fan hub bearing washer for the direct drive type fan hub used on QSK45 and QSK60 series engines equipped with a direct drive fan hub. The new washer has increased material hardness. The washer is located between the two bearings in the fan hub. Its purpose is to maintain preload on the bearings within the fan hub to increase durability.

The washer is denoted by item 3 in Figure 1 below.

Fan Hub Washers	
Part Number	Washer Status
3171138	Superseded
3635836	Current for production and service
