Technical Service Bulletin: tsb100290

Released Date: 22-Jul-2004

New Front Engine Support Bushing

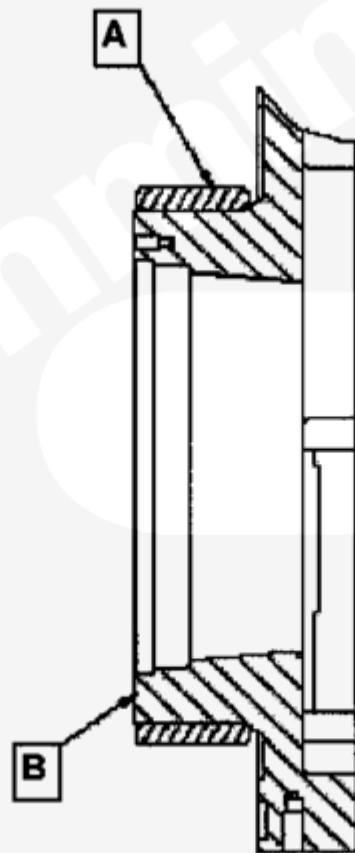
Figure 1

The purpose of this change was to eliminate possible interference issues with the front cover radius when the bushing was installed.

Due to this change the installation tolerances have also changed when installing the bushing to the front cover.

Press the bushing (item A, Figure 1) until it is flush to 1.0 mm [0.040 in] MAX the surface (B, Figure 1).
