**BLUETOOTH
MASS PRODUCTION (MP) TOOL
Release Note V4927**

2017/08/23

BLUETOOTH MP TOOL

Mass Production Release Note

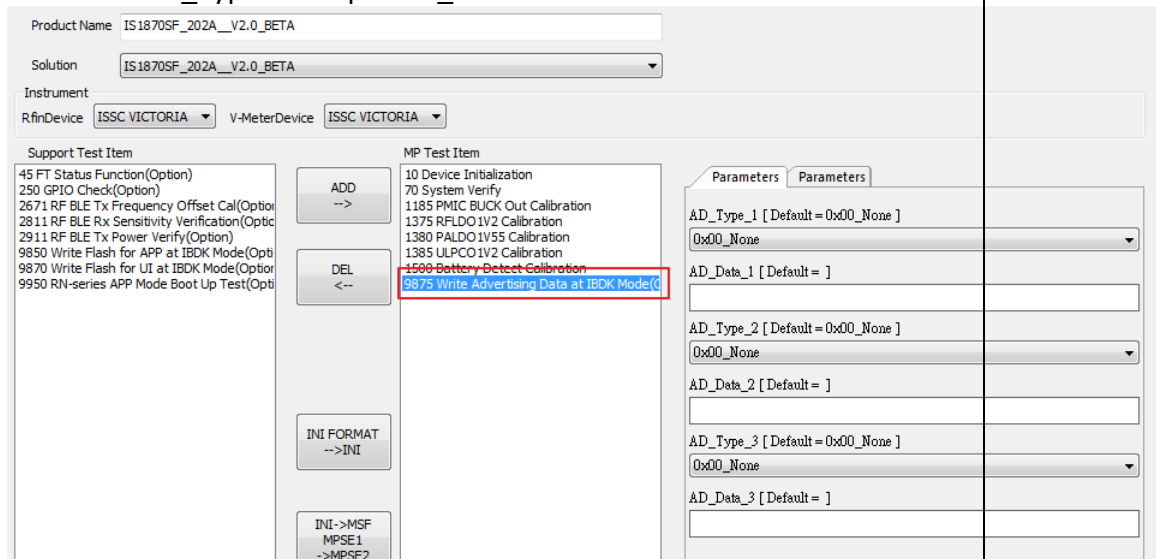
We added the test item 9875 to customer update Advertising Data. User can select AD_Type and input AD_data to match them format.

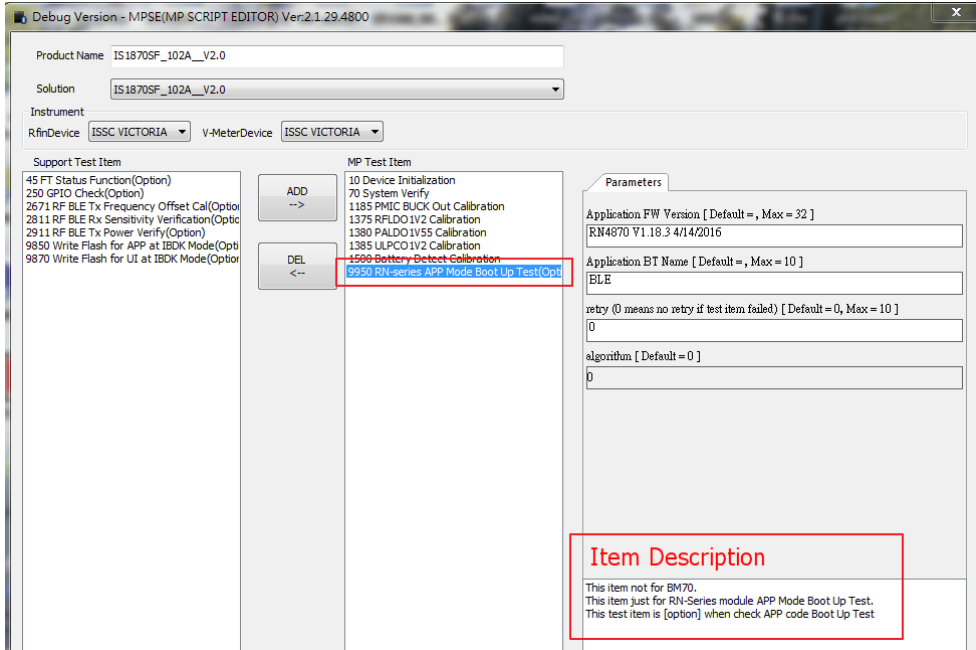
2.1.29.4804	<p>[MPBT] <u>New support item (!NEW)</u></p> <p>1. MPBT to support new item 9950 (RN-series APP Mode Boot Up Test) for RN Series test. This item will check FW boost string and boost commands are correct or not for RN series in the APP mode.</p>

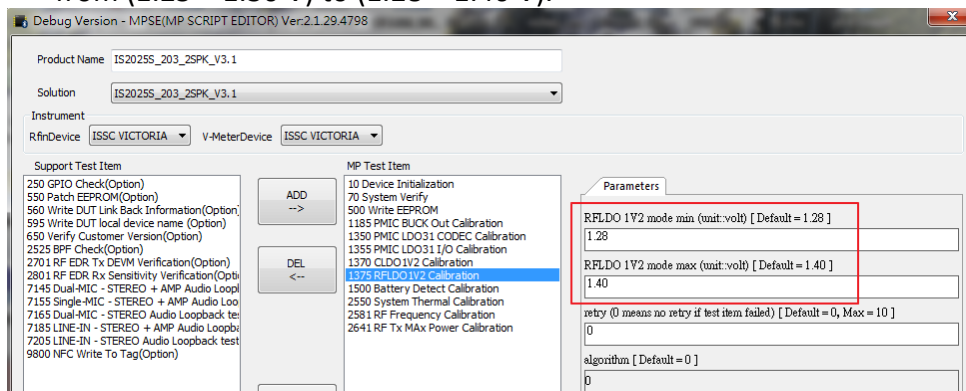
Parameter Name	Address	Length	Old	New	Remarks
RFLDO setting	0x02AC	0x01	C0	F0	Change RFLDO to 0xF0.

- 1.2 Modified the MPSE item 1375 (RFLDO1V2 Calibration) default limit from (1.25 ~ 1.30 V) to (1.28 ~ 1.40 V).

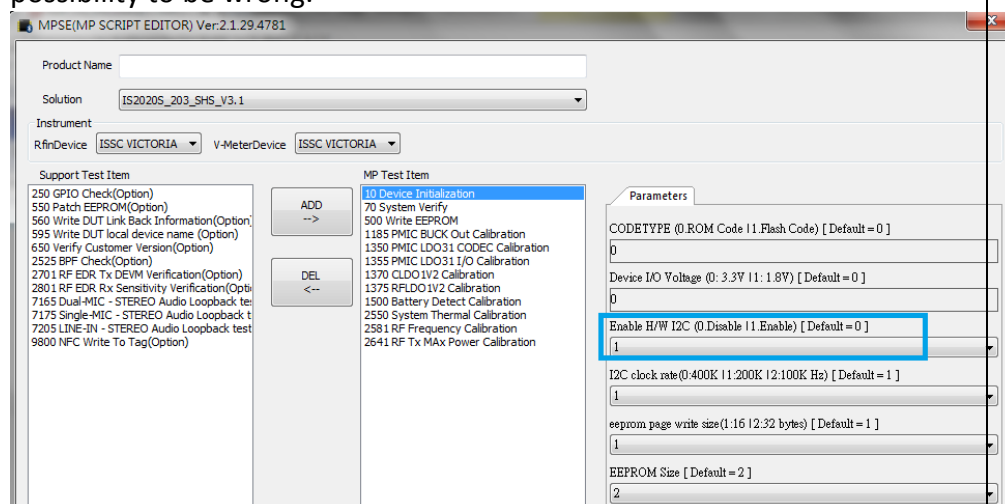
The user who enables the hardware I²C function to speed up the EEPROM programming would suffer an issue when writing special parameter (e.g. device name, calibration parameter ...etc.), the stored parameter is with possibility to be wrong.

MP tool will automatically disable hardware I²C after item500 (write EEPROM) is completed.
