Technical Service Bulletin: tsb100300

Released Date: 23-Sep-2004

New Turbocharger Oil Supply Plumbing for Single-Stage Engine

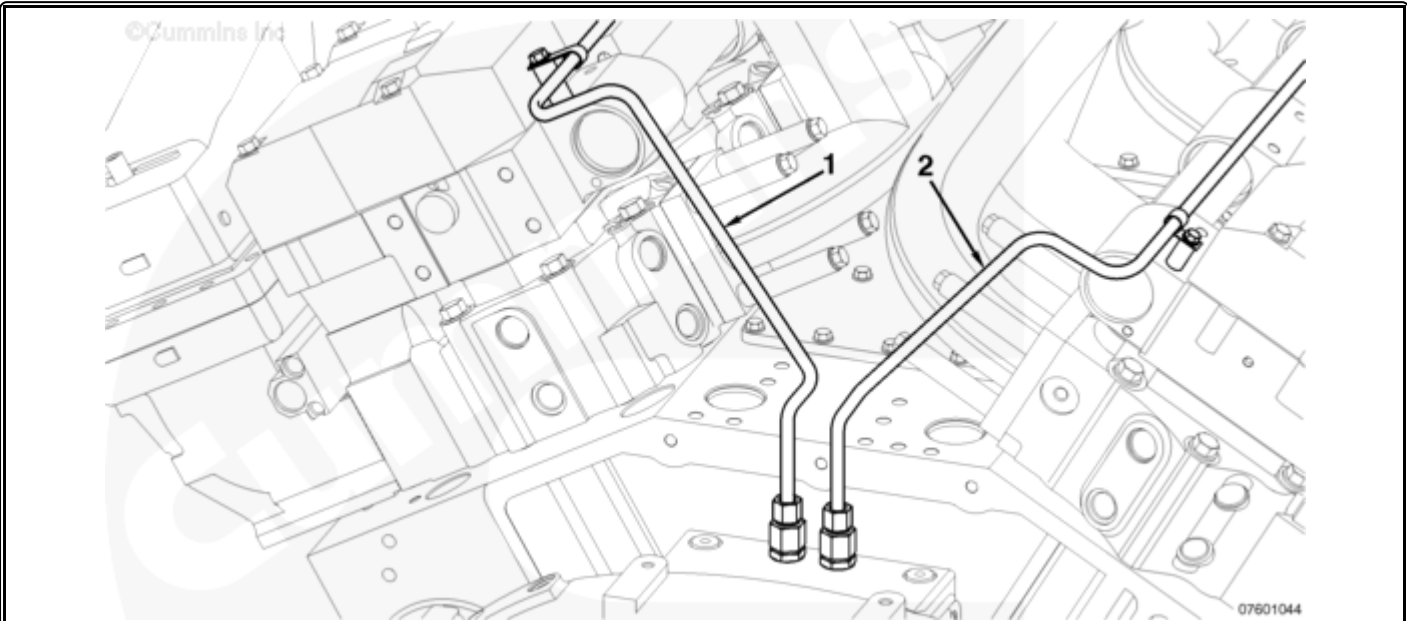
Figure 1, Old arrangement with oil supply tubes from the flywheel housing.

The turbocharger oil supply hoses have been rerouted as illustrated below, constituting a product improvement over the previous hybrid arrangement made of tubes and hoses.

- 1. Old Part Number 3171844 (left bank)
- 2. Old Part Number 3171845 (right bank)

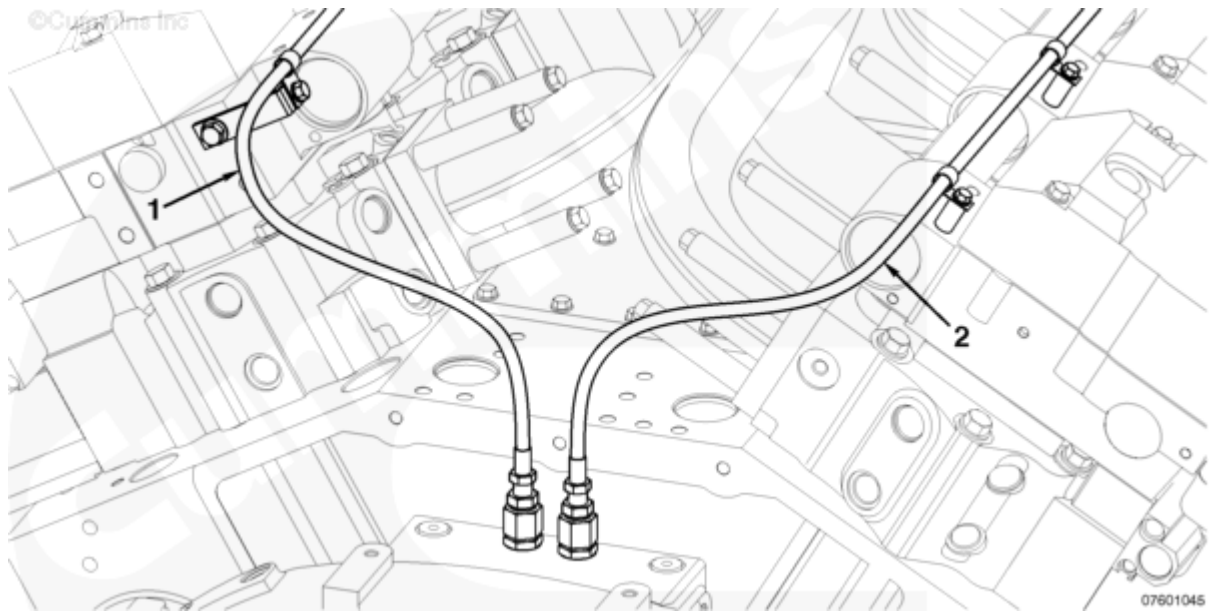
Figure 2, New arrangement with oil supply hoses from the flywheel housing to tees

1. New Part Number 3635130 (left bank)
2. New Part Number 3635131 (right bank)

The new oil hoses use their own hardware, clips and connections, as detailed in Table 1. Reuse the existing spacers, capscrews, and clip stand-offs. Replace the part numbers in all entries of the old turbocharger oil supply option TP 6726 listed above with new part numbers on hard copies of the QSK60 and QSK60G Parts Catalogs.

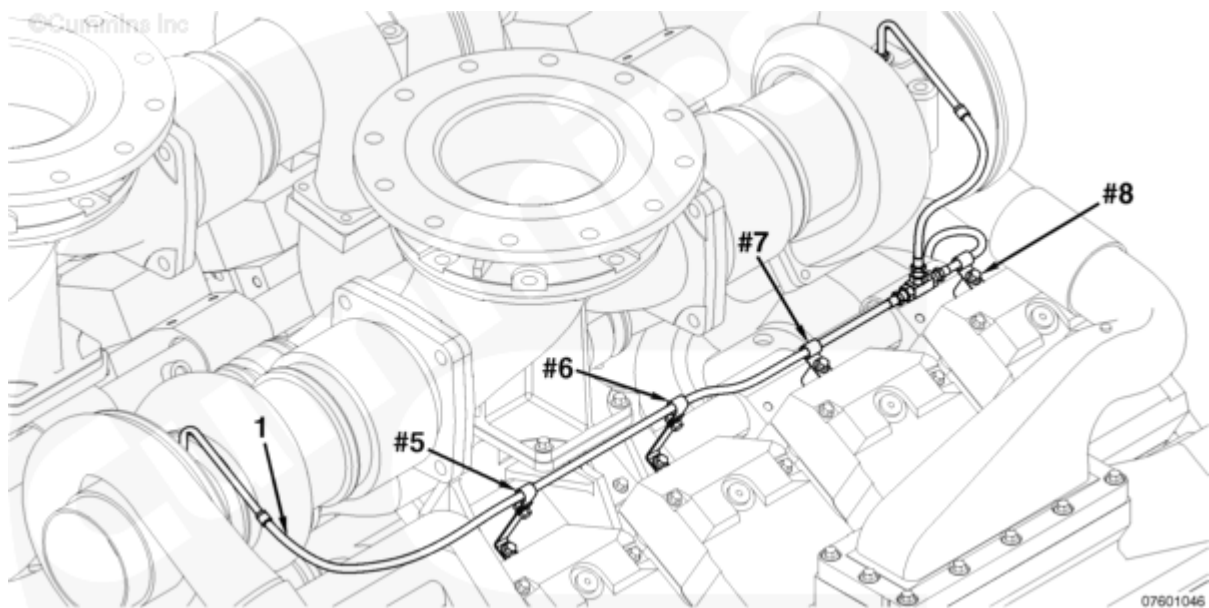
Figure 3, Left Bank, Clips at Number 5 and Number 6 are extended, clips at Number 7 and Number 8 are short.

1. New Part Number 3635129 (left bank)

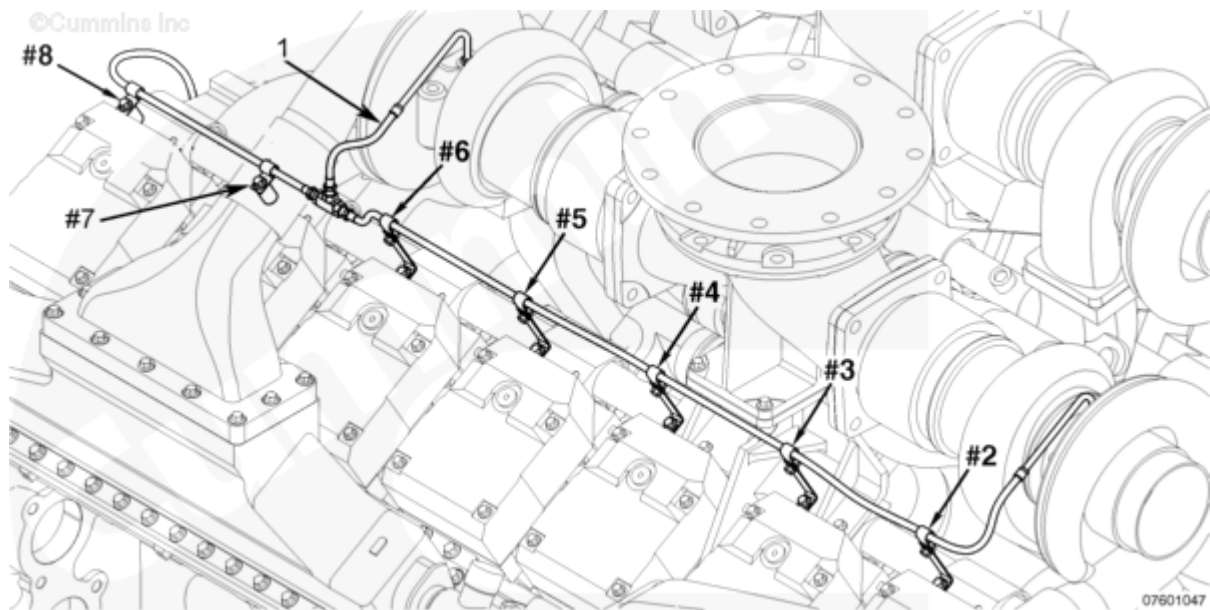
Figure 4, Right Bank, Clips at Number 2 to Number 6 are extended, Clips at Number 7 and Number 8 are short.

1. New Part Number 3635128 (left bank).
