Installation Note

Agilent Technologies E8257D PSG Signal Generators Add Option 1E1 (Attenuator)

Add Option 1E1 (Attenuator)

This upgrade kit adds Option 1E1 (Attenuator) to the E8257D (Analog) PSG Signal Generators.

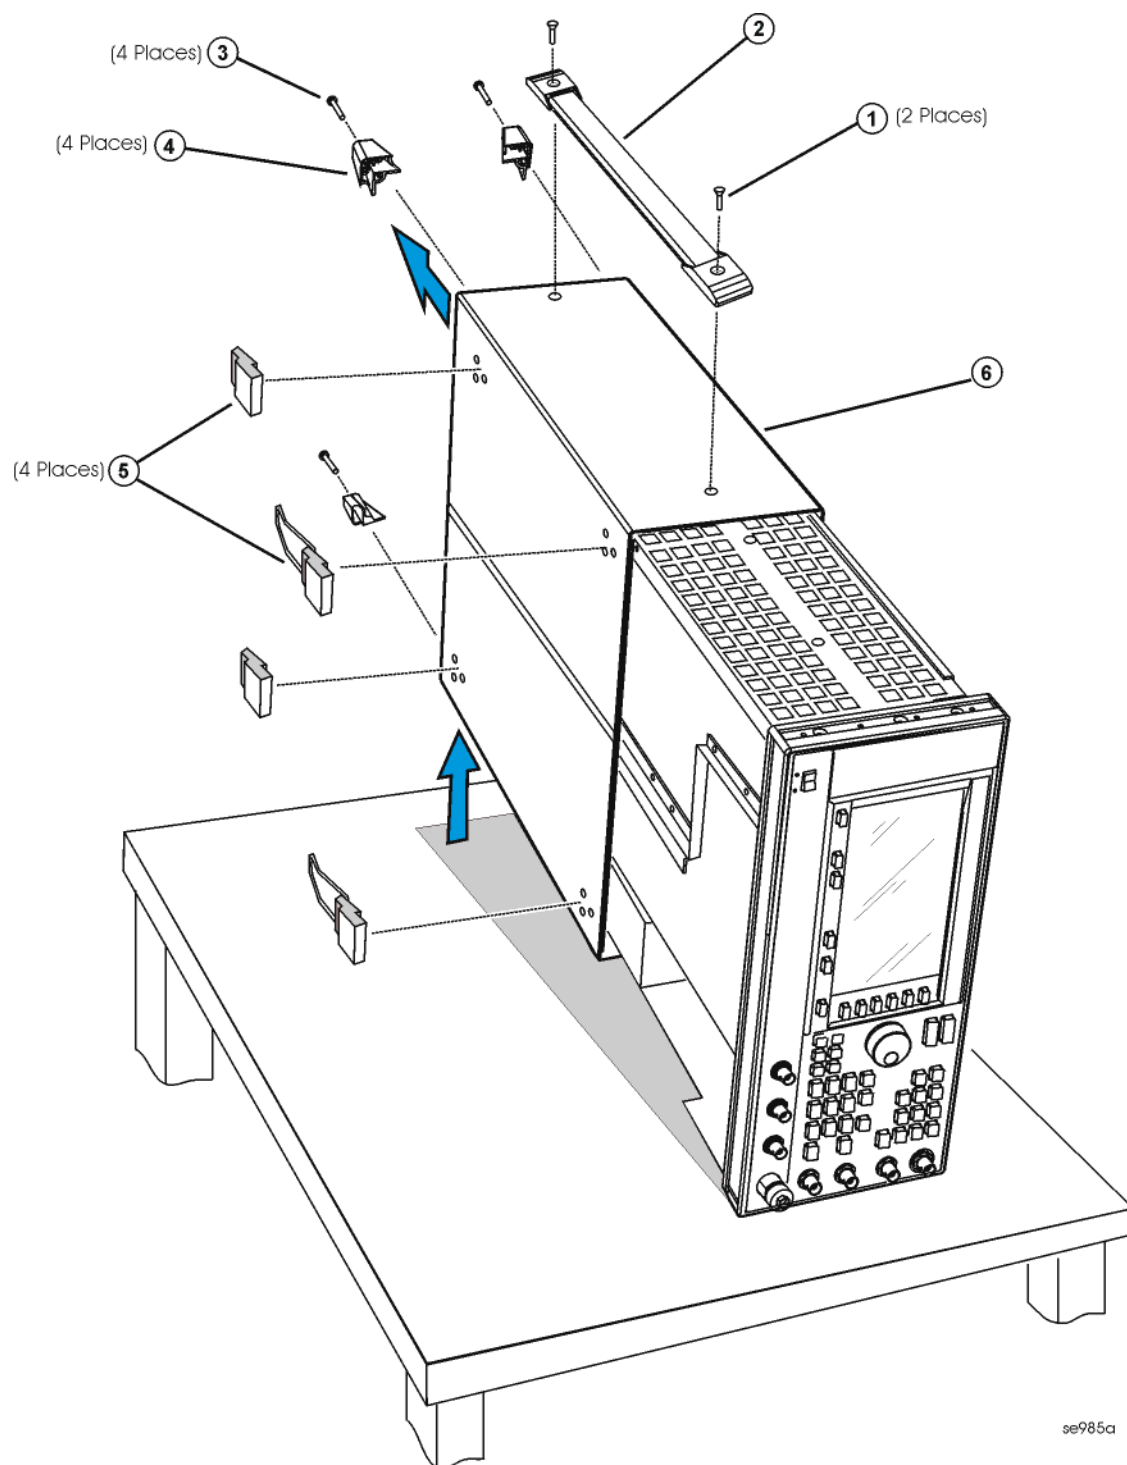
Figure 1 **Outer Cover Removal**

1. Disconnect the power cord.
2. Using a T-20 driver, loosen the two screws (1) and remove the strap handle (2).
3. Using a T-15 driver, remove the center screws (3) on the four rear-panel feet (4).
4. Remove the four bottom feet (5) from the cover by lifting the tab and sliding the foot toward the tab.
5. Place the signal generator on its side.
6. Tilt the signal generator forward and slide the outer cover (6) back to remove it from the frame.

Refer to [Figure 1](#).

Refer to [Figure 1](#) and [Figure 2](#).

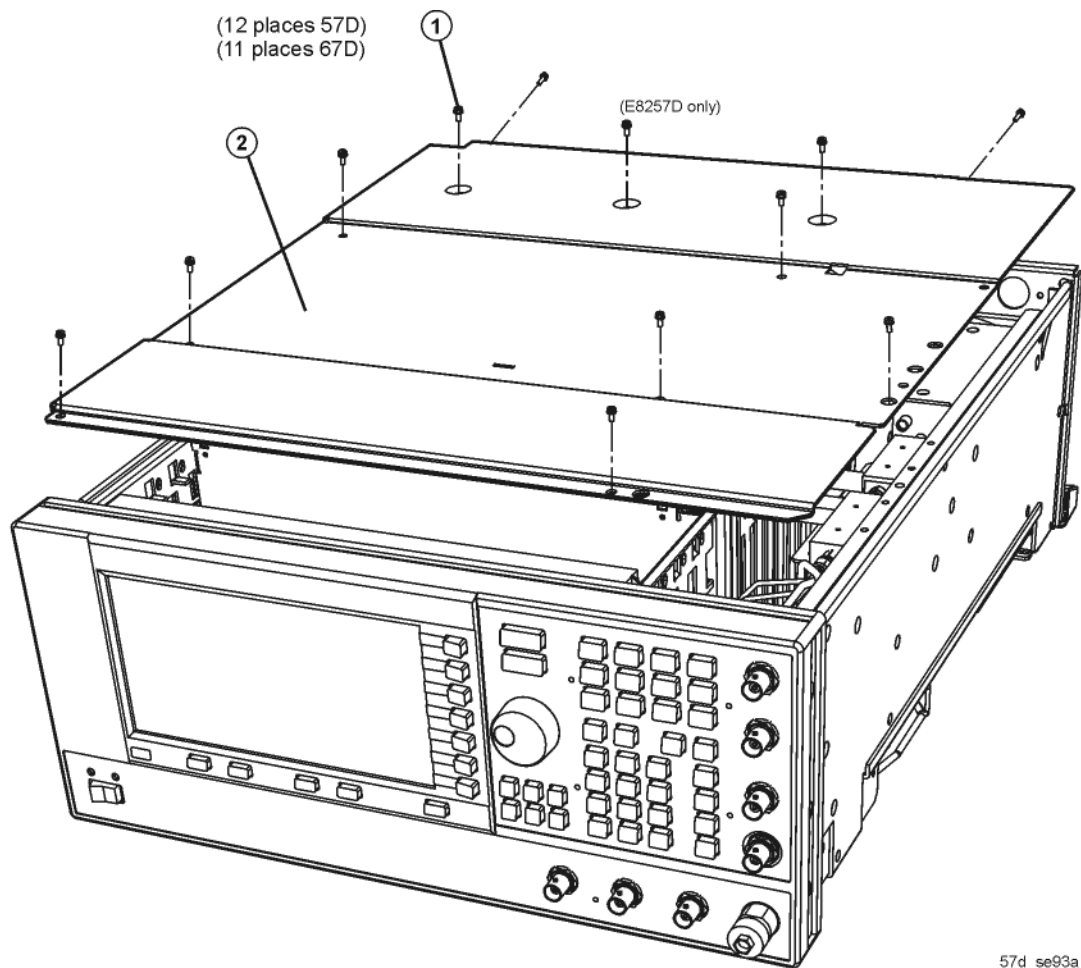
Figure 2

1. Using a T-10 driver, remove the twelve screws (1) from the inner-top cover (2).
2. Remove the inner-top cover.

Inner Top Cover Removal

Refer to [Figure 2](#).

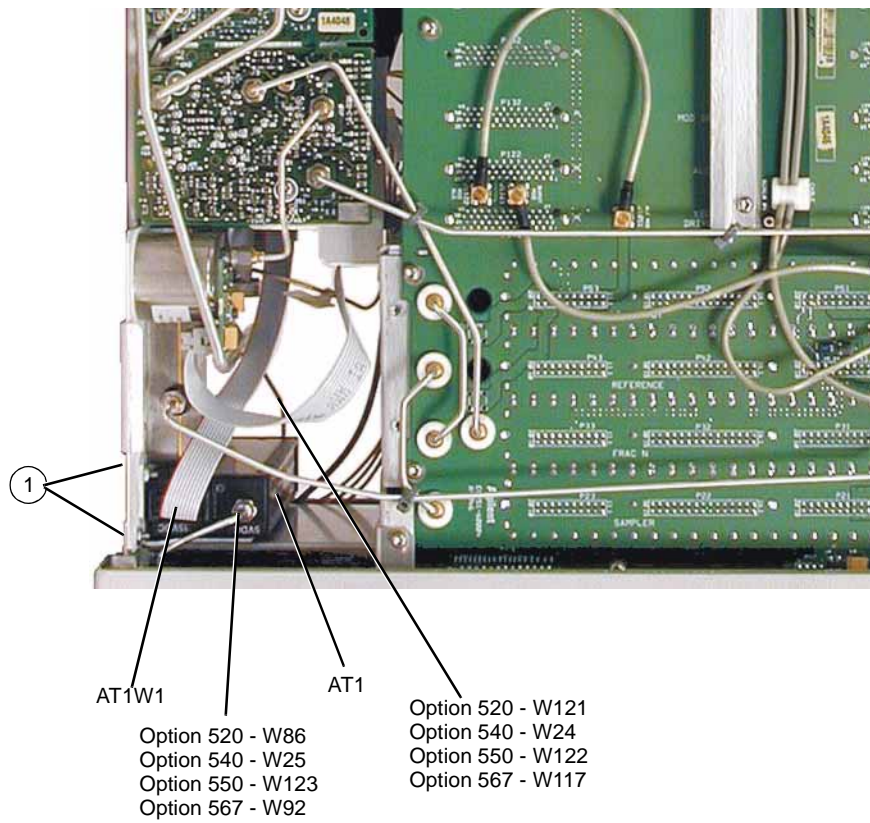
Figure 3

3. Refer to [Figure 3](#). Position the attenuator so it can be attached to the RF deck.
4. Using the T-10 driver, insert the two screws (1) through the side deck into the metal bracket that is attached to the attenuator. Torque these screws to 9 in-lbs.

Option 1E1 (Front Panel RF Output)

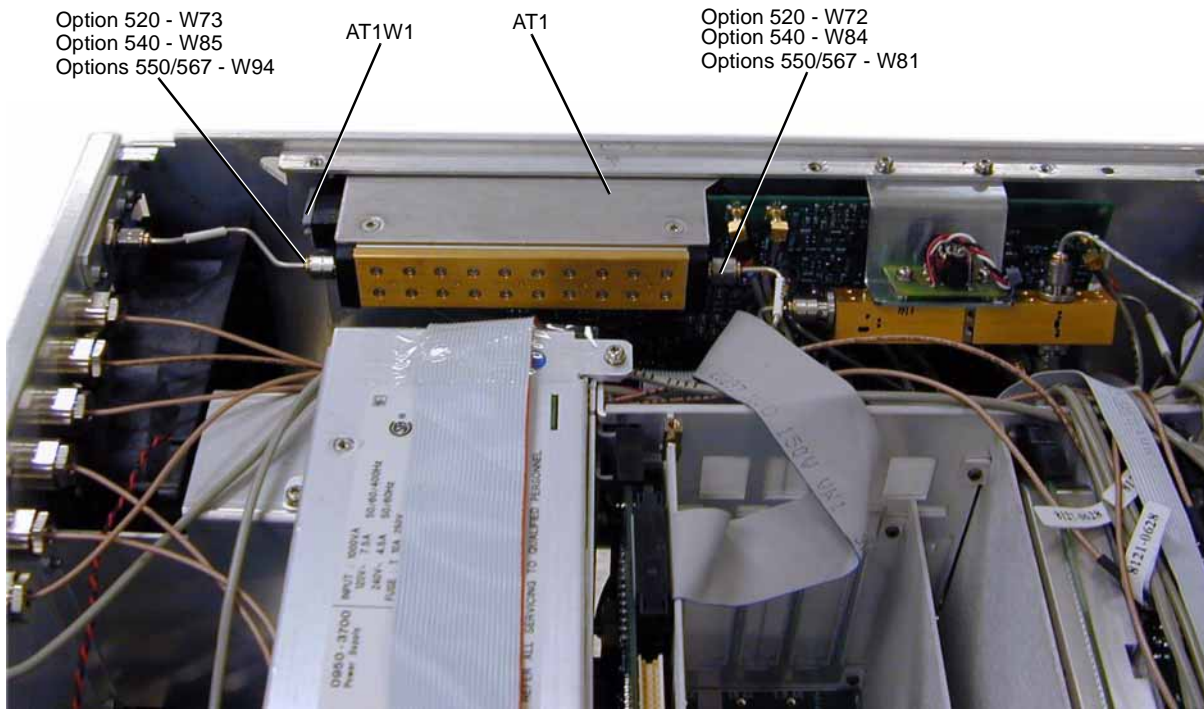
3. Refer to [Figure 4](#). Position the attenuator so it can be attached to the RF deck.
4. Using the T-10 driver, insert the two screws through the side deck into the metal bracket that is attached to the attenuator. Torque these screws to 9 in-lbs.

Figure 4 **Option 1E1 (Rear Panel RF Output)**
