Technical Service Bulletin: tsb101296

Released Date: 04-Aug-2003

Fan Hub Bearing Spacer

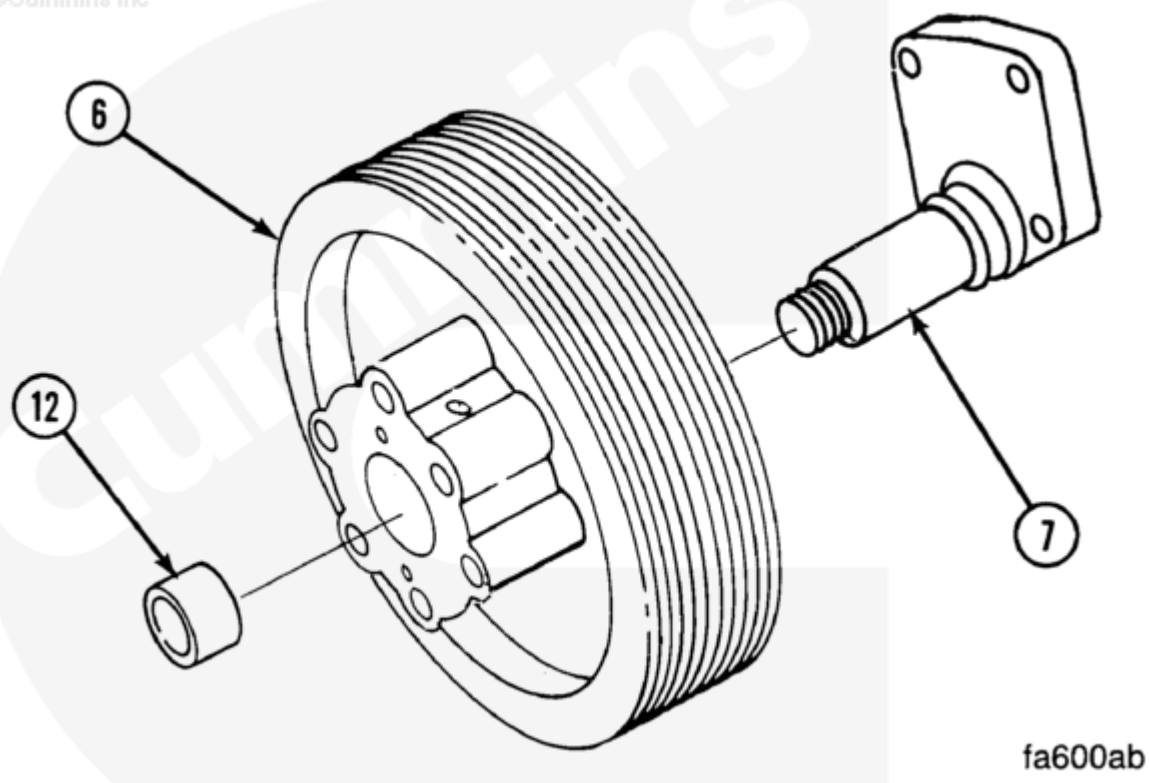
This service/parts topic introduces a new fan hub bearing spacer for the QSK45 and QSK60 engines equipped with a direct drive fan hub. The spacer is located between the two bearings in the fan hub. Its purpose is to maintain preload on the bearings within the fan hub to increase durability.

The spacer is denoted by arrow 12 in Figure 1 below.

Previous to the introduction of this spacer, the fan hub for QSK45 and QSK60 engines did **not** contain a spacer. When replacing the bearings or rebuilding the fan hub on engines built prior to the introduction of the fan hub bearing spacer, install the new spacer to the fan hub.

The new spacer, Part Number 4100760, was introduced in production at Daventry with engine serial number first 33152994 on 19-August-2002 and is compatible with all QSK45 and QSK60 engines fitted with the direct drive fan hub.
