TX3 SERIES FAQs

VOICE ACCESS

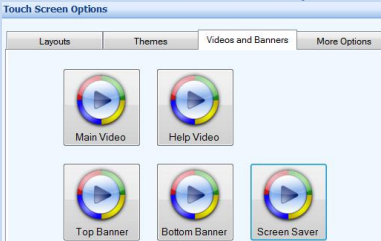
U5	Can you install your own screen saver on the TX3-TOUCH?	<ul style="list-style-type: none"> Yes, you simply use the configurator's Touch Screen>>Video banner's folder to upload your new video. Ensure that the video is of the same Video format as the default screensaver for operational assurance.

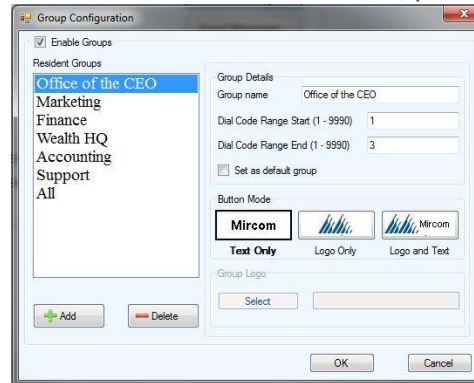
U6 Can you separate tenant's records in groups for the TX3-TOUCH?

- Yes, you simply go to advance>>"more Options">>Resident Groups to separate the tenants into groups. Ensure that the tenant's records are organized via dial codes. For more information, please see instruction manual.
