Technical Service Bulletin: TSB120250

Released Date: 28-Sep-2012

New QSK45/60 Tier 1 Exhaust Gas Temperature Sensor Harnesses

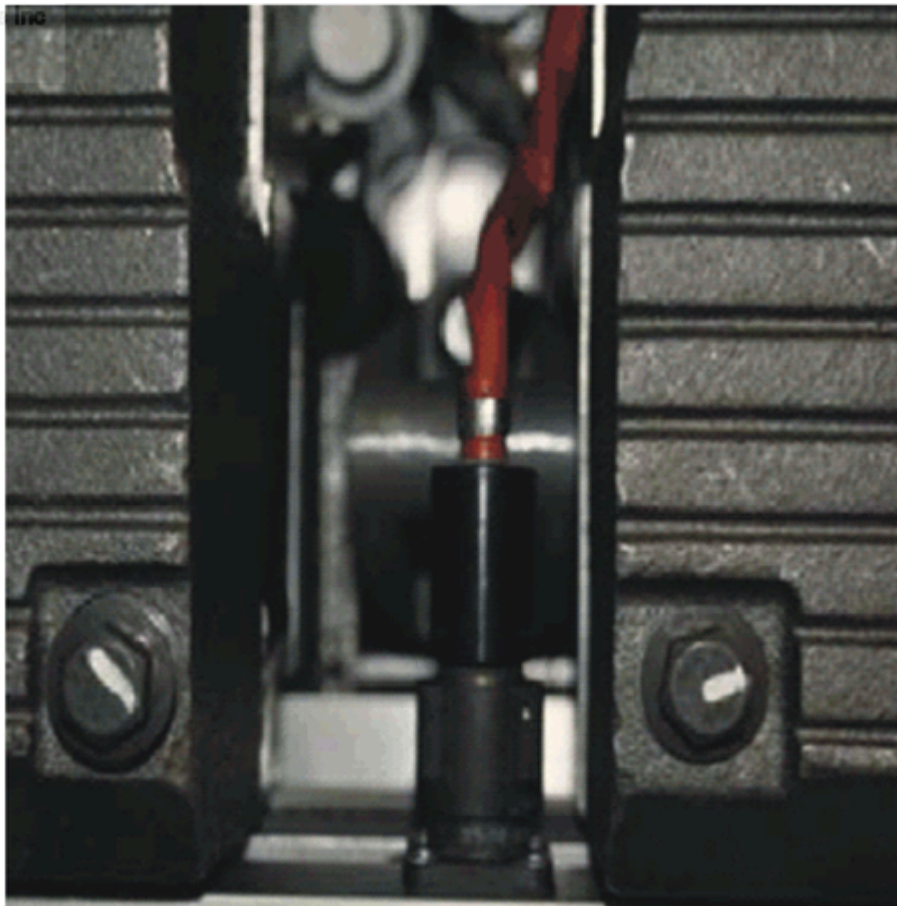
Figure 1. Original Connector Location

This document announces the release of new exhaust gas temperature sensor (EGTS) harnesses for Tier1 QSK45 and QSK60 engines. It was determined that damage could be caused to the EGTS harness when lifting the engine, due to the proximity of the lifting bracket to the EGTS connectors. This issue has been resolved by moving the connectors away from the lifting bracket.

The photographs show the original connector location (Figure 1) and the revised connector location (Figure 2).
