York Central – Phase 1C

Information Review and Basis of Design

0052817-BHE-XX-XX-RP-YG-0001

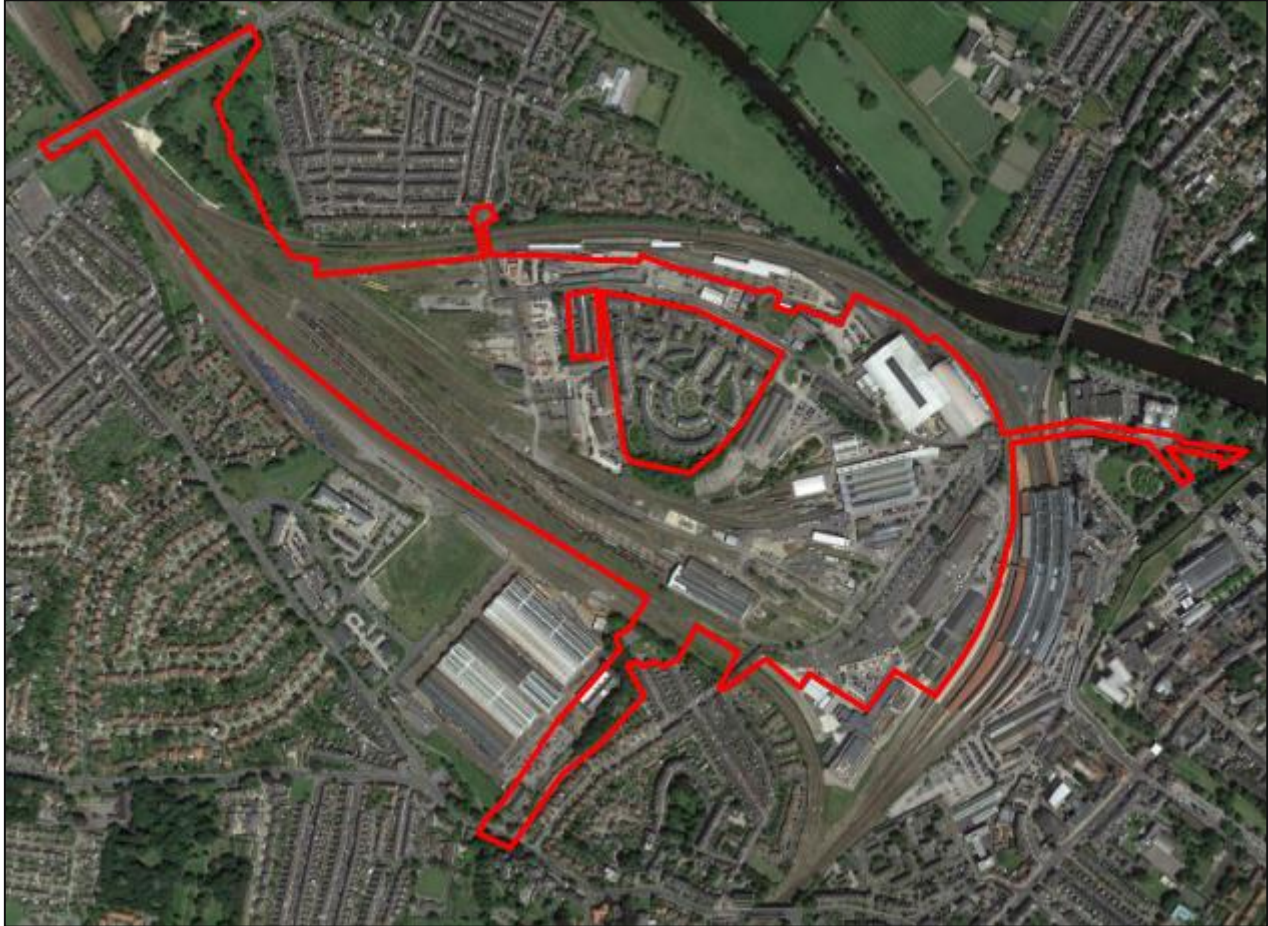
Figure 3-1 - Study area of Arup (2020) UXO Strategy report.

The purpose of the report was to provide a strategy for managing site-wide UXO risks during ground investigations and construction. The study area is shown by Figure 3-1 below and corresponds with the redline boundary for the York Central masterplan area.

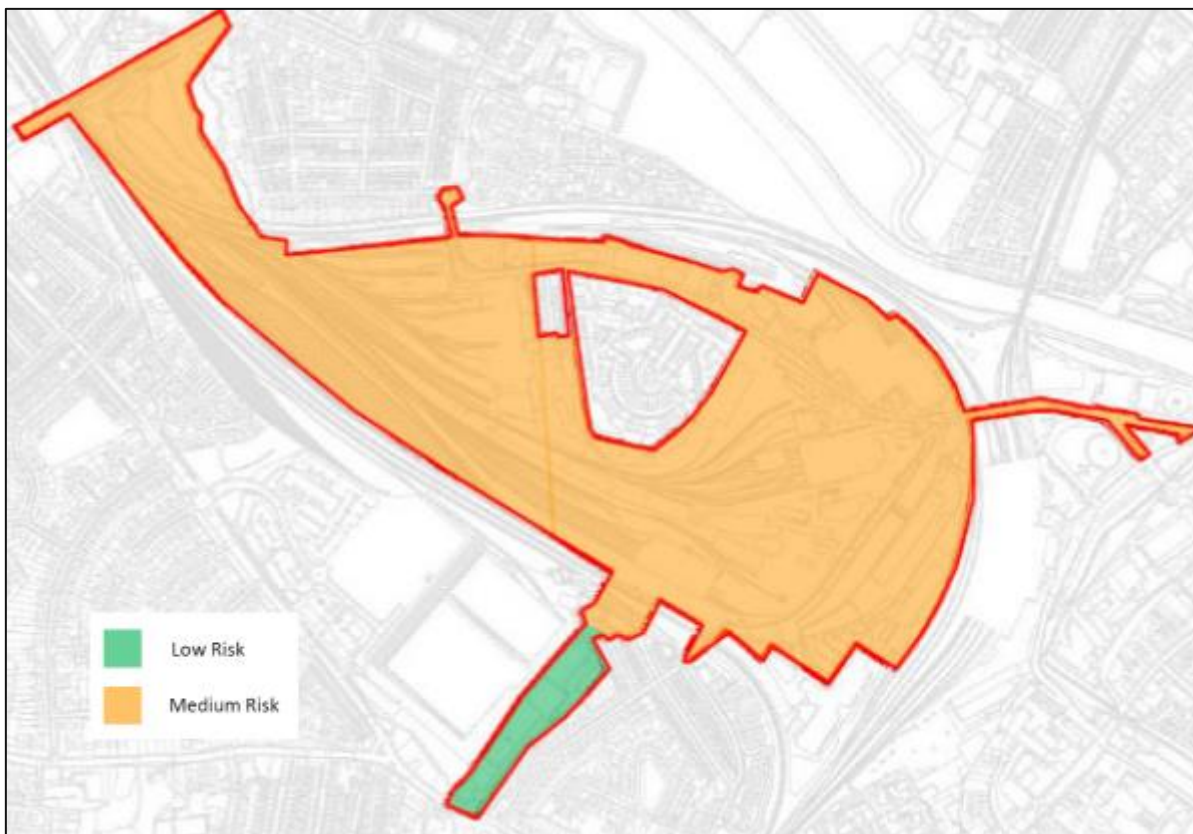
Figure 3-2 - UXO risk map from 1st Line Defence (2018) Detailed UXO Risk Assessment.

1st Line Defence was commissioned by Arup to conduct a Detailed UXO Risk Assessment for the proposed works at York Central in accordance with CIRIA . The report assessed the site to comprise areas of Medium and Low Risk from items of aerial delivered UXO, see Figure 3-2.

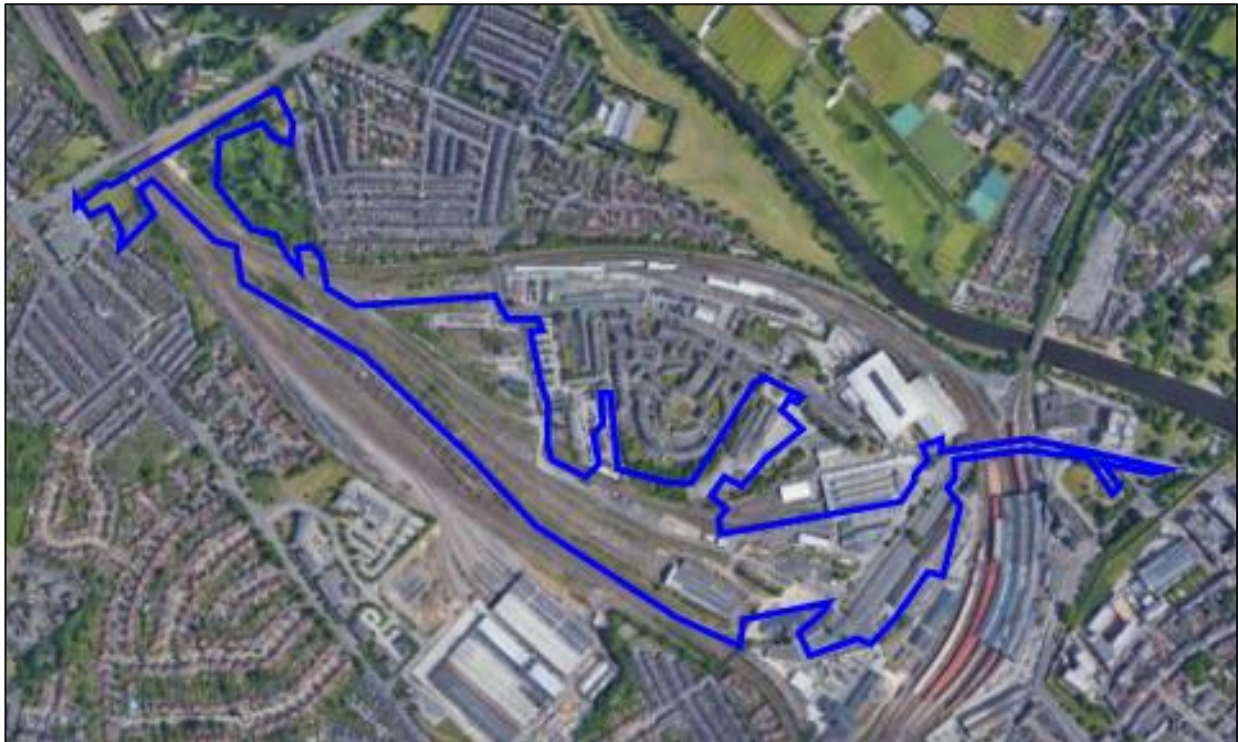
Figure 3-3 - Study area of Zetica UXO (2022) UXO Desk Study & Risk Assessment

Zetica Ltd was commissioned by WSP to carry out a UXO Desk Study & Risk Assessment for part of the York Central site. The study area appears to correspond with the IP2 works boundary, however this isn't stated / confirmed in the report (see Figure 3-3).

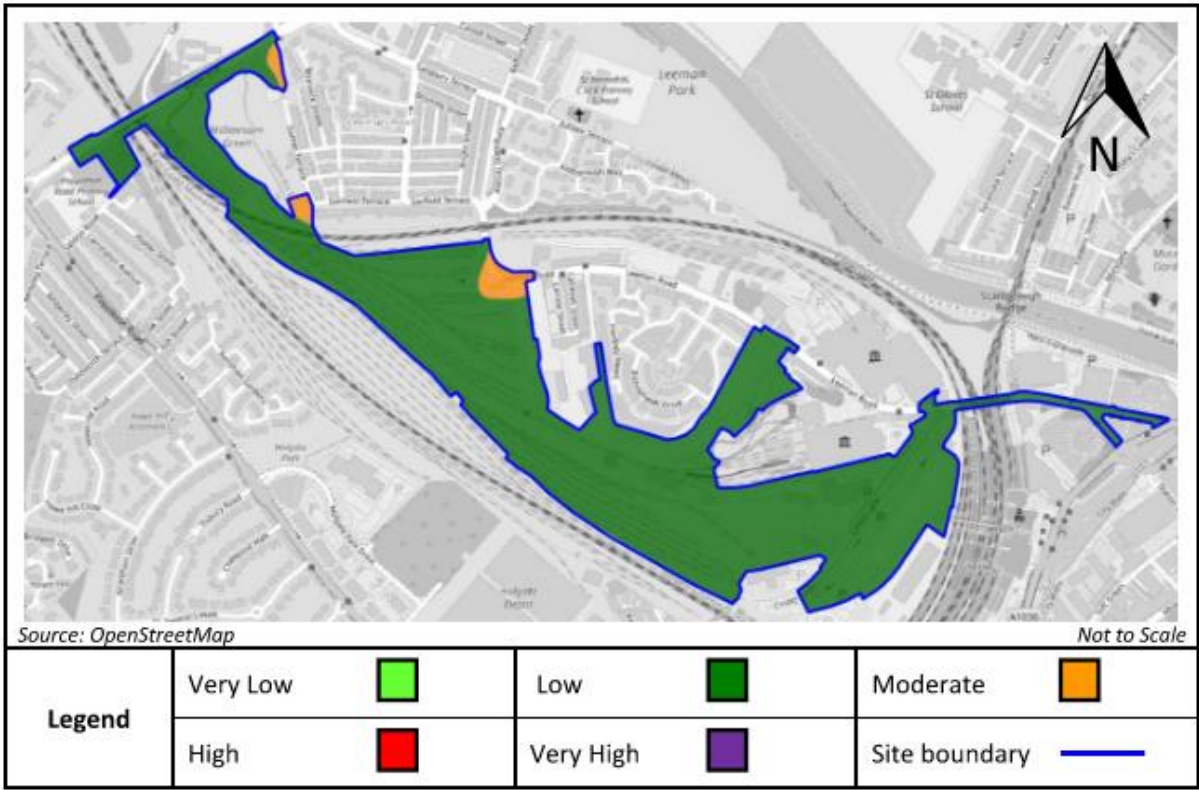
Figure 3-4 - UXO risk map from Zetica UXO (2022) UXO Desk Study & Risk Assessment

Zetica assigned areas of the site with recorded bomb a moderate risk associated with UXO. The remainder of the site was assigned a low risk associated with UXO, see Figure 3-4.

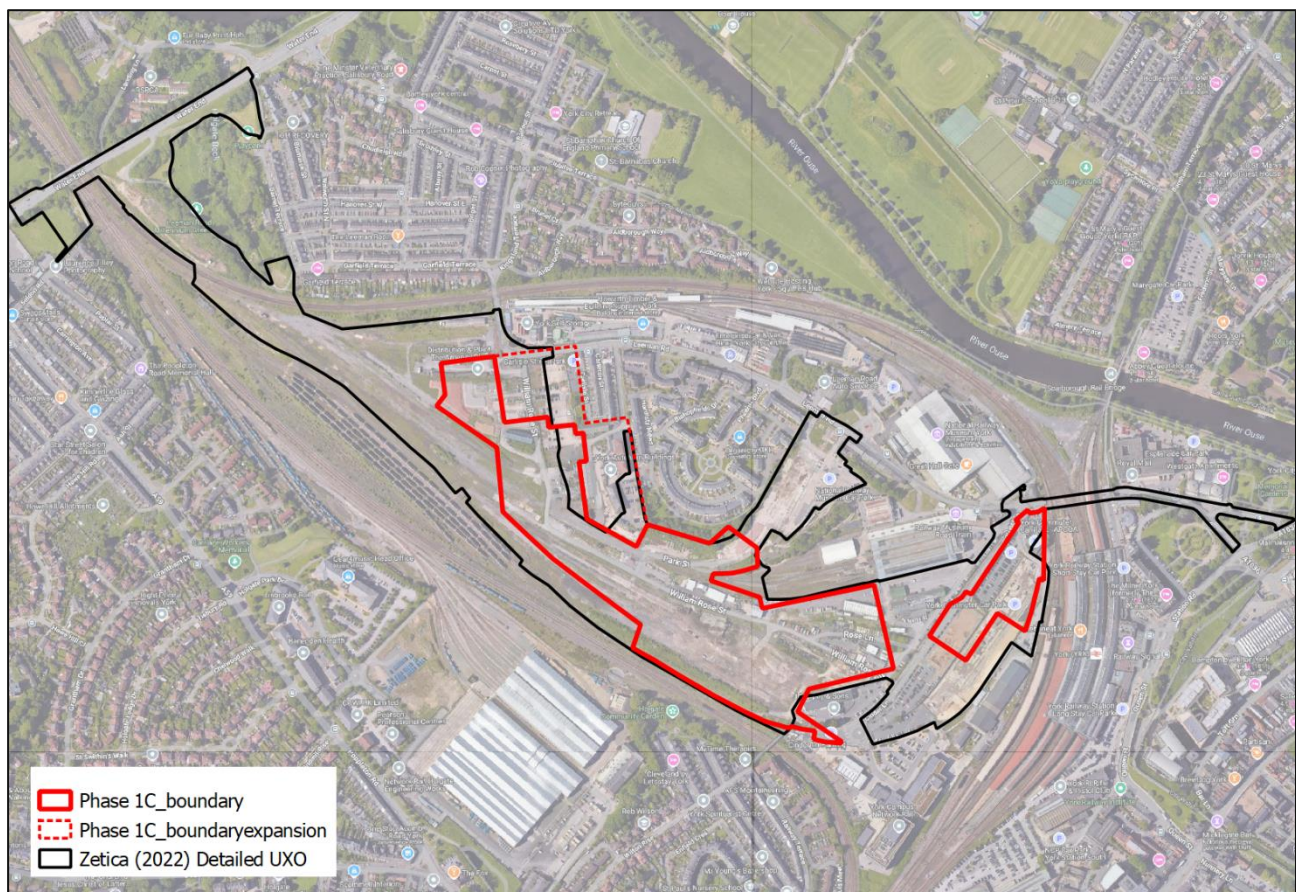
Figure 3-5 - Zetica (2022) Detailed UXO Risk Assessment boundary (IP2 works) compared with Phase 1C boundary.

7. It may be worthwhile to commission an additional Detailed UXO Risk Assessment specific to the Phase 1C area. Any additional Detailed UXO Risk Assessment should take in account local ground investigation information and details of post-WWII development – in particular recent IP2 works which likely overlap with the Phase 1C area (see Figure 3-5).

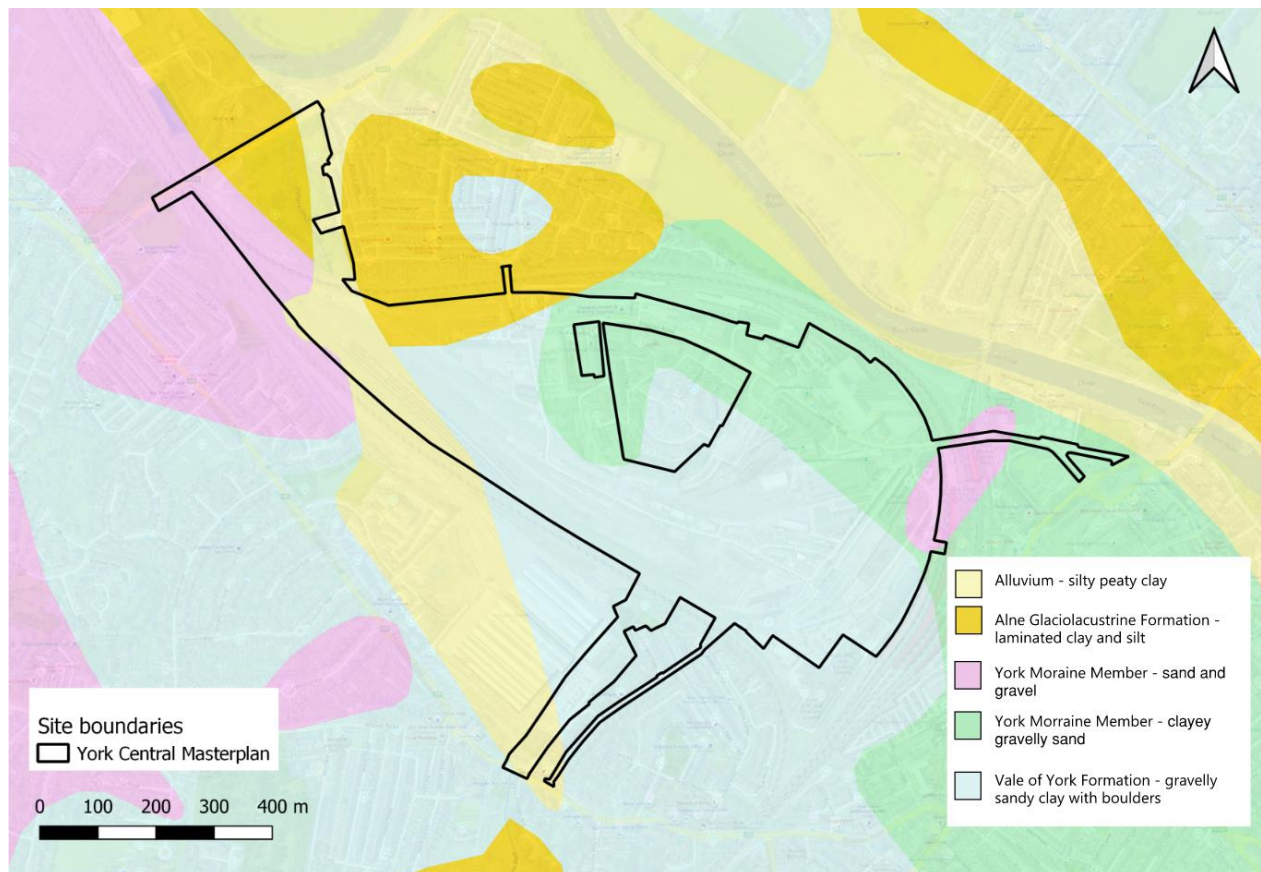
Figure 4-2 - 1:50,000 Superficial Geology (British Geological Survey, 2025)

Made Ground has been identified across the site with local variation in composition and thickness associated with historical land use – typically between 0.3 and 2.0m bgl, but locally to between 2.0m bgl and 4.0m bgl. Made Ground is underlain by superficial deposits from several geological units, see Figure 5-3 and Figure 5-2. These include Alluvium, Aine Glaciolacustrine Formation, York Moraine Member and the Vale of York Formation, which all outcrop at surface or are present beneath Made Ground. The Hemingborough Glaciolacustrine Formation is present at depth, above bedrock. Beneath the superficial deposits is bedrock of the Sherwood Sandstone Group, described as extremely weak to weak fine to medium grained sandstone – with the upper part sometimes weathered. The depth and elevation of the upper surface varied considerably throughout the site, varying between 12m bgl and 38.3m bgl.
