Technical Service Bulletin: tsb100166

Released Date: 19-Jun-2002

New Cam Follower Shaft Dowel Rings

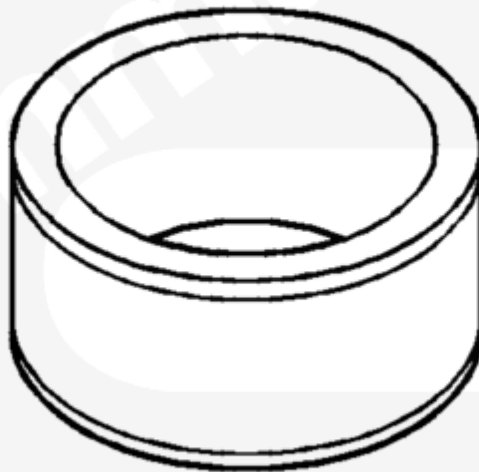
04a00021

The affected applications are all QST30 engines made prior to August 16, 2001 and prior to engine serial number 37199919. This change is implemented due to a possible assembly issue with the previous ring dowels. The old dowels were soft enough to mislocate and deform upon initial installation, thus possibly mislocating the cam follower shaft and causing capscrew clamp load problems. No stock of the old dowel is left in factory production, as of September 17, 2001

Engine serial first for the new, hardened dowel rings is 37199919, built August 16, 2001. This new dowel ring, Part Number 4067993, supersedes Part Number 3092504 for the cam follower assemblies **only**.
