BURNED-AREA REPORT
(Reference FSH 2509.13)

- A. Fire Name: South Umpqua Complex B. Fire Number: OR-UPF-000264
C. State: OR D. County: Douglas and Jackson Counties
E. Region: 6 F. Forest: Umpqua and Rogue River Siskiyou
G. District: Tiller (UNF) and High Cascades (RRSNF) Ranger Districts H. Fire Incident Job Code: P6LOQ2
I. Date Fire Started: July 15, 2018 J. Date Fire Contained: 9/13/2018 (65% contained)
K. Suppression Cost: \$82,580,966

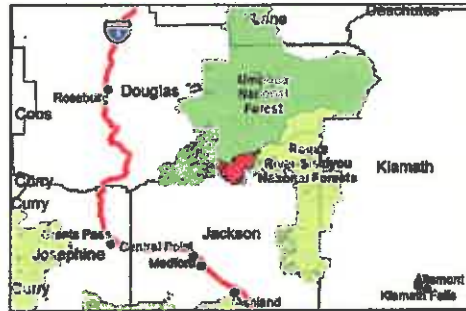
South Umpqua Complex - Miles Final Soil Burn Severity - September 14, 2018

Soil Burn Severity

Severity	Acres
High	1,133
Moderate	9,918
Low	26,948
Unburned	1,086

Fire	Unburned	Low	Moderate	High	Unmapped within Fire Perimeter	Grand Total
Columbus	170 (2%)	9,362 (84%)	1,359 (12%)	110 (1%)	29	11,030
Miles	1,086 (3%)	26,948 (69%)	9,918 (25%)	1,133 (3%)	1	39,085
Total Acres	1,256 (2%)	36,310 (67%)	11,277 (21%)	1,243 (3%)	9	50,115
