Technical Service Bulletin: TSB101061

QST30 Piston Ring Set - Top Compression Ring Change for Service

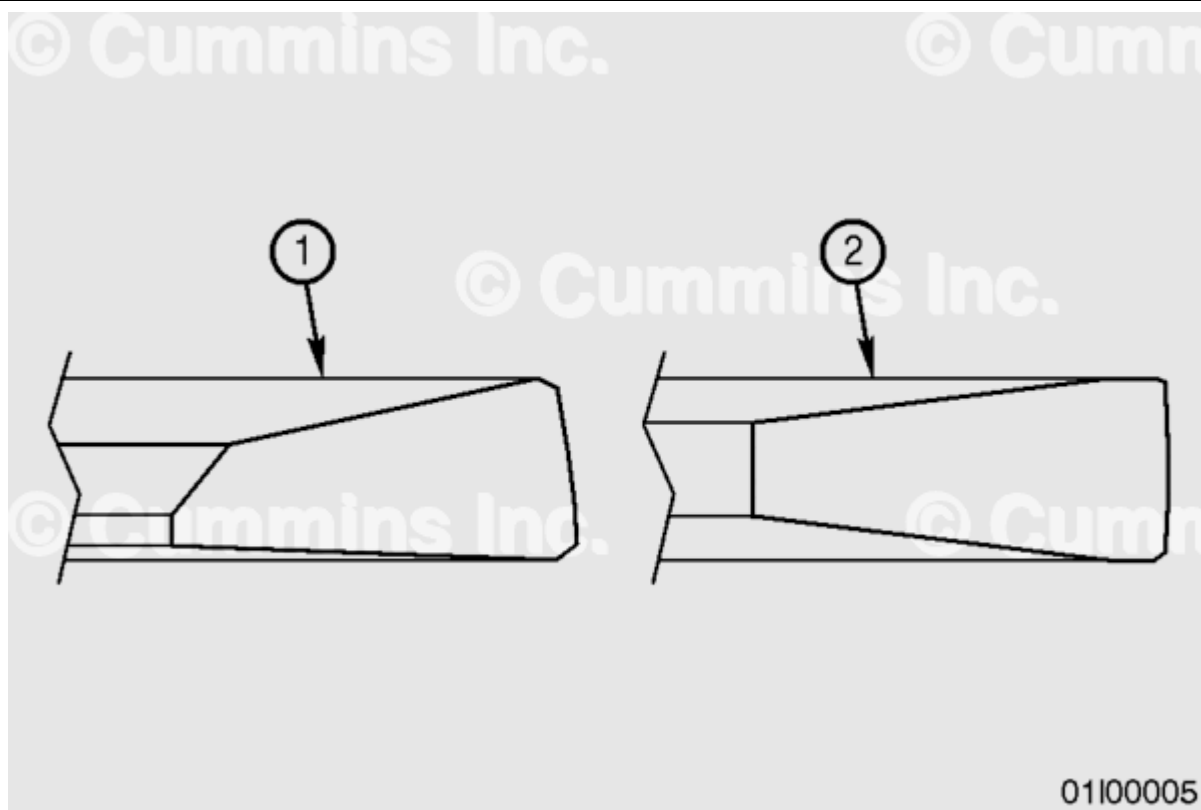
The two different top compression rings are interchangeable, but can be identified by the difference in appearance. The new service top compression piston ring has a white paint mark and the top compression piston ring installed from the factory has an orange color paint mark. The two top compression rings also have different profiles that are shown in Figure 1.

Figure 1. Profile of New Service Top Compression Piston Ring (left) and Profile of Factory Installed Top Compression Piston Ring and Old Service Top Compression Piston Ring (right).

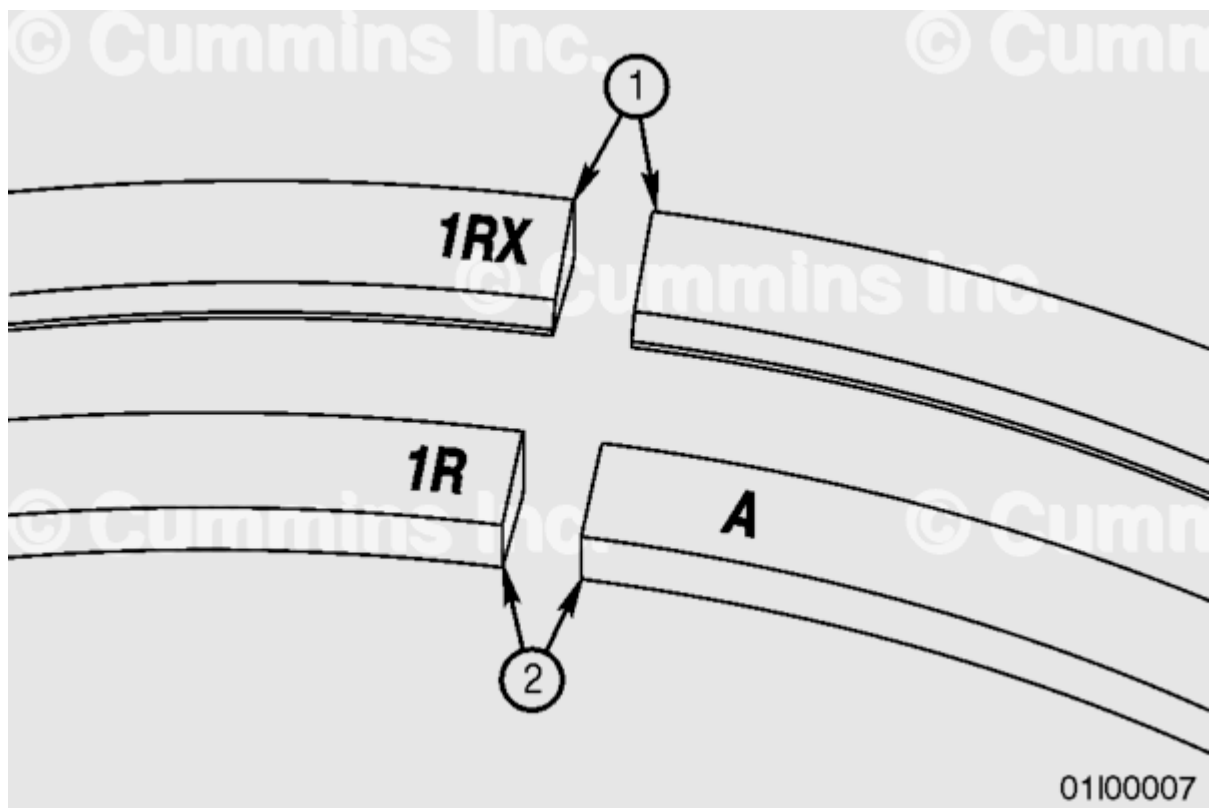
Different markings appear on the two top compression rings. The top compression ring used for service (1) is marked with "1RX" and the top compression piston ring formerly used for service and presently installed in the factory (2) is marked with "1R" on one side of the end gap and "A" on the other side. These markings are shown in Figure 2.

Figure 2. Locations of distinguishing markings on both top compression piston rings.

When installing all piston rings, make sure the identification markings are facing up.
