BURNED-AREA REPORT
(Reference FSH 2509.13)**PART I - TYPE OF REQUEST**

- A. Fire Name: Soldier Basin B. Fire Number: AZ-CNF-000274
C. State: Arizona D. County: Santa Cruz
E. Region: Southwestern (3) F. Forest: Coronado
G. District: Sierra Vista H. Fire Incident Job Code: P3HG5M
I. Date Fire Started: 05/17/2013 J. Date Fire Contained: 05/28/2013
K. Suppression Cost: \$1,400,000 on 05/28/2013
L. Fire Suppression Damages Repaired with Suppression Funds
 1. Fireline waterbarred (miles): Handline - 6
 2. Fireline seeded (miles): 0
 3. Other (identify): 1 Petroglyph site
M. Watershed Numbers: 150503010203 (Harshaw Creek), 150503010206 (Middle Sonoita Creek), 150503010303 (Canada de la Paloma – Sanata Cruz River)
N. Total Acres Burned: 10,773 total acres
 NFS Acres(10,225) Other Federal () State () Private (548)

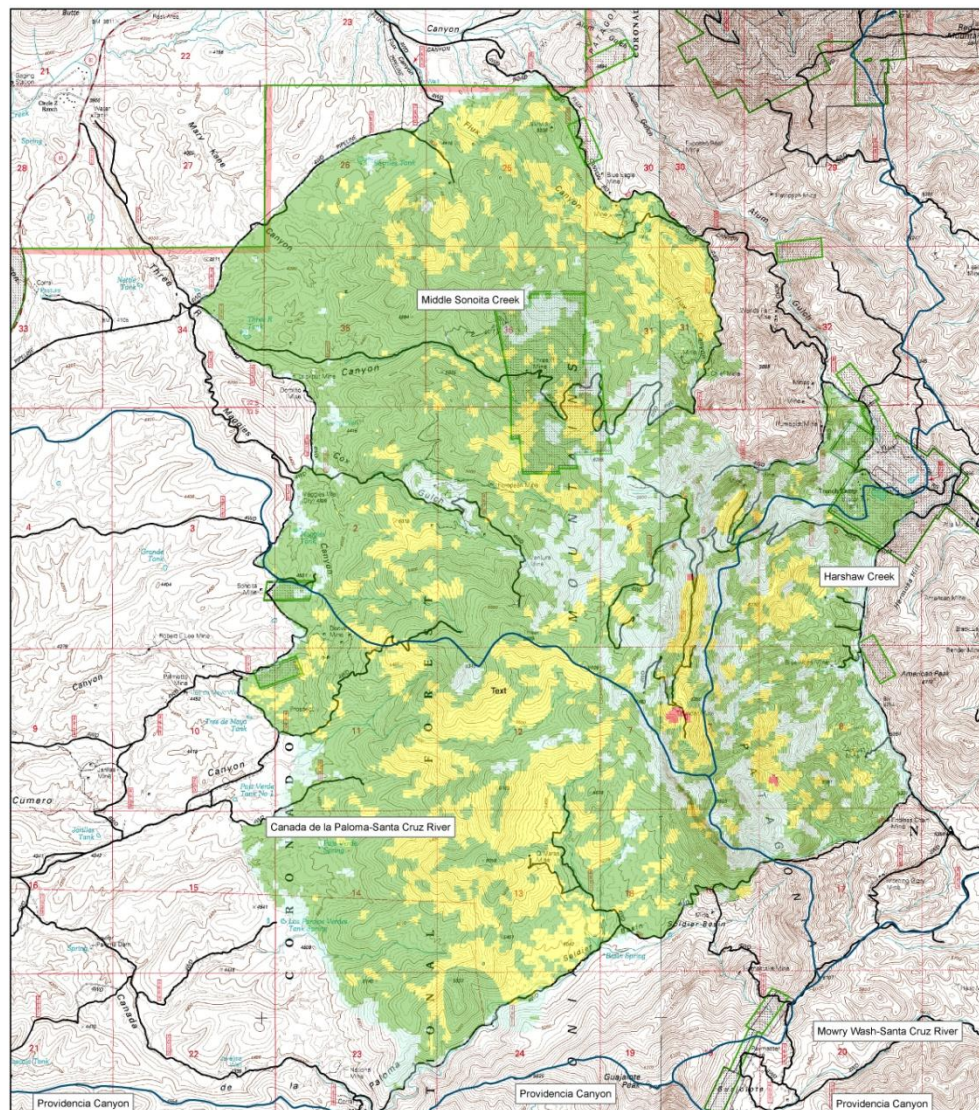
APPENDIX A. Soil Burn Severity Map

Soldier Basin Fire
BAER Assessment Team
Final Soil Burn Severity
June 2, 2013

Soil Burn Severity
