Technical Service Bulletin: TSB120224

Released Date: 08-Mar-2022

New Turbocharger Kit Containing B16 bolt for 0.25 mm [0.010 in] Shim

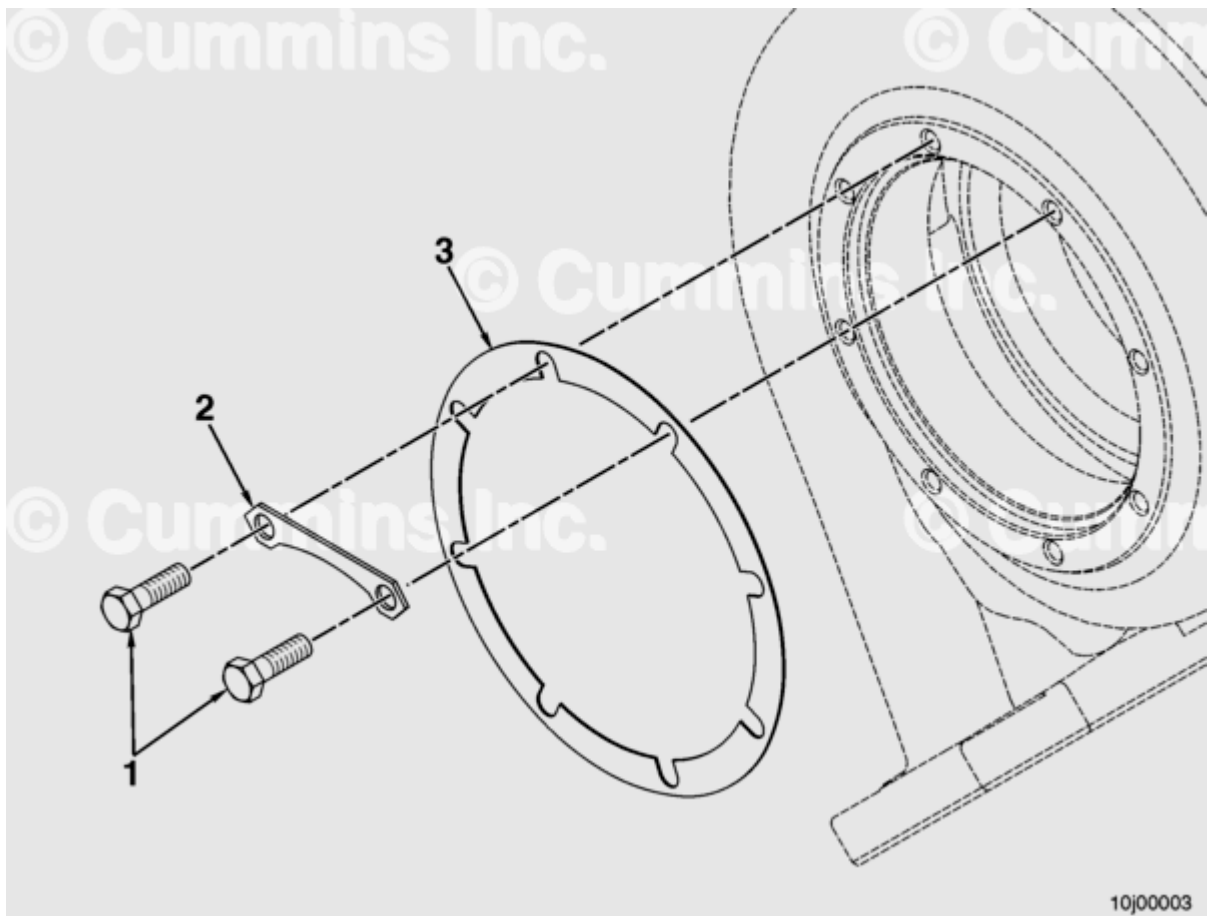
Figure 1 - Turbocharger Kit, Part Number 4034095 Contents

This document announces the release of a new turbocharger kit, Part Number 5357484. This kit is intended as a Step 3 solution for an active serious quality problem project investigating the A286 stainless steel capscrews breaking in the bearing-to-turbine housing joint. The turbocharger kit will contain new B16 capscrews (1), and new lock plates (2). The 0.25 mm [0.010 in] shim is fitted between the flange of the bearing housing and the turbine housing. See Figure 2 (ordered separately).

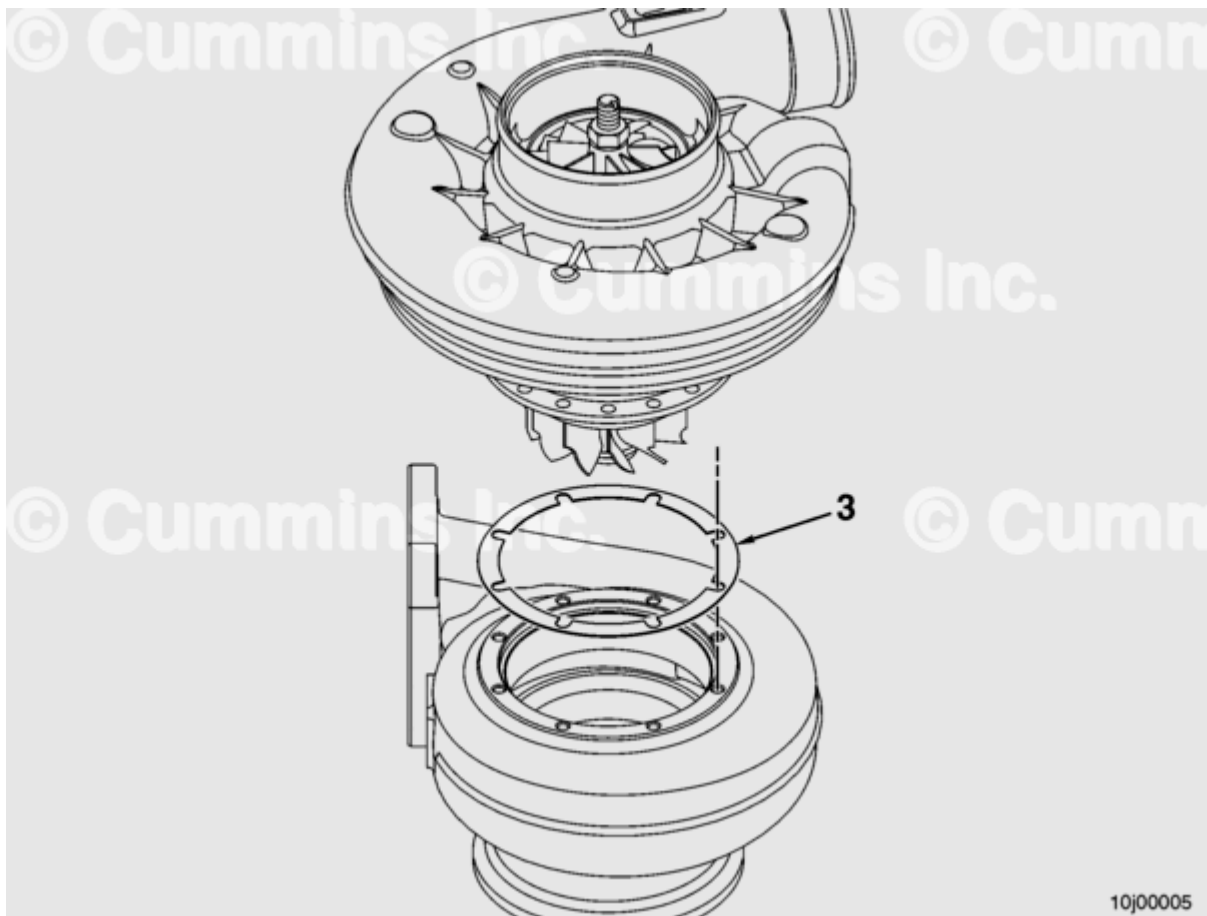
Figure 2 - Shim Location

Shims can only be installed on turbochargers that do not use the C-seal.

This kit will also contain an installation sheet with instructions on how to install the shim.
