Date of Report: 9/12/2020**BURNED-AREA REPORT**

PART II - BURNED-AREA DESCRIPTION**A. Fire Name:** Lake**B. Fire Number:** CA-ANF-03273**C. State:** CA**D. County:** Los Angeles**E. Region:** 05**F. Forest:** Angeles**G. District:** Los Angeles Gateway**H. Fire Incident Job Code:** P5NE45 - 0501**I. Date Fire Started:** 8/12/2020 @ 1540**J. Date Fire Contained:** 95% 9/12/20**K. Suppression Cost:** 63m**L. Fire Suppression Damages Repaired with Suppression Funds (estimates)**

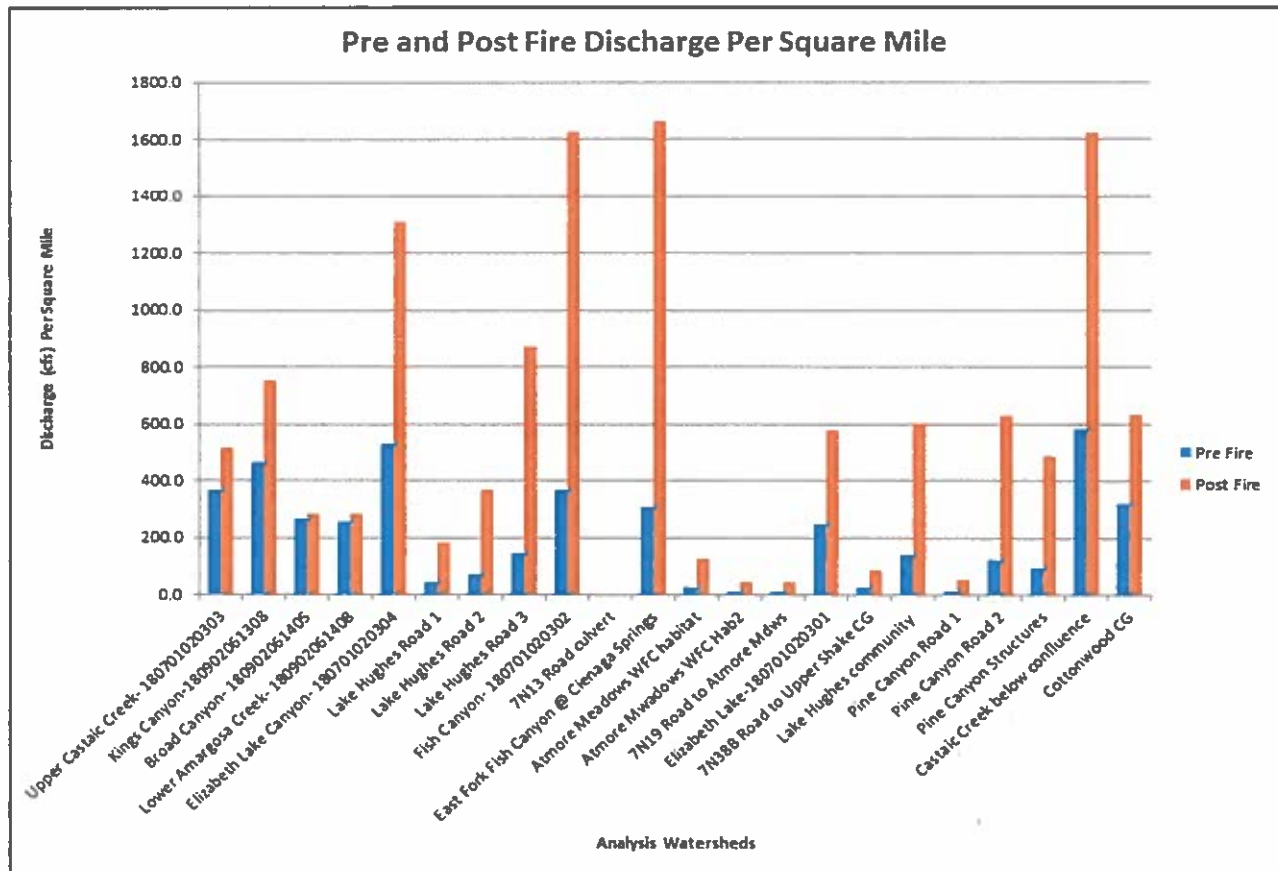
• Pine Canyon Road 2	5.13	23.5	122.19	95,046.5	4,206.3	5.20	22.60
• Pine Canyon Structures	3.33	28.2	145.96	64,438.4	2,733.7	5.18	23.57
• Castaic Creek below confluence	64.81	9.0	25.01	411,488.4	53,143.1	2.78	7.74

• Cottonwood CG	26.72	12.0	23.72	118,575.2	22,177.9	1.98	5.35
Modeled Storm: Storm: 2 year. 3-hour (1.44 inches)
