Technical Service Bulletin: TSB200195

Insite Data Monitor Exhaust Temperature Sensor Display Issue

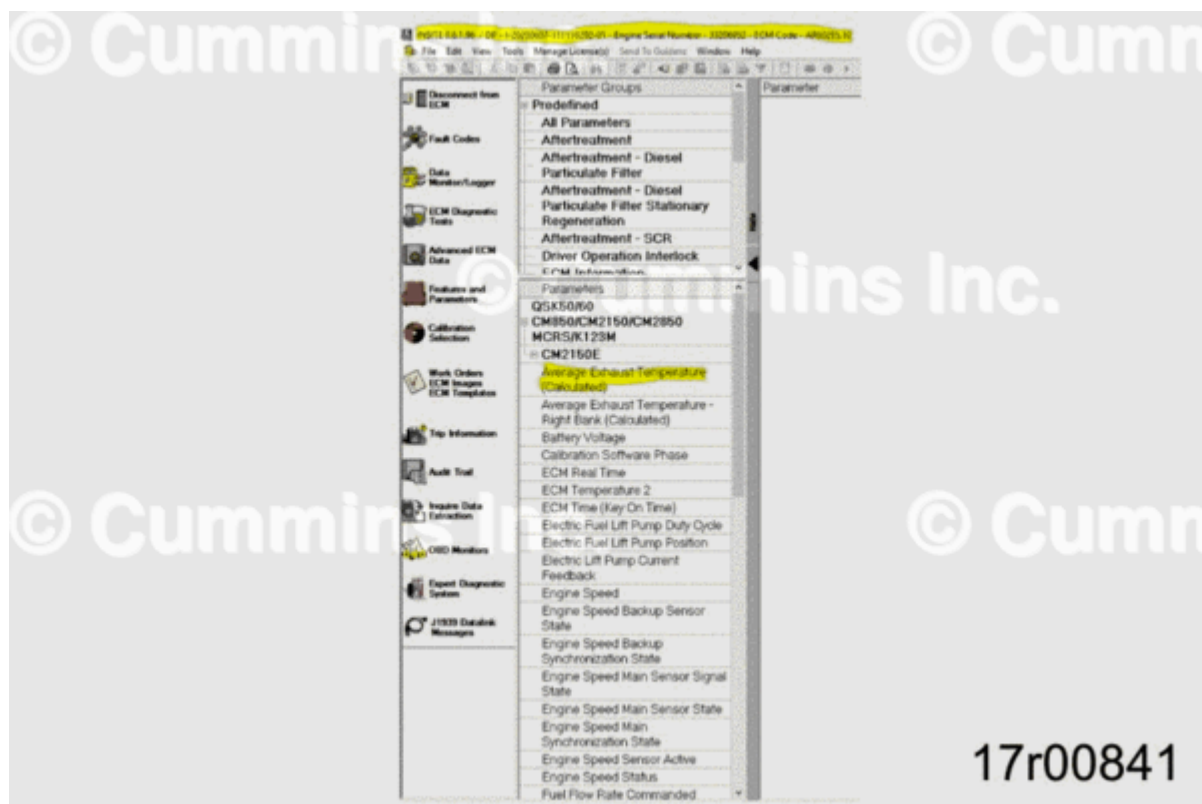
Root Cause: Insite version 8.6.1.96 does not have the ability to display exhaust temperature sensors individually.

The Insite version mentioned above produces a display as shown.

Figure 1, Individual Exhaust Temperature Sensors Not Visible

Contact Cummins IT to downgrade Insite to previous version 8.6.0.104 or 8.6.0.116 to display individual exhaust temperature sensors.

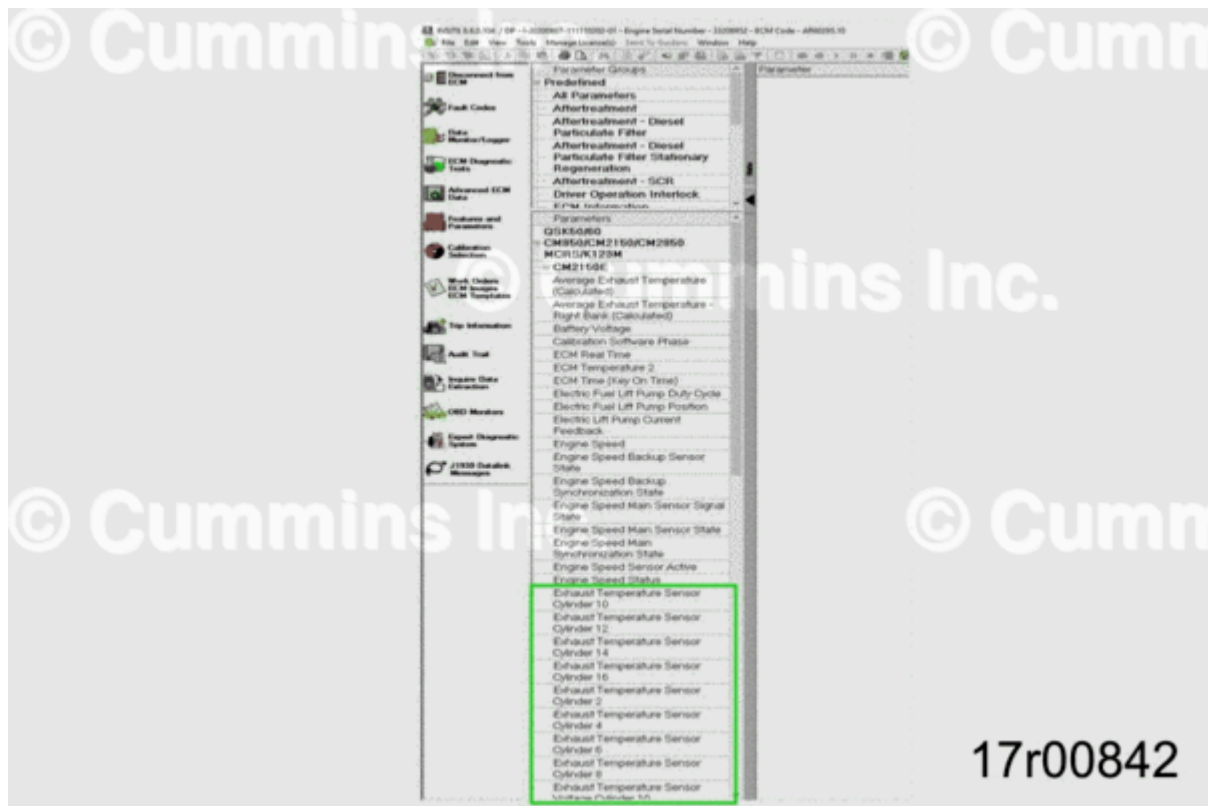
Figure 2, Visible Individual Exhaust Temperature Sensors

The ability to view individual exhaust temperature sensors will work when Insite 8.7.0 is released.
