Date of Report: July 14, 2016

**BURNED-AREA REPORT**  
(Reference FSH 2509.13)

**A. Fire Name:** Pine

**F. Forest:** Los Padres

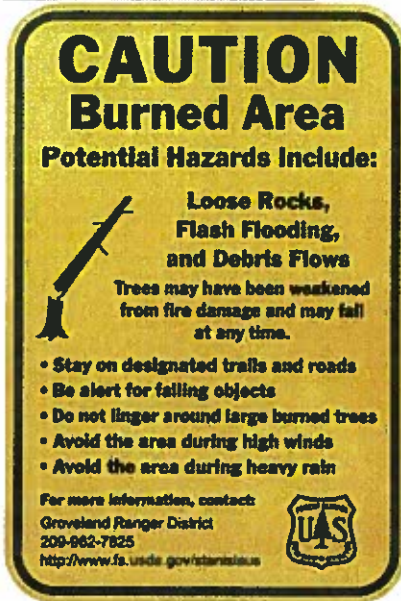
Examples of signs are:

Burned area signs warn the public identifying of the possible dangers associated with a burned area on major entry points into the burned area and recreational areas. They shall contain language specifying items to be aware of when entering a burn area such as falling trees and limbs, rolling rocks, and flash floods.

**General Description:** This treatment is for the installation of burned area warning signs. Five trailheads provide access to the burn area. The BAER team recommends placing "Caution – Burned Area" signs at the following trailheads: Reyes Creek, Reyes Peak, Piedra Blanca, Cedar Creek, and Fish Bowls.
