**Date of Report: September 22, 2022****BURNED-AREA REPORT****PART I - TYPE OF REQUEST****A. Type of Report**

**PART II - BURNED-AREA DESCRIPTION****A. Fire Name: Four Corners****B. Fire Number: ID-PAF-005394****C. State: Idaho****D. County: Valley, Gem and Adams****E. Region: 04****F. Forest: Boise NF and Payette NF****G. District: Cascade, Emmett and Council****H. Fire Incident Job Code: P4POFD22****I. Date Fire Started: August 13, 2022****J. Date Fire Contained: Est. 09/24/2022****K. Suppression Cost: \$37,900,000 (as of 09/20/2022)****L. Fire Suppression Damages Repaired with Suppression Funds (estimates):**

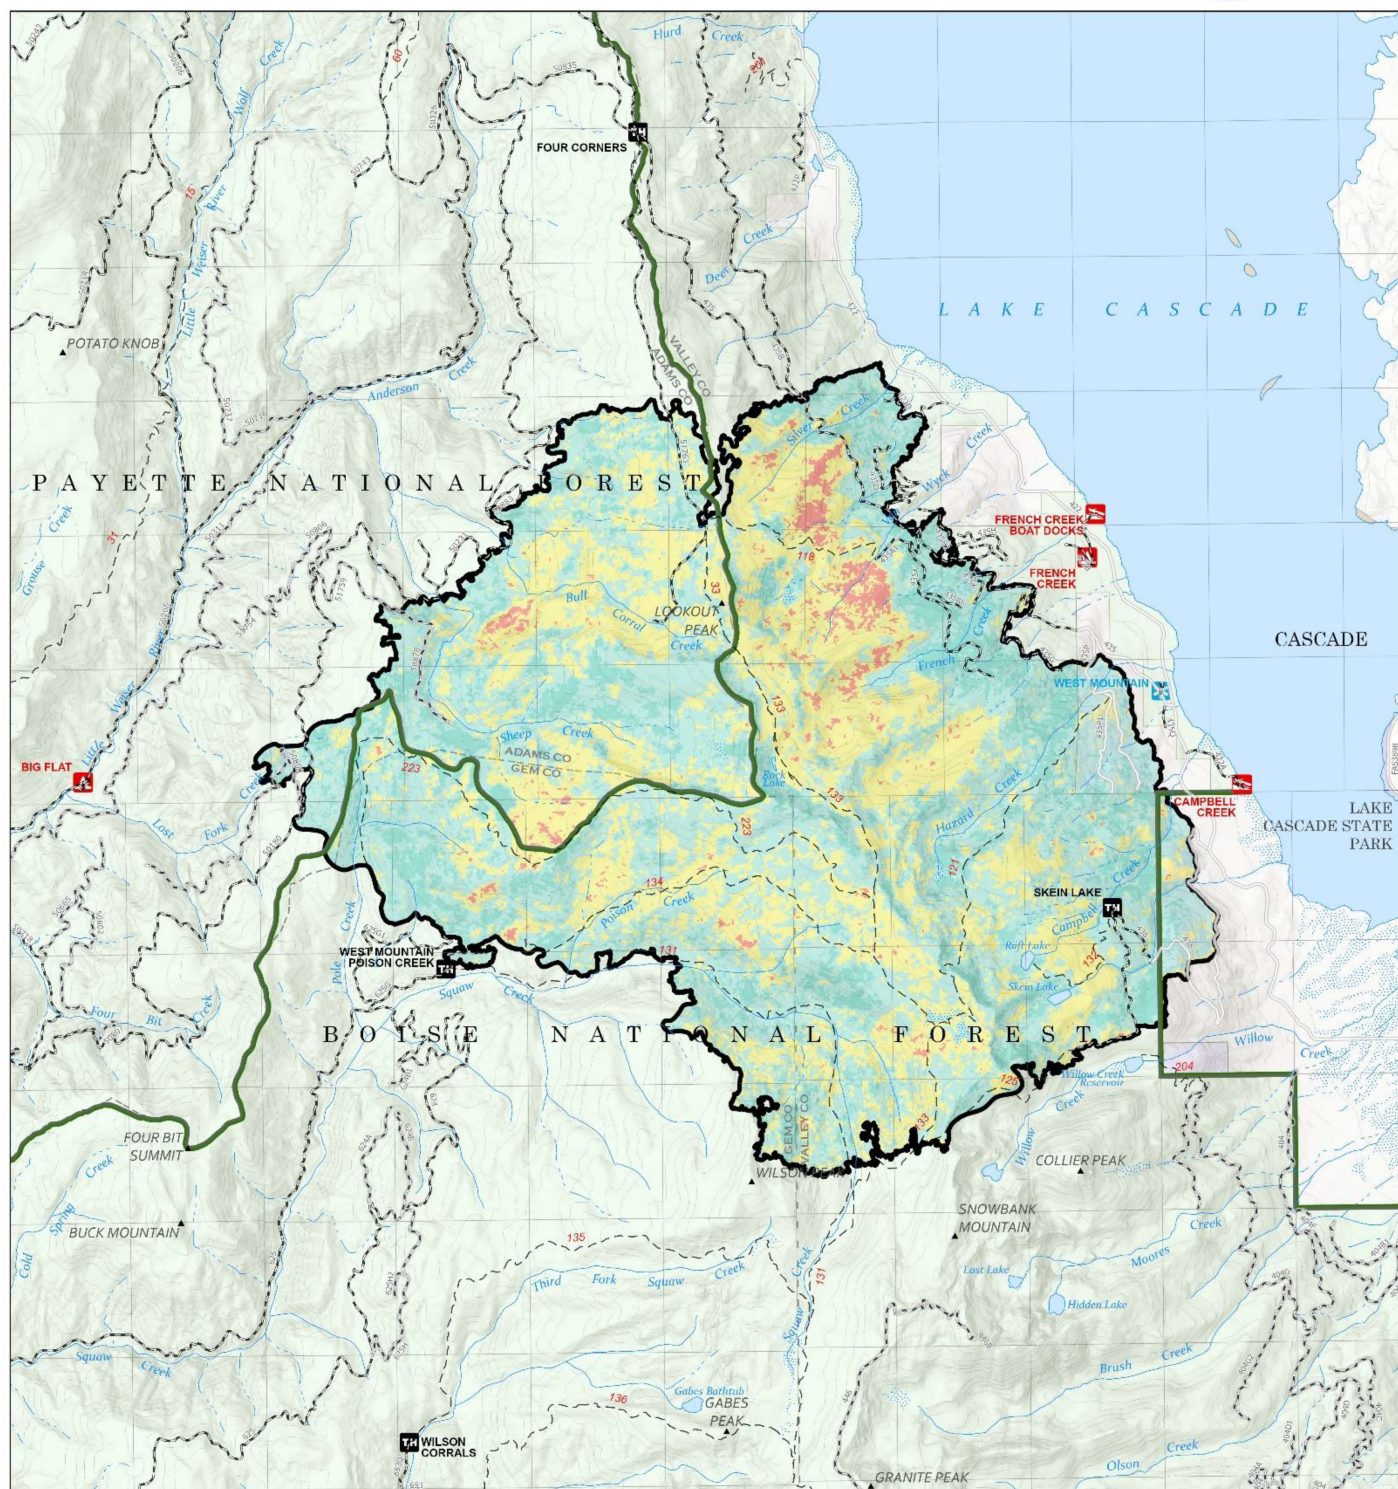
# Four Corners Fire BAER - Soil Burn Severity Boise and Payette National Forests, Region 4

Soil Burn Severity	Acres USFS	Acres Private	Percent
Unburned/Very Low	2338	72	16%
Low	6948	408	48%
Moderate	5217	81	34%
High	326	1	2%
<b>Total</b>	<b>14829</b>	<b>563</b>	<b>15393 acres</b>

## Soil Burn Severity
