Test Report - VxScan Bulk Scan & Warm Operational Conditions

Pius Wong , created Aug 10, 2024 , updated Oct 17, 2025

Summary

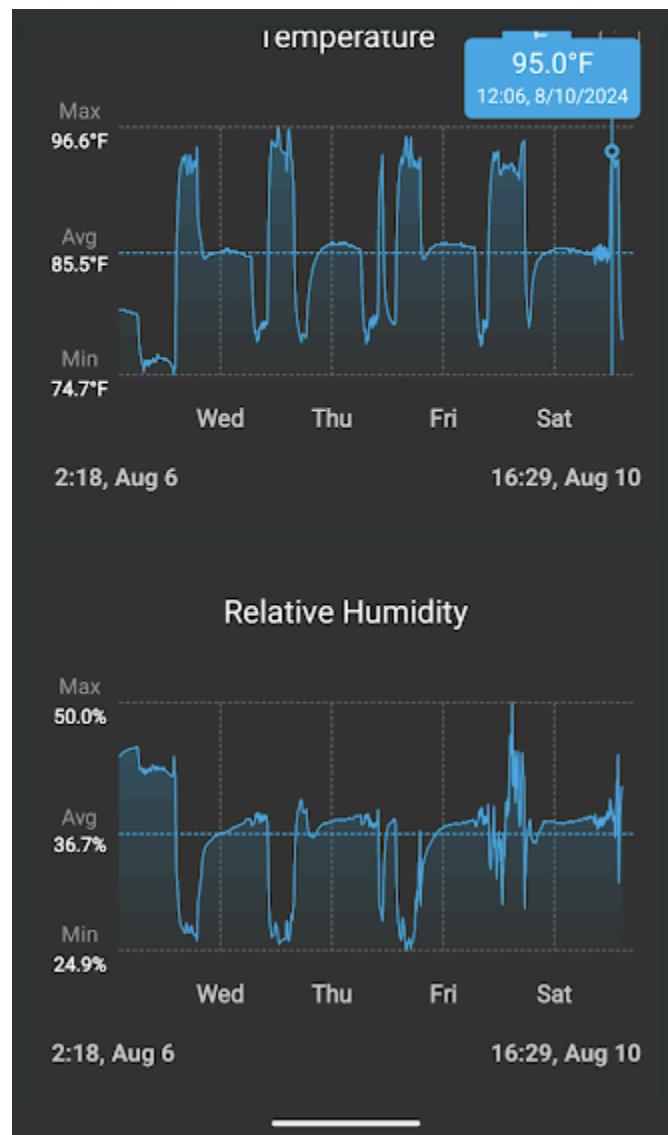
The image below shows the environmental data read by the thermometer-hygrometer above the MCM over the test period. The temperature highs around 95°F occurred when the heater and humidifier were on, and also when scanning took place. The other temperatures at about 85°F and lower occurred when the heater and humidifier were off, allowing the climate tent to cool down to the ambient temperature of the lab during those dates outside of work hours.

As shown above, humidity was more difficult to control. RH% readings during testing fluctuated between 25-50%RH on different days, with the later days having better control due to getting more experience with the humidifier and filling it more fully with water.

5. Future warm operational tests should use stronger or more robust humidity control.

The Govee humidifier used in this test helped the climate tent hit the desired humidity better when it was more filled up with water at least 30% full. Future tests should make sure to do the same, instead of only filling up less than that. Alternatively, a stronger humidifier system could be used.

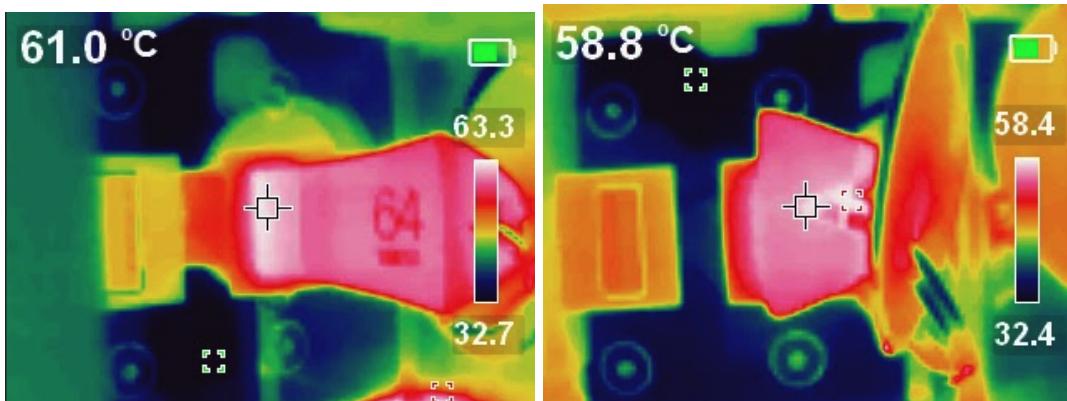
6. The MCM was hot on the left side of the system.

This unit did not have any fans or active cooling. Temperatures in the system rose mostly on the left side. The surface temperature of the metal panel above the SBC on the left side reached about 121°F (50°C), or an increase from warm ambient temperatures of about +25°F (+15°C):

4. The MCM needs cooling solutions for the components in the left compartments.

EN 62368-1:214 Table 38 and IEC 62368-1:20xx Table 38 lists maximum safe touch temperatures for metal surfaces held by ordinary users for 1-10 seconds as 140°F (60°C). For informed users, this temperature is 158°F (70°C). The USB stick approaches the edge of safe touch temperatures. The Samsung bar USB stick also hovered around its own [operating temperature maximum of \(140°F\) 60°C](#). A cooling solution should be implemented to reduce risks from hot temperatures on the left side.

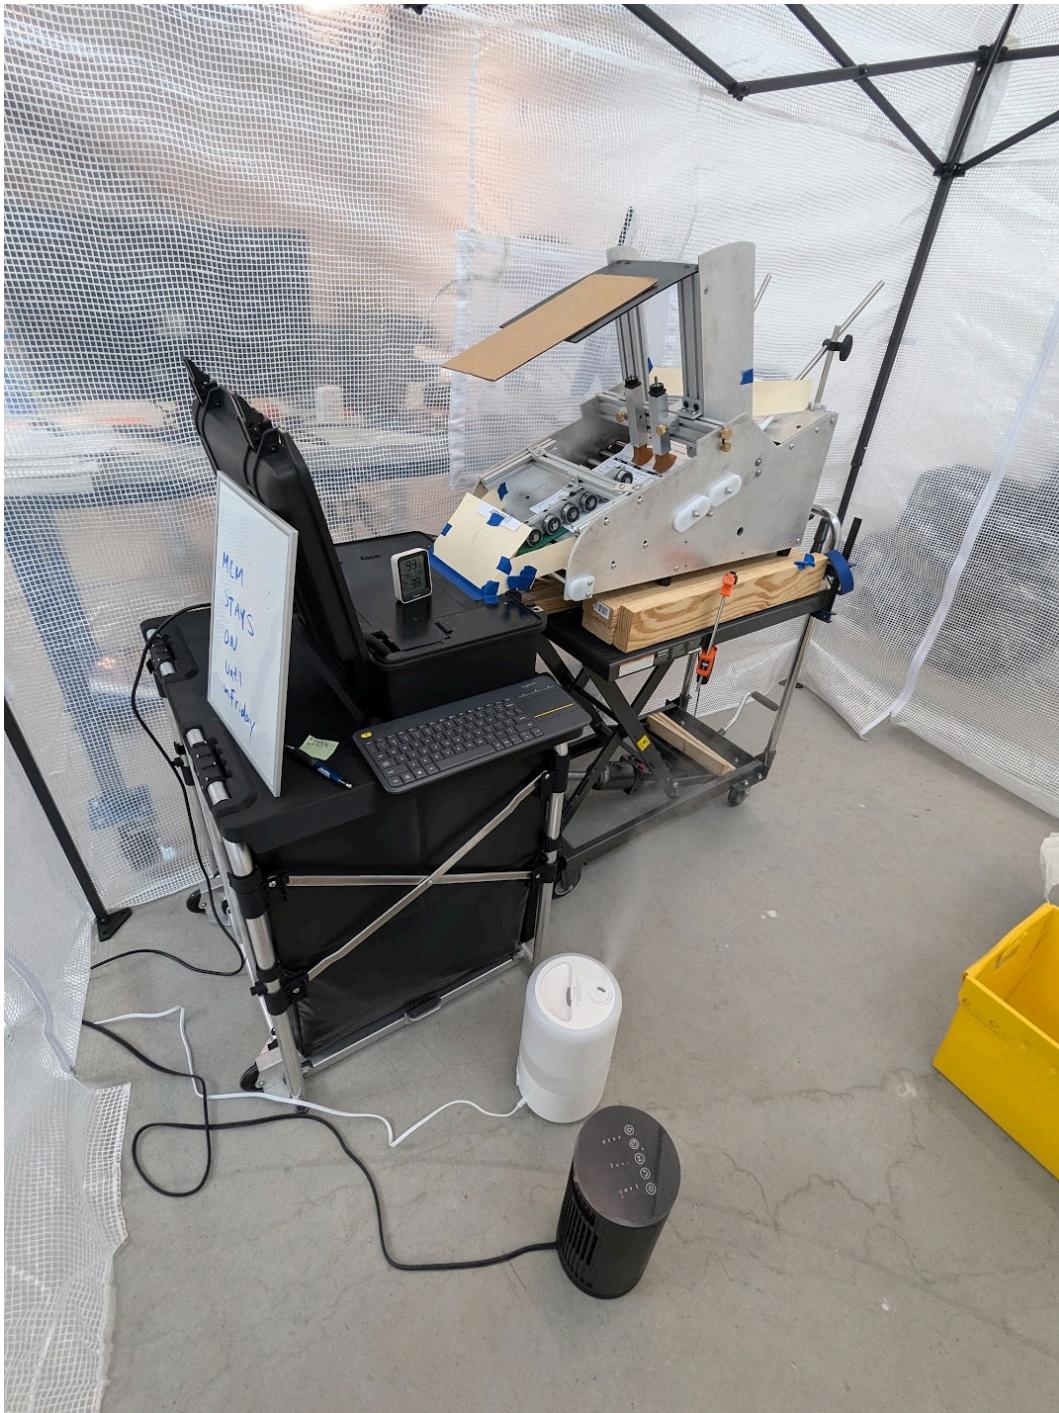
Figure A.5. Another photo of the test setup inside the climate tent, from an angle behind the MCM, showing more of the auto-paper-feeder. The yellow bin on the right held additional ballots inside the climate tent, for reloading the auto-paper-feeder as needed. For this test, the auto-paper-feeder could feed a sheet approximately once every 7-10 seconds, giving enough time for the MCM to scan and respond to the sheet. The auto-paper-feeder could only function well for stacks of approximately 200 sheets or less (or for about 30 minutes' worth of sheets), and so new stacks of ballot sheets had to be added periodically for this test.
