Test Report - VxScan v4 Bulk Scan Test in Warm Operational Conditions - Build 0 / LP2

Created Aug 10, 2024 , Updated Pius Wong Sep 17, 2024

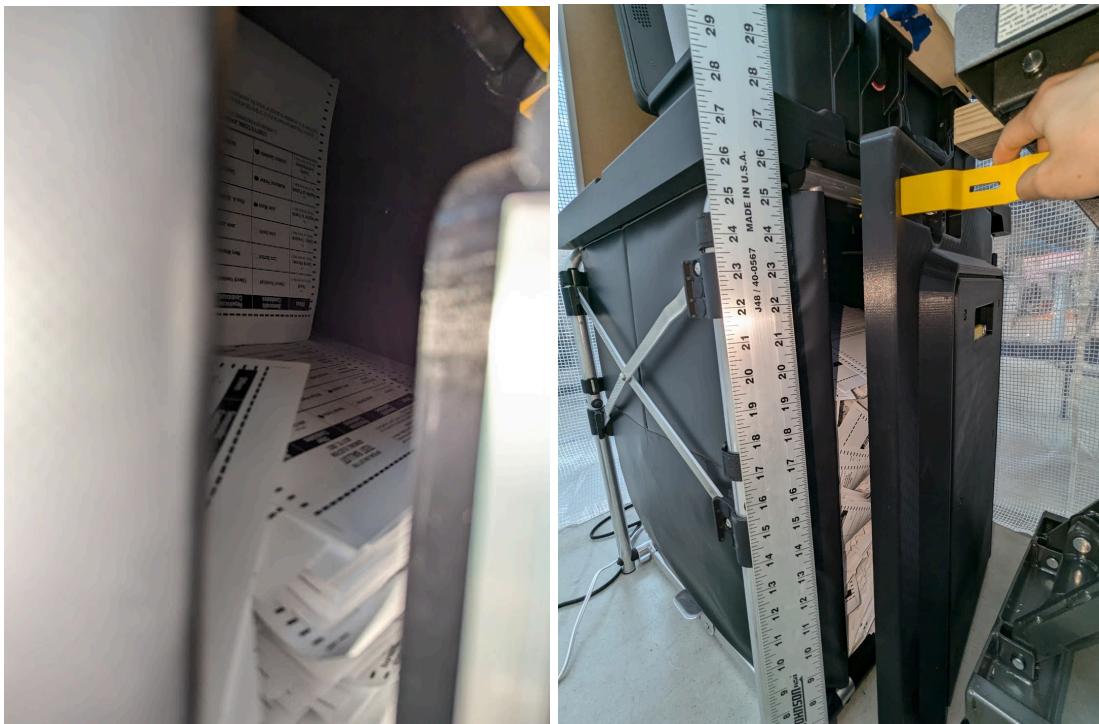
Testing stopped at 5882 ballots in the ballot box. These included 5873 scanned properly, and 9 unscanned “ghost ballots” that were not scanned but still in the ballot box due to a known bug in dealing with ballots stuck on the pile of ballots in a full ballot box. (see image below) The ghost ballot error started occurring at scan 5825, and was fairly consistent by scan 5872. The pile of ballots in the ballot box was about 19 inches high from the internal bottom floor of the ballot box.

Full ballot box. New ballots scanned after this point start to have the possibility of getting stuck at the top of the pile without poll worker intervention, opening or shaking the ballot box to get the ballot unstuck.

Full ballot box showing bulging at the sides. The ballot box was not weighed but was very heavy and would not be recommended to move without emptying it.

1. An absolute maximum hardware limit to the ballot box capacity could be defined as 5000, for 8.5" x 11" paper with 28# bond weight.

5000 sheets is 85% of the observed maximum ballot box capacity of 5825 sheets, at which ballots began to get stuck in the ballot box. A safer or more conservative recommended maximum capacity could be 4000 of these types of paper sheets. VotingWorks should recommend that poll workers empty the ballot box at or before reaching this recommended maximum.

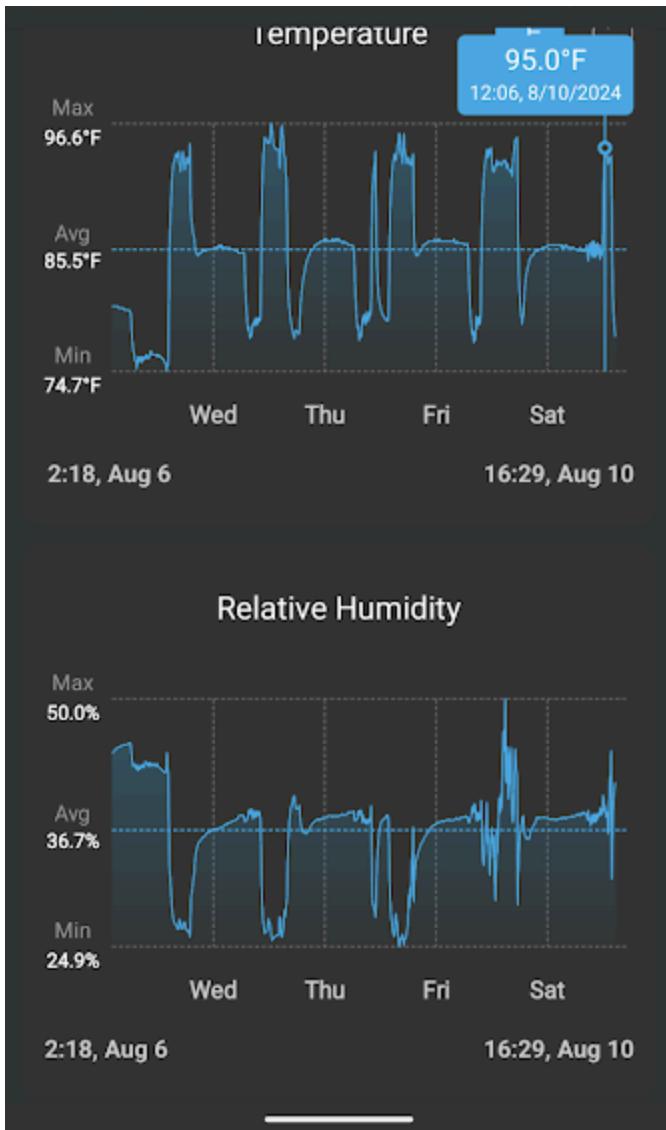
The image below shows the environmental data read by the thermometer-hygrometer above the MCM over the test period. The temperature highs around 95°F occurred when the heater and humidifier were on, and also when scanning took place. The other temperatures at about 85°F and lower occurred when the heater and humidifier were off, allowing the climate tent to cool down to the ambient temperature of the lab during those dates outside of work hours.

As shown above, humidity was more difficult to control. RH% readings during testing fluctuated between 25-50%RH on different days, with the later days having better control due to getting more experience with the humidifier and filling it more fully with water.

5. Future warm operational tests should use stronger or more robust humidity control.

The Govee humidifier used in this test helped the climate tent hit the desired humidity better when it was more filled up with water at least 30% full. Future tests should make

sure to do the same, instead of only filling up less than that. Alternatively, a stronger humidifier system could be used.

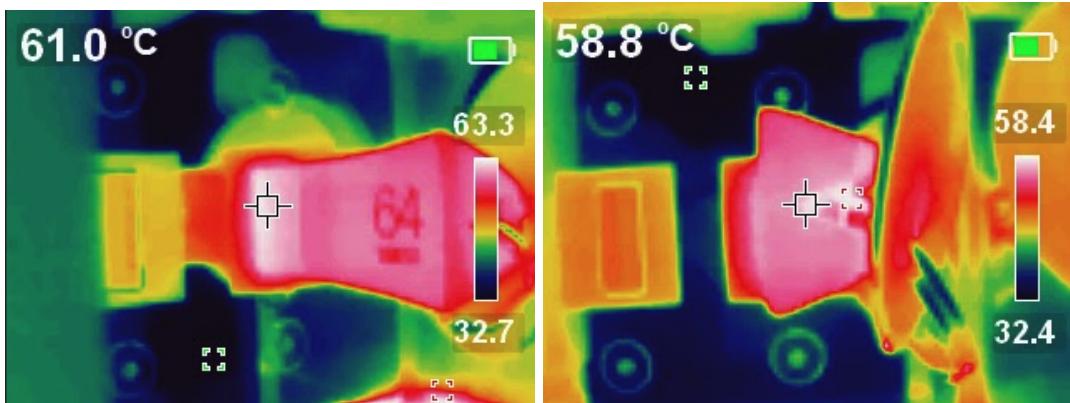
6. The MCM was hot on the left side of the system.

This unit did not have any fans or active cooling. Temperatures in the system rose mostly on the left side. The surface temperature of the metal panel above the SBC on the left side reached about 121°F (50°C), or an increase from warm ambient temperatures of about +25°F (+15°C):

The Samsung metal bar USB stick reached about 140°F (60°C) along its length, or an increase from warm ambient temperatures of about +45°F (+25°C):

[EN 62368-1:214 Table 38](#) and [IEC 62368-1:20xx Table 38](#) lists maximum safe touch temperatures for metal surfaces held by ordinary users for 1-10 seconds as 140°F (60°C). For informed users, this temperature is 158°F (70°C). The USB stick approaches the edge of safe touch temperatures. The Samsung bar USB stick also hovered around its own [operating temperature maximum of \(140°F\) 60°C](#). A cooling solution should be implemented to reduce risks from hot temperatures on the left side.

4. The MCM needs cooling solutions for the components in the left compartments.
