**BURNED-AREA REPORT**  
(Reference FSH 2509.13)**PART I - TYPE OF REQUEST**

| A. Fire Name: <u>Moonlight</u> | B. Fire Number: <u>CA-PNF-000670</u> |

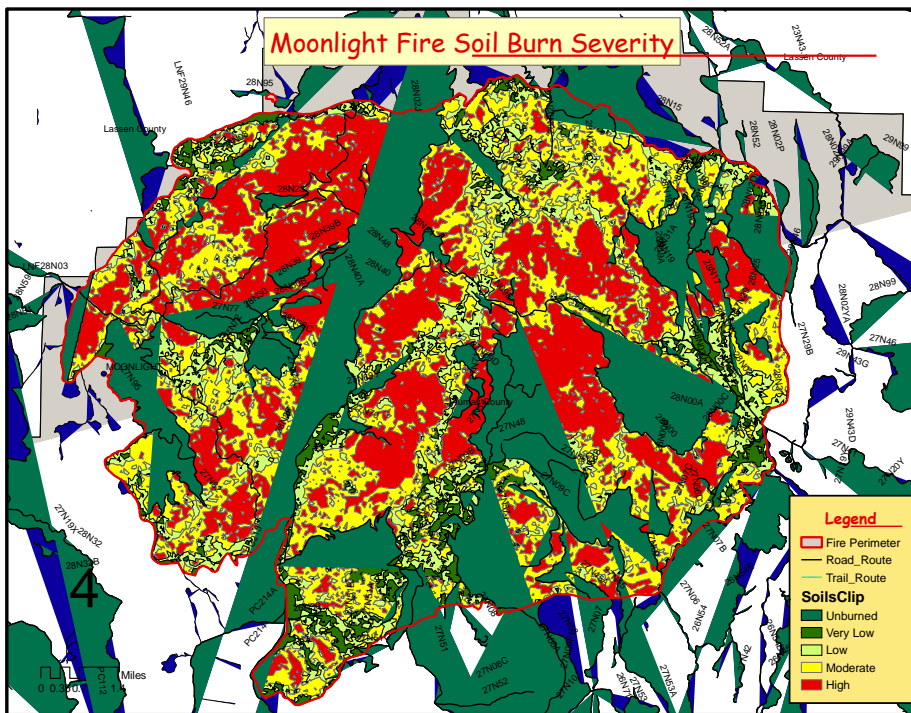
The BAER Watershed group stratified the fire into analysis watersheds and analyzed the amount of high burn severity, the predicted erosional response, and how much of the burn is on National Forest Lands to determine threats to identified values. The following subwatersheds were identified as having the greatest risk to identified values: East Branch Lights Creek (43% high severity), Lone Rock Creek (47% high severity), Middle Lights Creek (46% High severity), West Branch Lights (59% high severity) and Willow Creek (48% high severity)
