Date of Report:**11/12/2020**

DOLAN FIRE BURNED-AREA REPORT

Los Padres National Forest
Monterey Ranger District
October 13, 2020

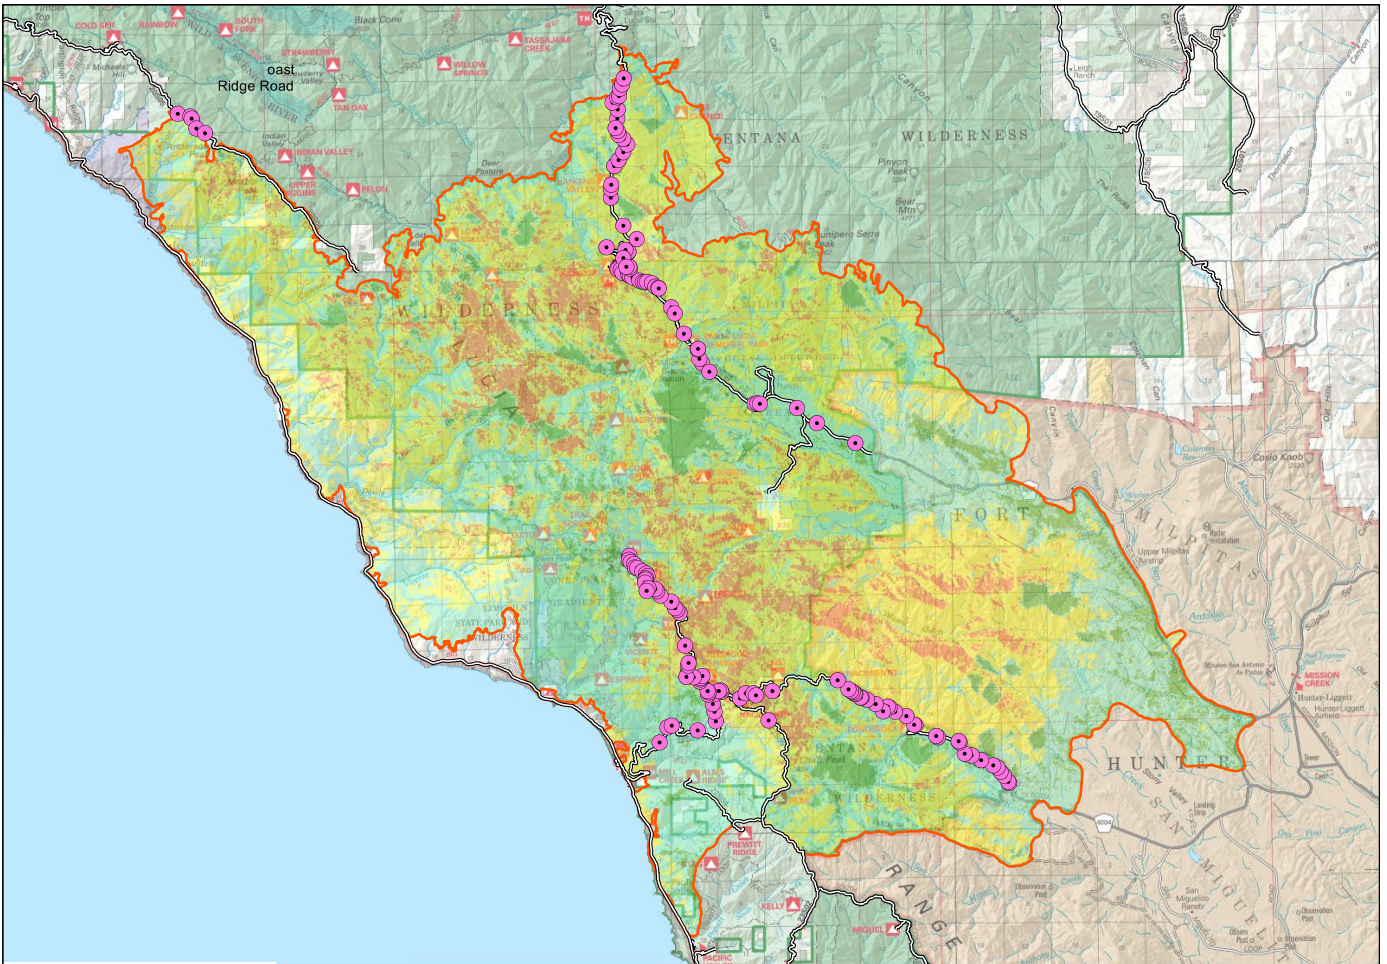
Road Treatments

Road treatment areas are denoted by a magenta dot along USFS roadways.

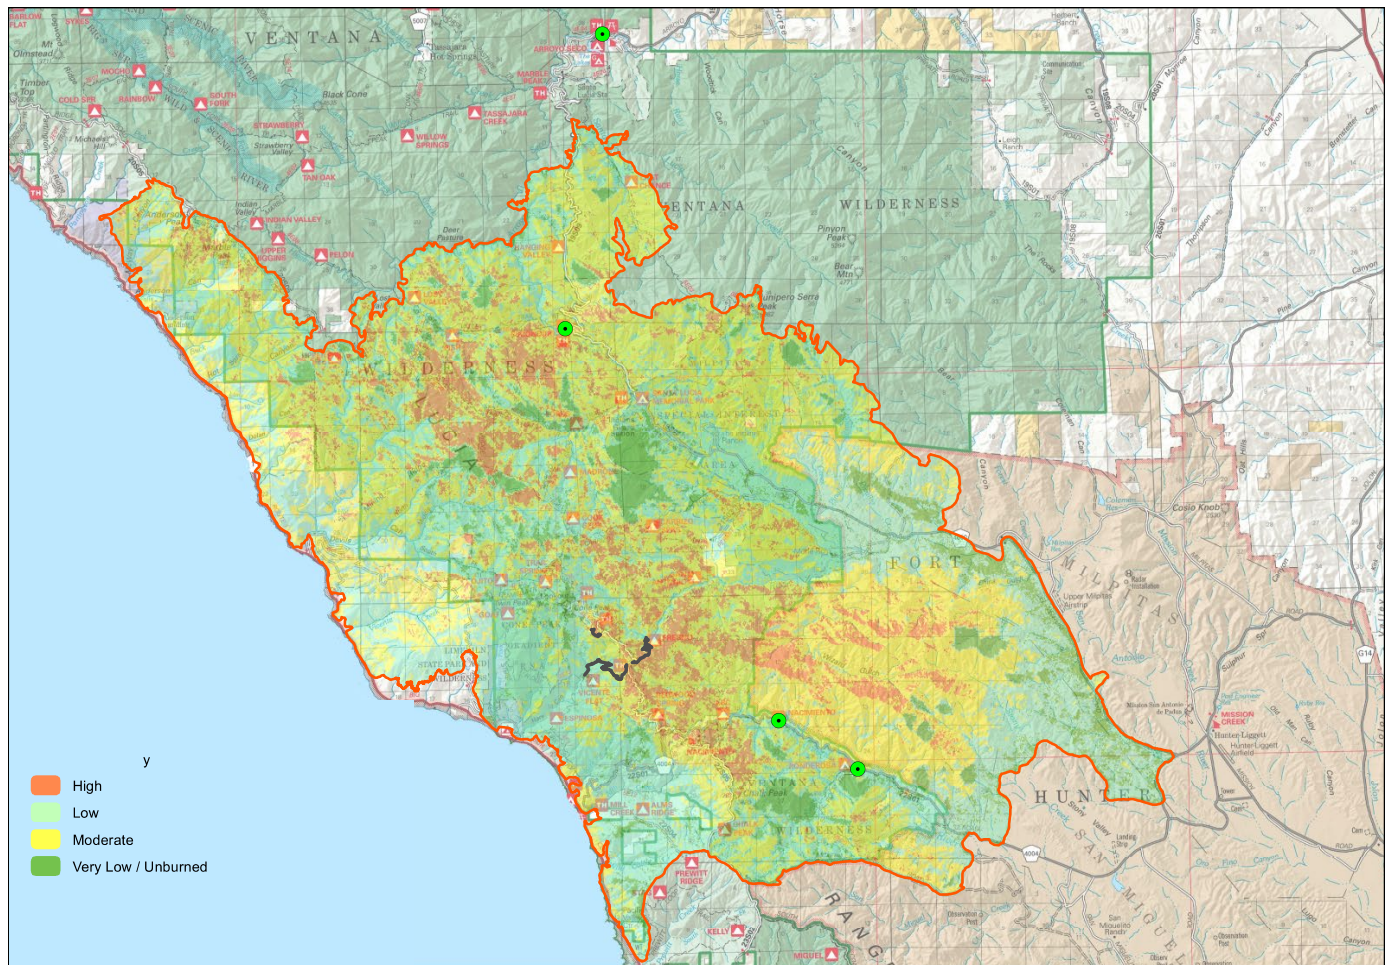
Recreation treatments

Trails that can be worked on are indicated by the black lines. The red dot indicates the location of Escondido Camp where there are dangerous trees. Funding for their removal is not requested in this report and will be attained via other appropriate avenues.

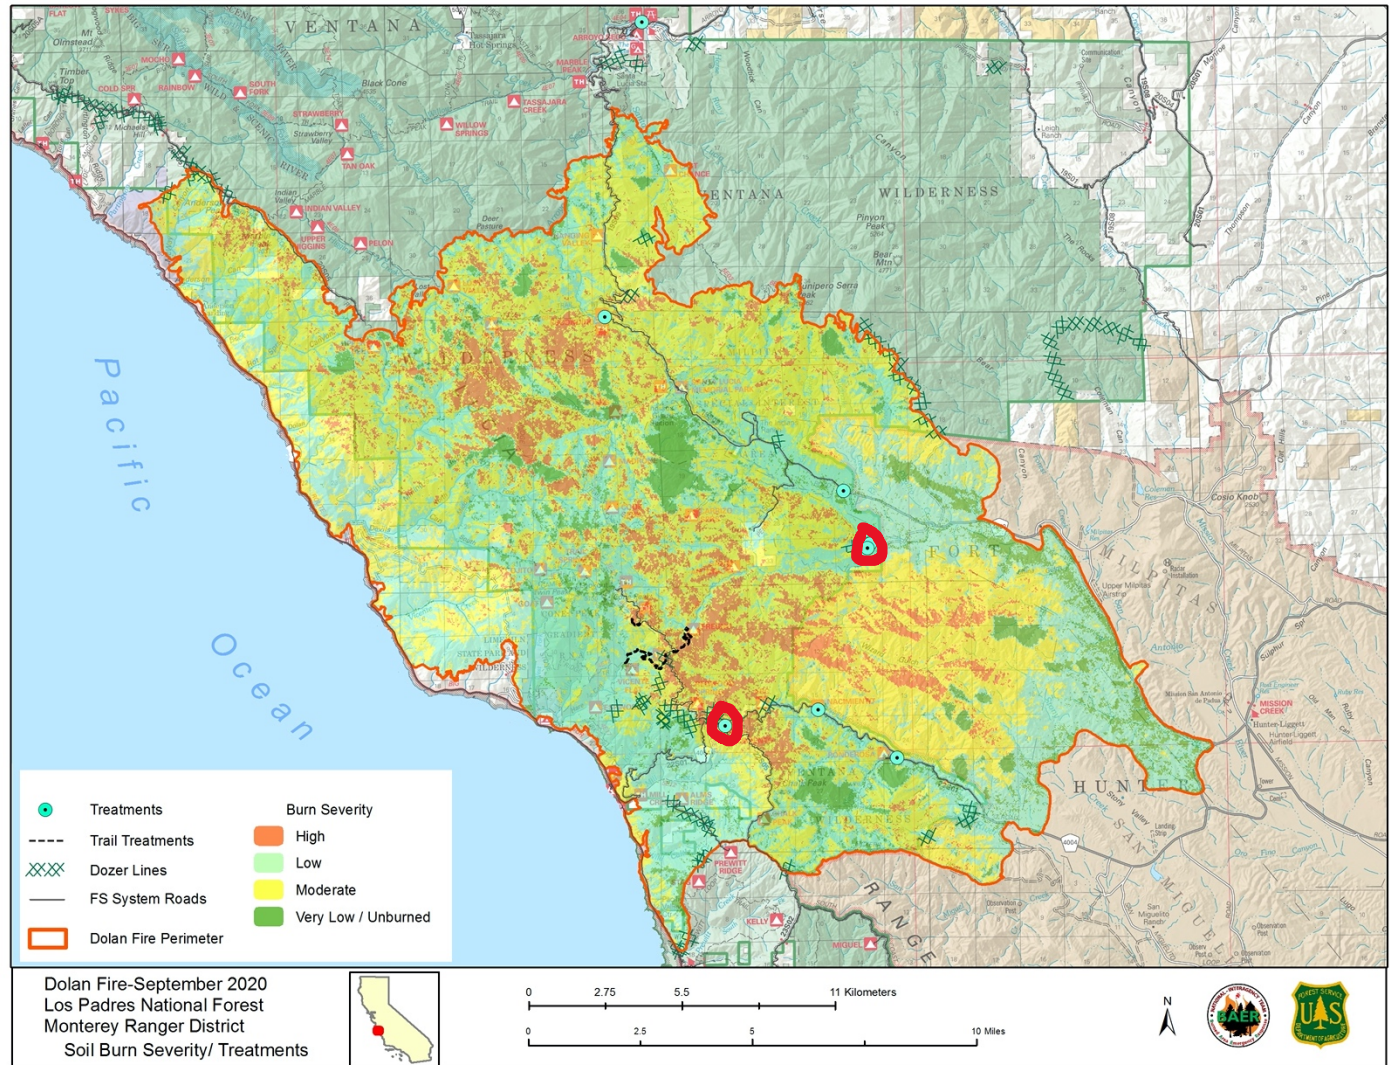
Dozer lines and Hazmats

Dozer lines are indicated by green Xs. Red circles indicate hazmats at Nacimiento Station (southerly circle) and Merle Ranch (northerly circle).
