# Test Report - VxScan v4.0 Build 0 Cold Storage Test (lo-fi)

Pius Wong Sep 16, 2024 updated Sep 16, 2024

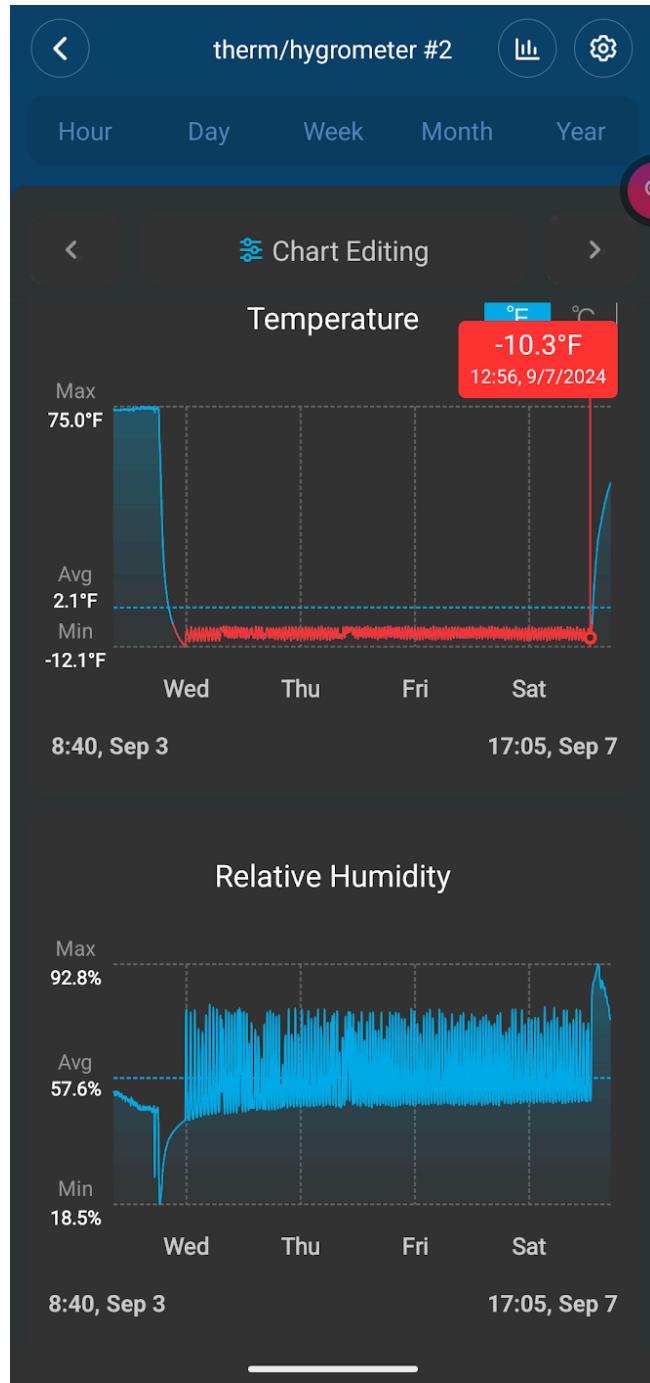
## 2. The unit was held at -10 to -5°F for about 92 hours undisturbed.

- a. The MCM was placed in the freezer, and the freezer was turned on from room temperature on Tuesday, Sep 3, 2024 at about 5pm. It reached below -4°F at approximately 9PM that night.
- b. The freezer was closed and undisturbed over the next 4 days. Internal freezer temperature was monitored remotely and stayed between -10°F to -5°F. Humidity fluctuated between 46-80%RH throughout this time.
- c. The freezer was turned off on Saturday, Sep 7, 2024, at about 1pm and remained closed. This corresponds to holding the unit between -10°F to -5°F for about 92 hours. This is longer than the VVSG requirements of holding at -4°F for

72 hours. An image of the temperature and humidity data collected during freezing is shown below:

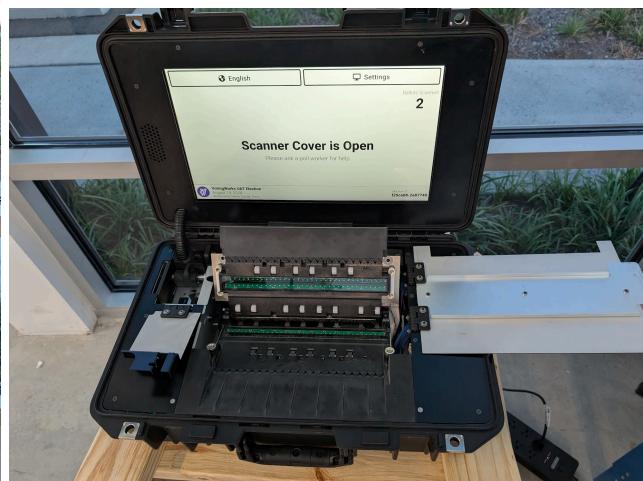
### 4. External structures appeared to be unaffected by freezing.

- a. Without opening it up, no problems were observed after freezing. See photos below for general appearance after freezing:

- b. All visible structures appeared to be the same as before freezing. The unit was not opened up for internal inspection because it had normal function.

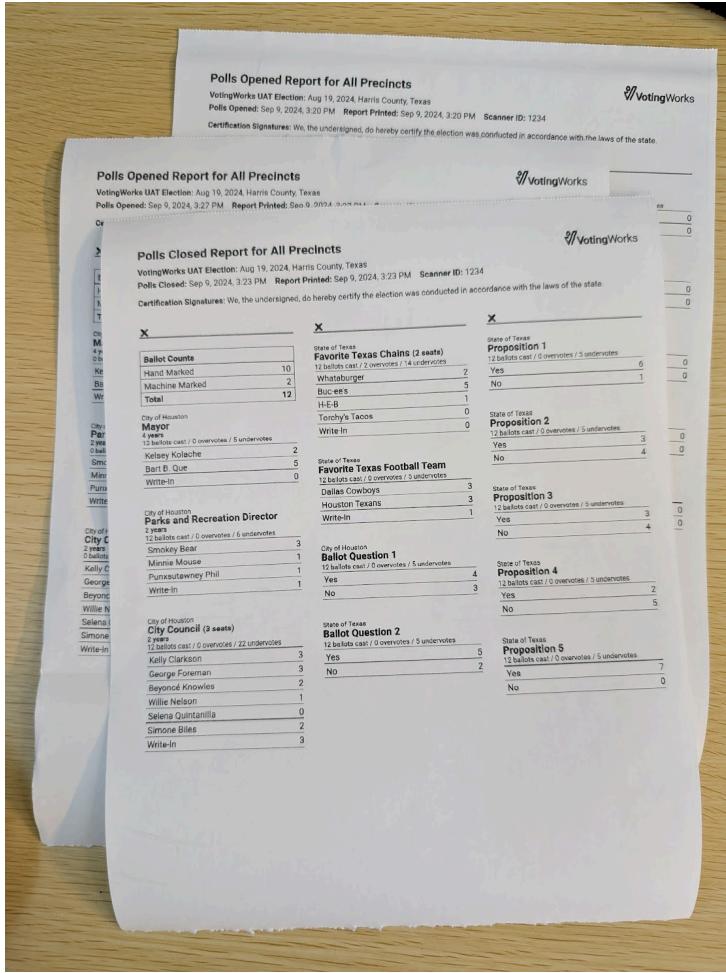
The thermal printer mechanism functioned properly as before freezing, with good print quality. The printer mechanism had no jams and no observable anomalies. A photo of example prints are shown below:
