Richards-Gebaur Memorial Airport

Draft Stormwater Permit Application

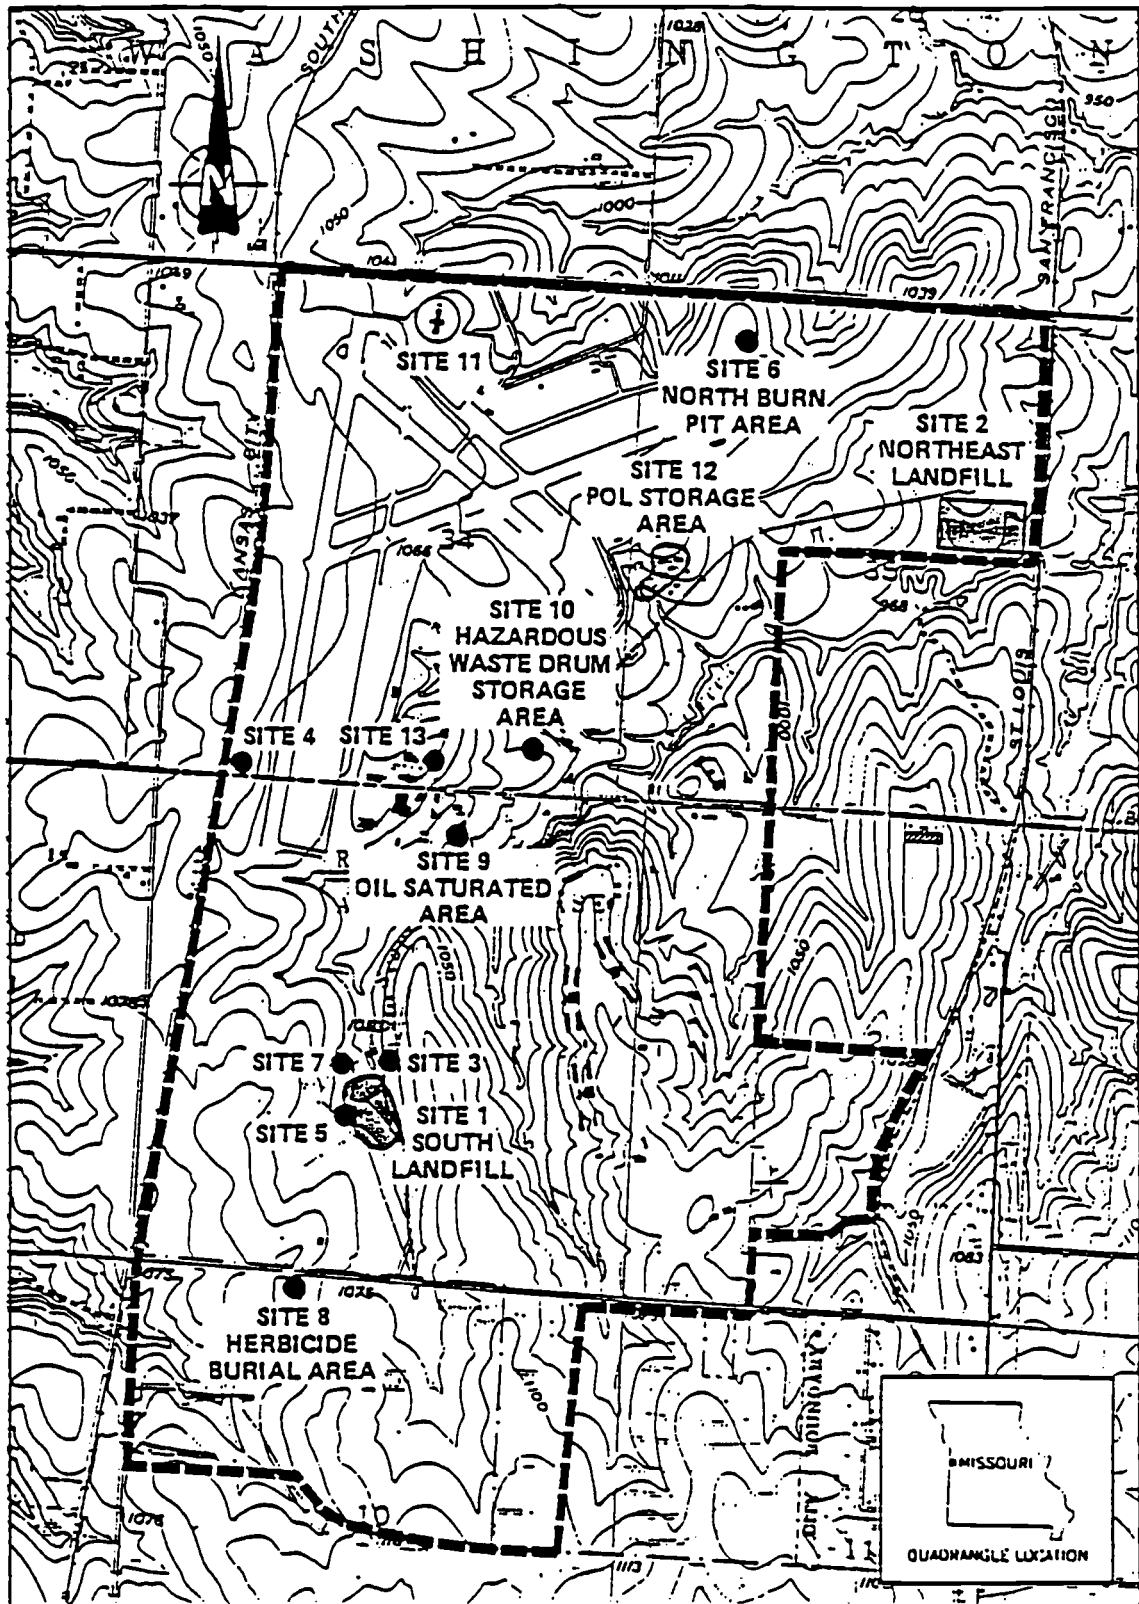
Figure B-1 OVERALL MAP OF BASE
Showing All of Potentially Hazardous Sites
Identified During Past Investigations

SOURCE: U.S.G.S. 7.5' Quadrangle, Belton, Mo.-Kans., 1975.

Figure B-1 Adapted from Figure 1 in
Reference No. 4

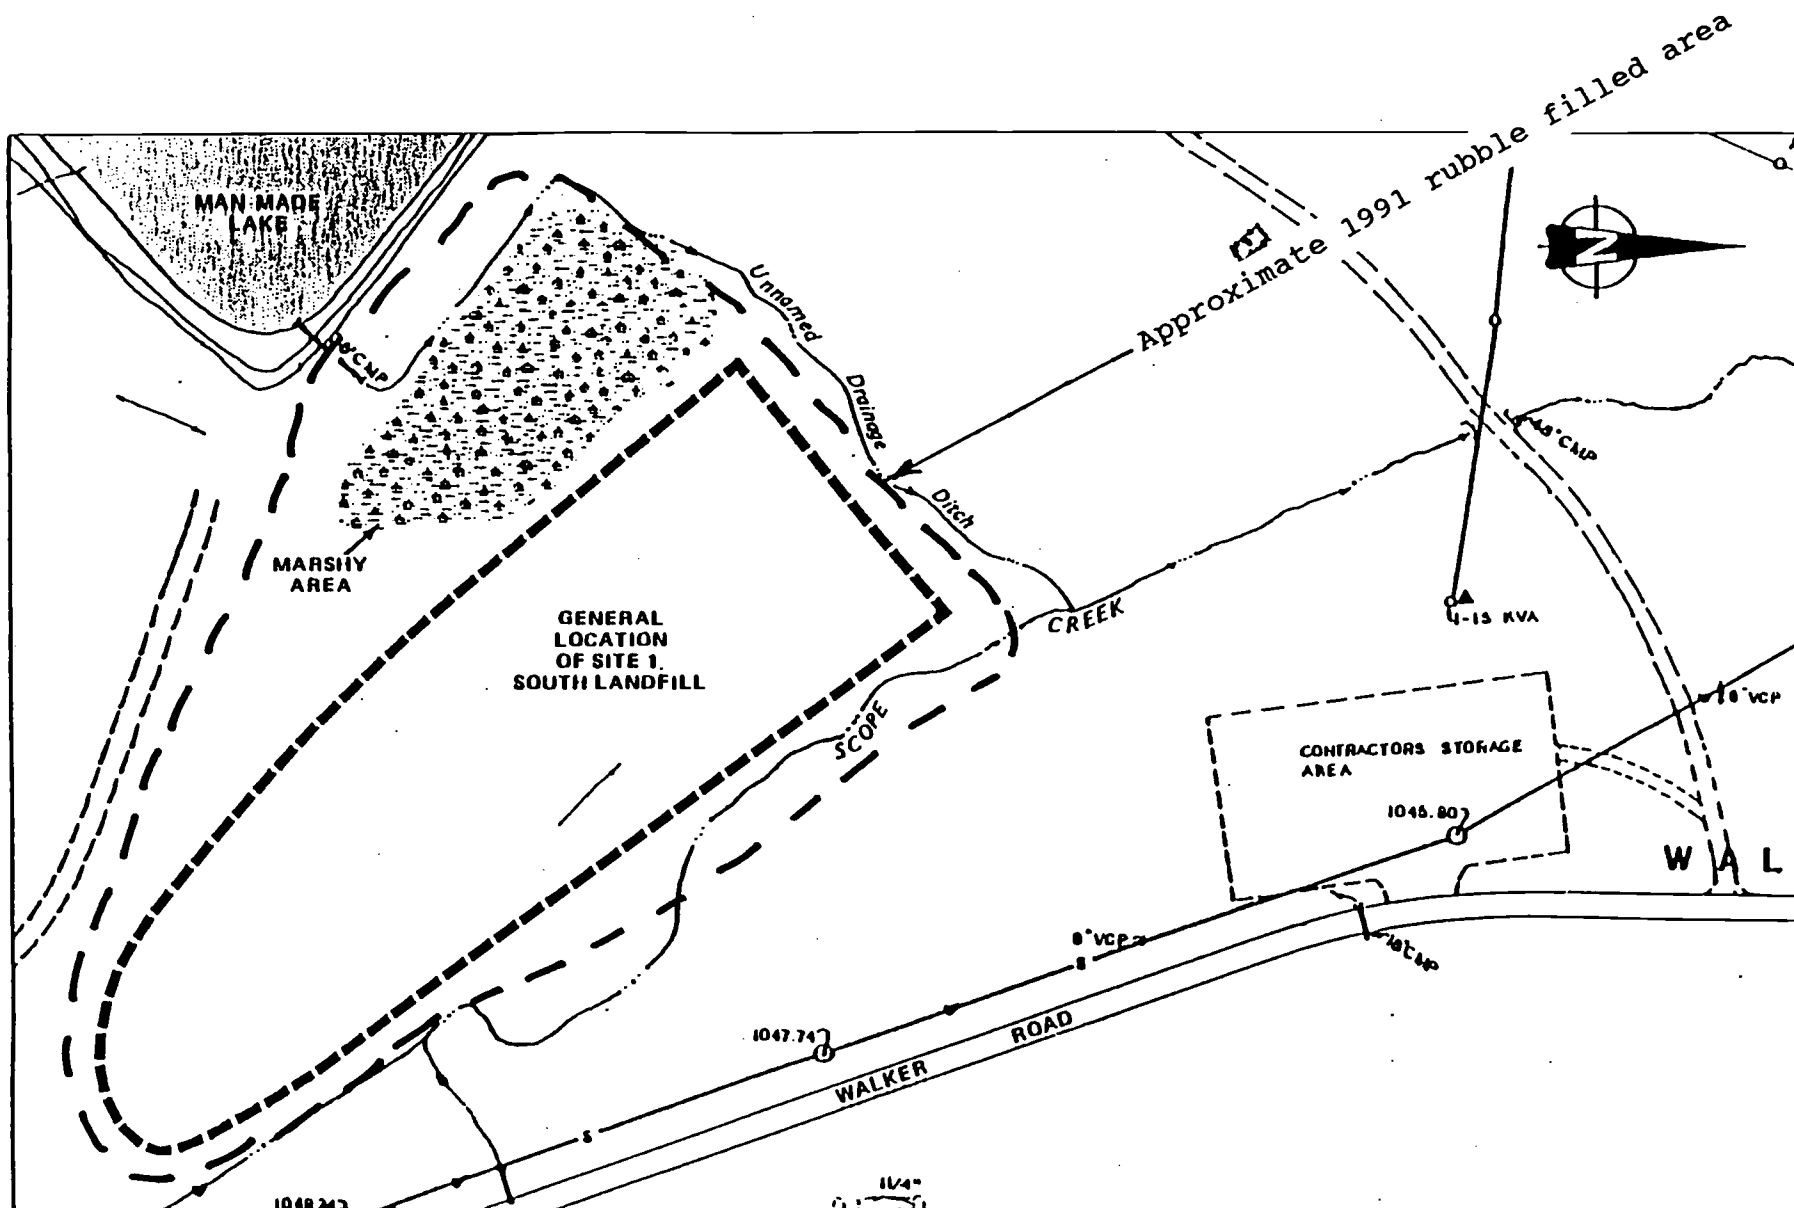
Figure B-2 Adapted from Figure 1-9 in Reference No. 4

SOURCE: Department of the Air Force, Air Force Communications Service, August 1985, Detail Utility Map, Richards-Gebaur AFB, Missouri.

KEY: Site Boundary (as designated in Ref. 4) Surface Runoff Direction

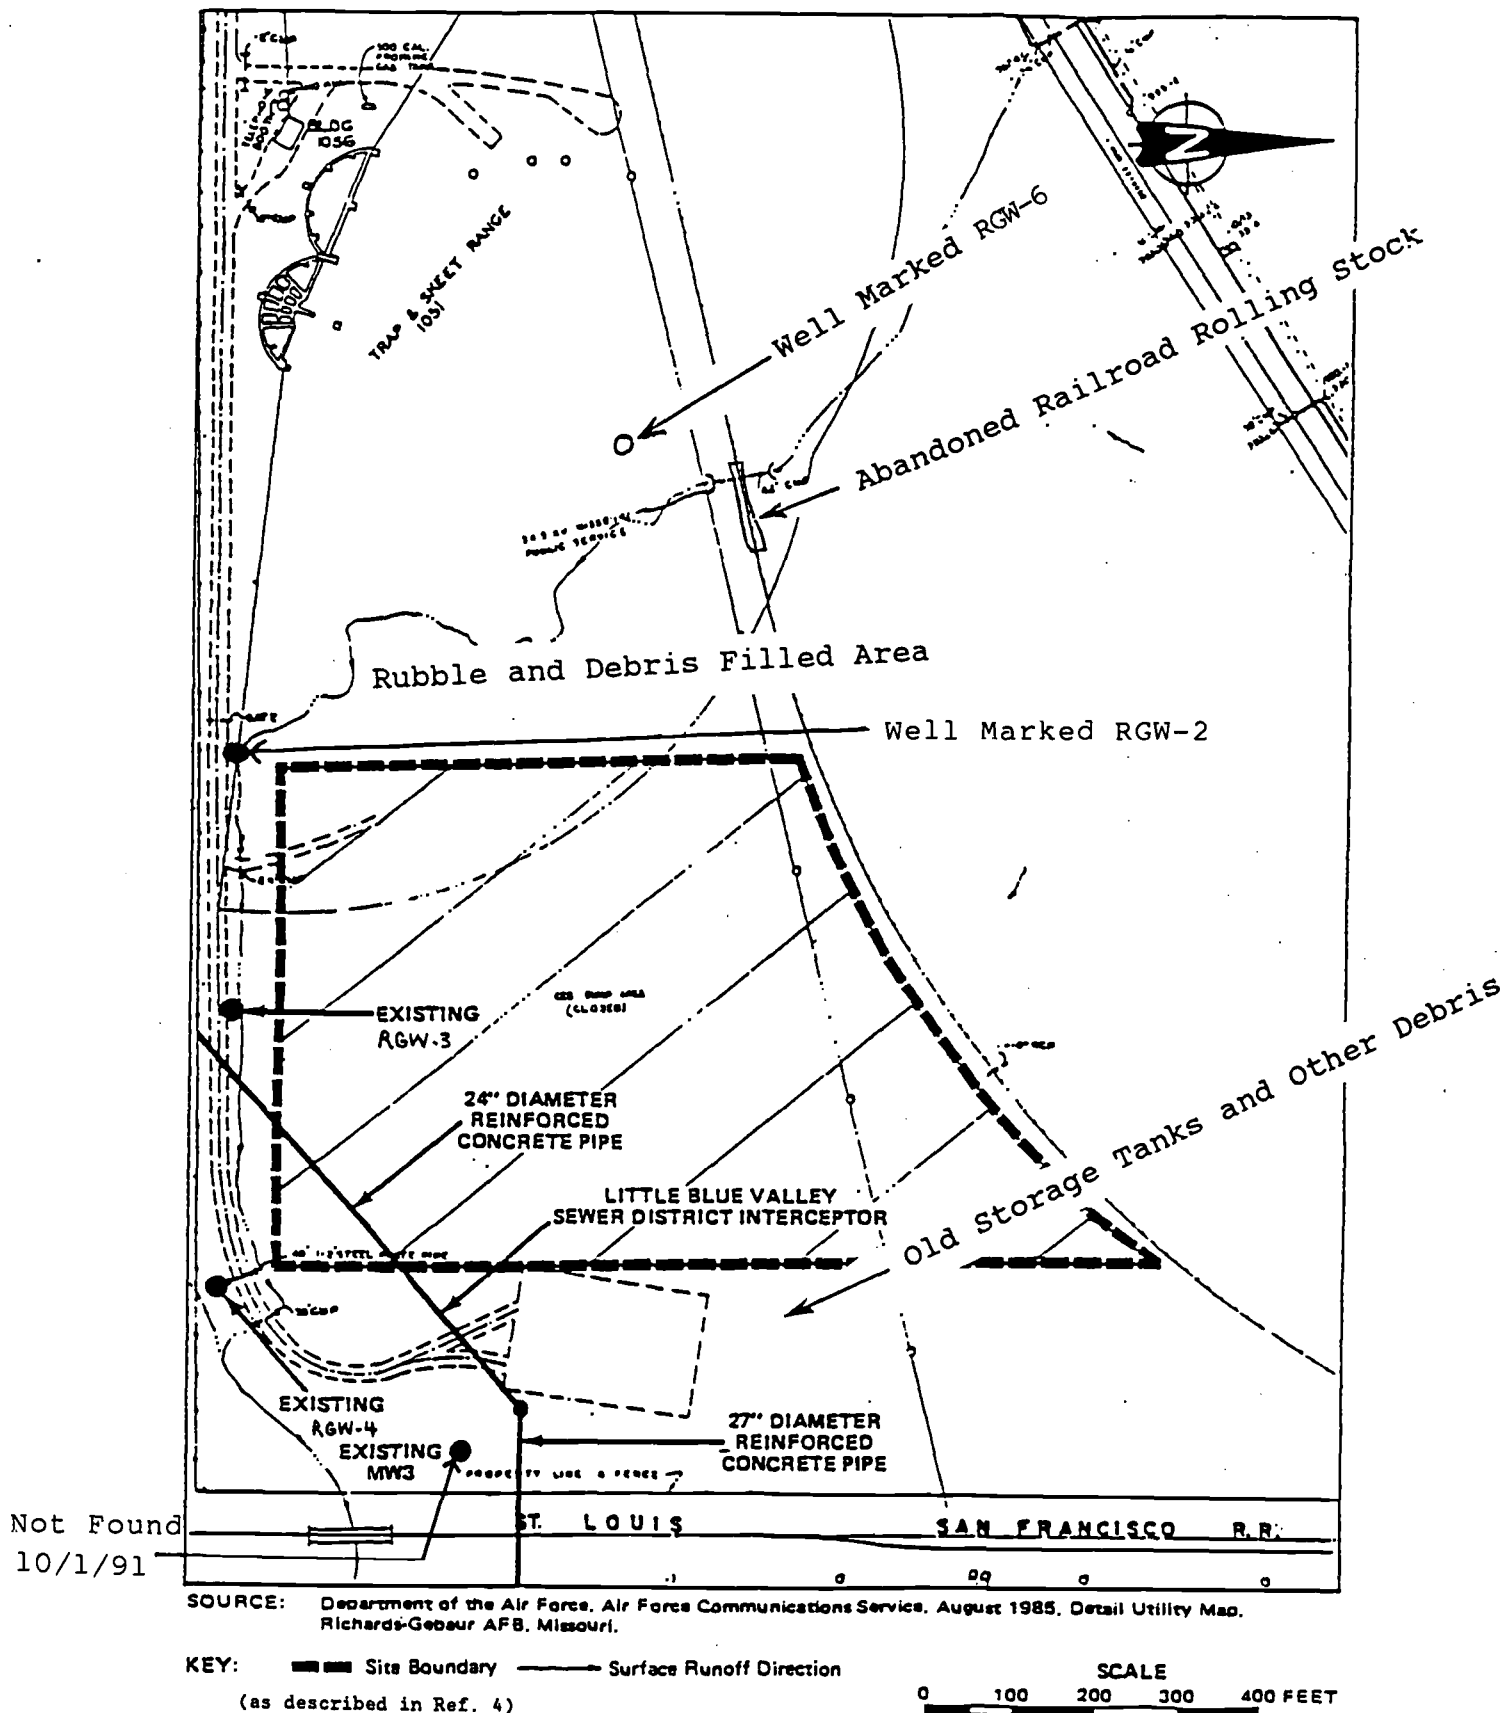
Northeast Landfill

Figure B-3 Adapted from Figure 1-11 in
Reference No. 4

Another individual interviewed³ indicated that this landfill began as a series of trenches about 8 feet deep adjacent to the access road at the south end of the area marked on Figure 1-11 of the E&E report.⁴ As filling progressed, the trenches moved to the north. However, he reported that they never moved as far north as indicated by this drawing. He also reported that the use of the Northeast Landfill began when the South Landfill was closed in the 1970's. A bulldozer was used for compaction.

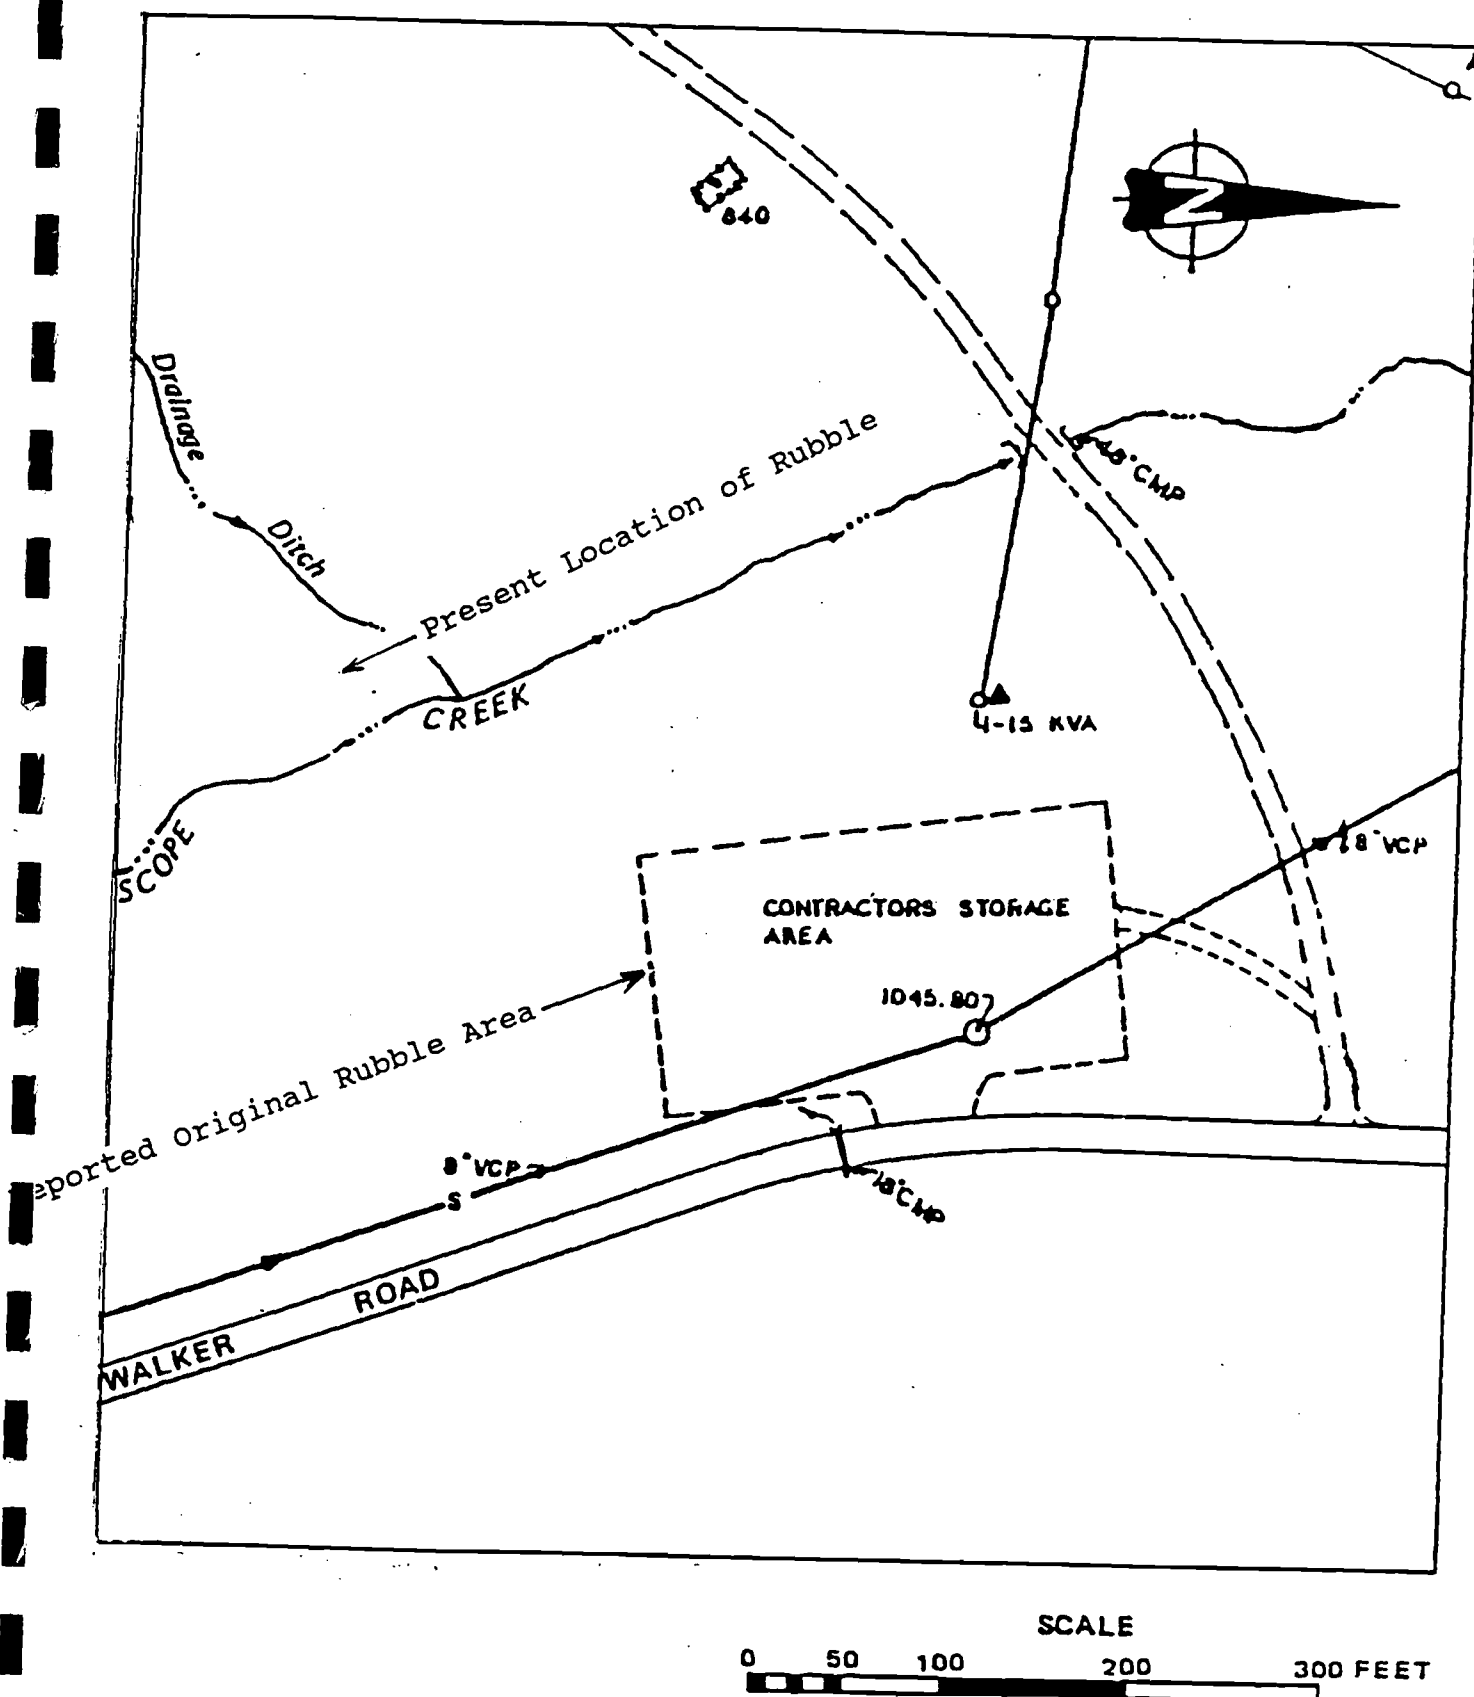
Contractor Rubble Area

Figure B-4 Adapted from Figure 1-9 in
Reference No. 4

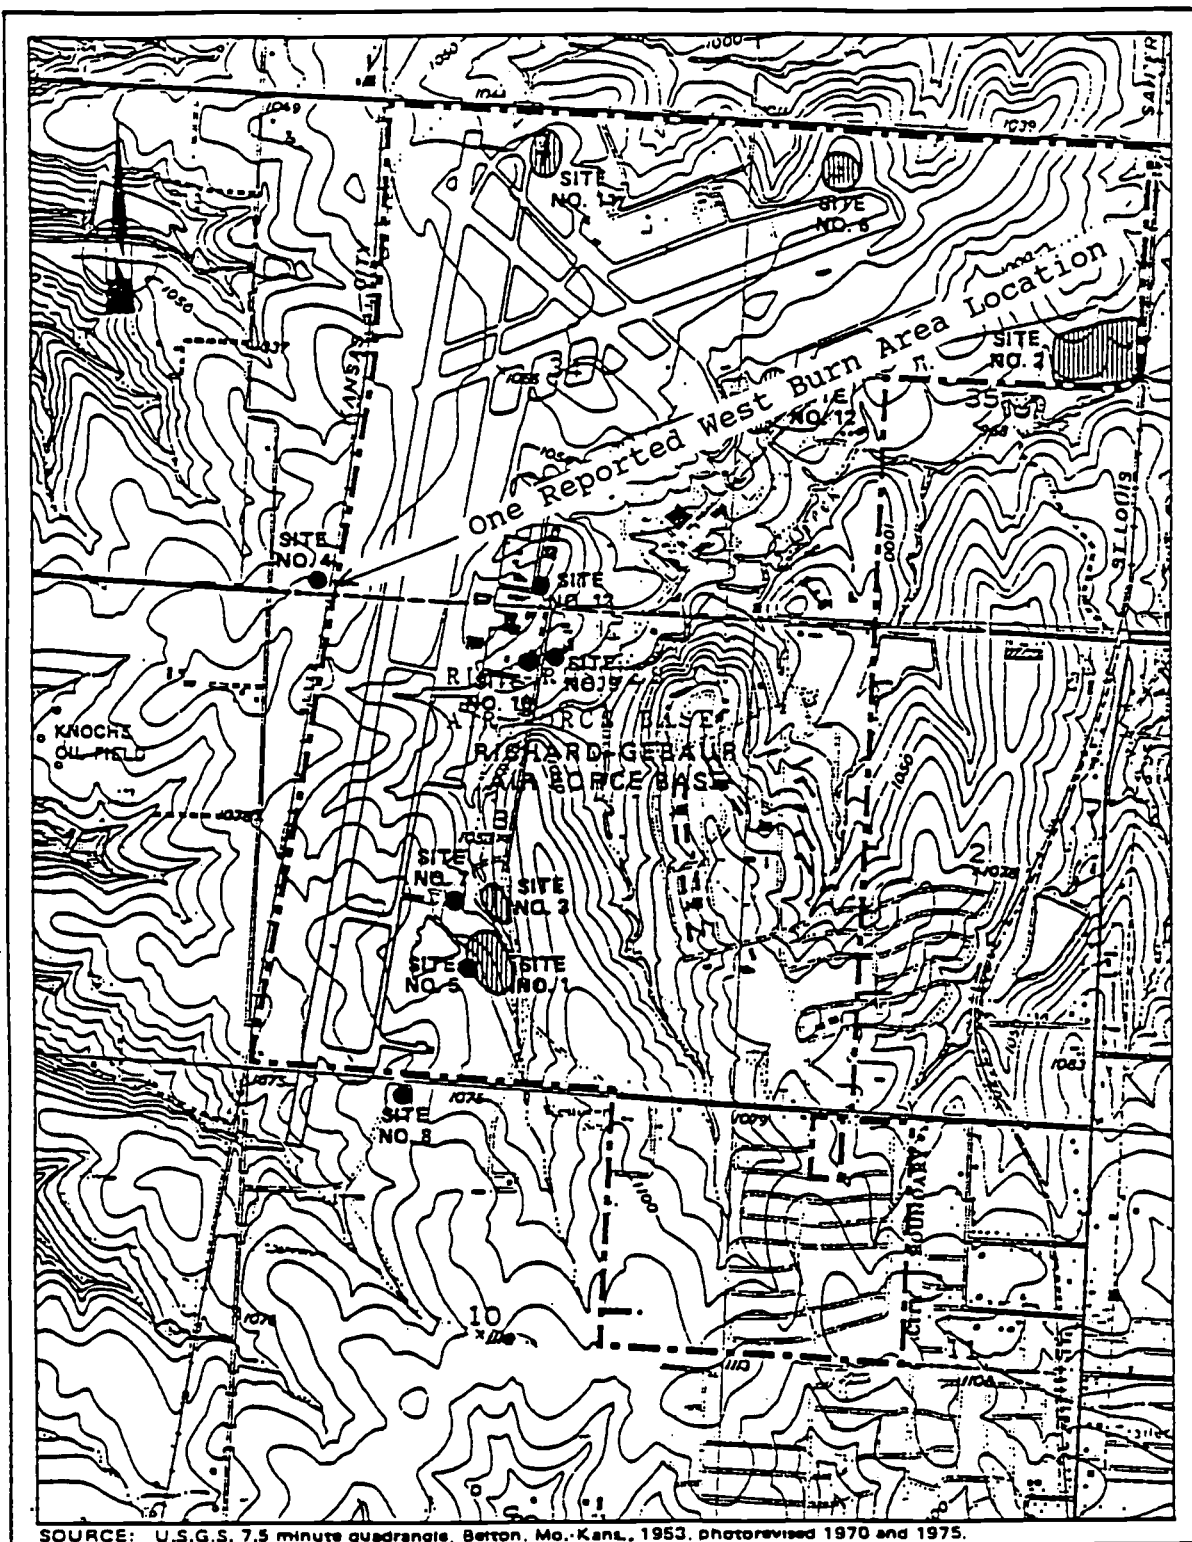
West Burn Area - First Location Indicated

Figure B-5A Adapted from Figure 2-1 in
Appendix N of Reference No. 4

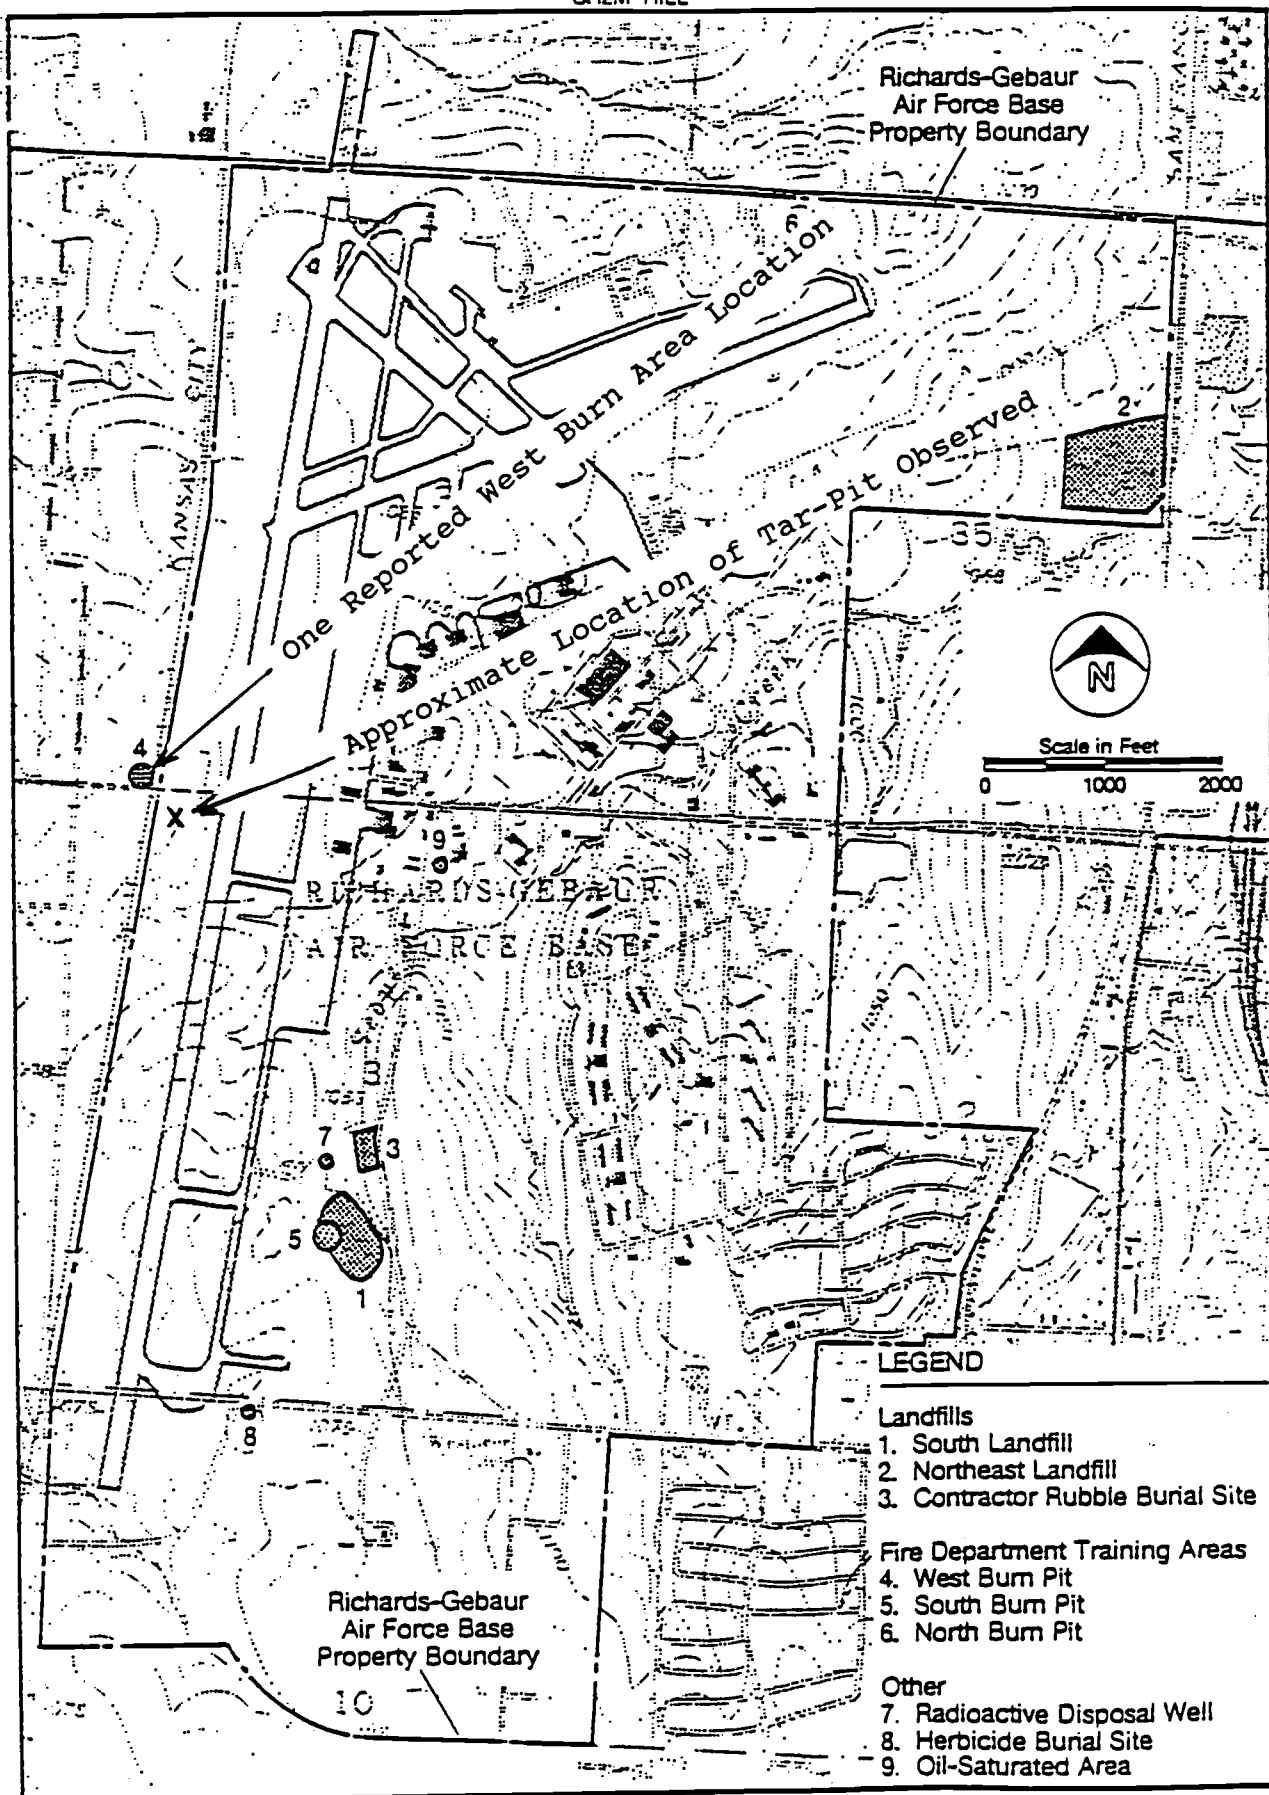
West Burn Area - Second Location Indicated

Figure B-5B Adapted from Figure 6 in Reference No. 2

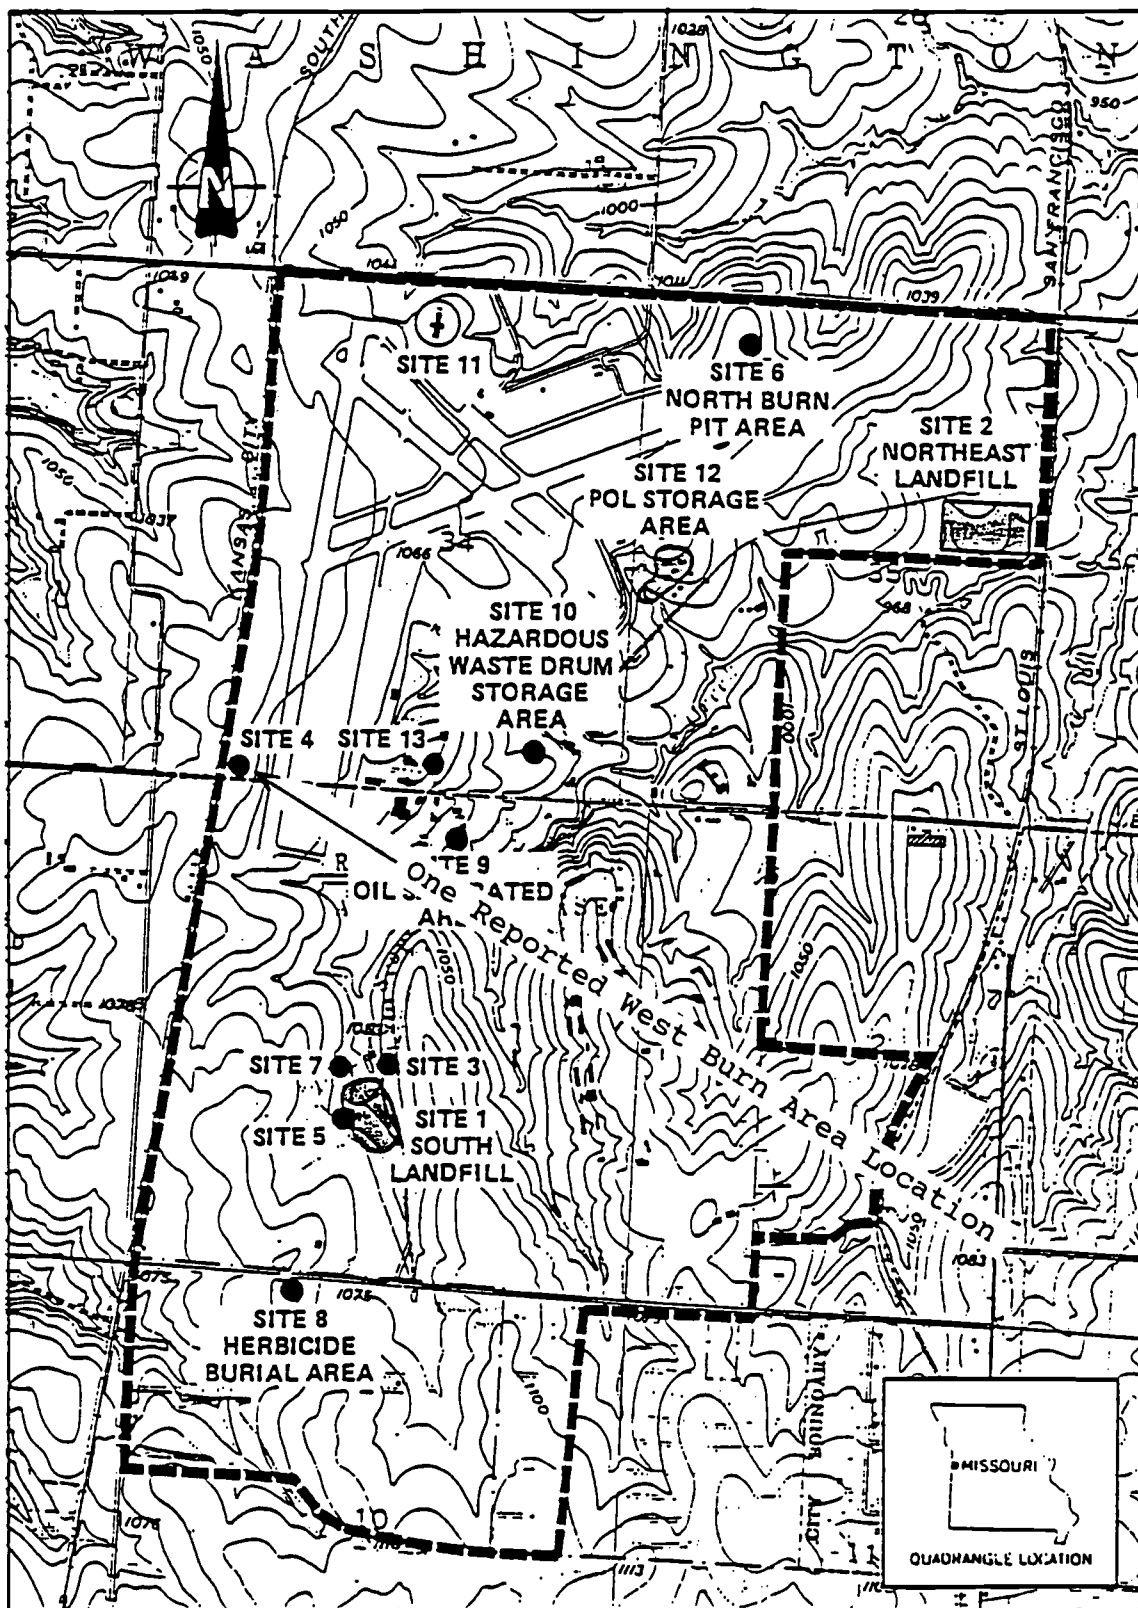
SOURCE: U.S.G.S. 7.5' Quadrangle, Belton, Mo.-Kans., 1975.

West Burn Area - Third Location Indicated

Figure B-5C Adapted from Figure 1 in
Reference No. 4

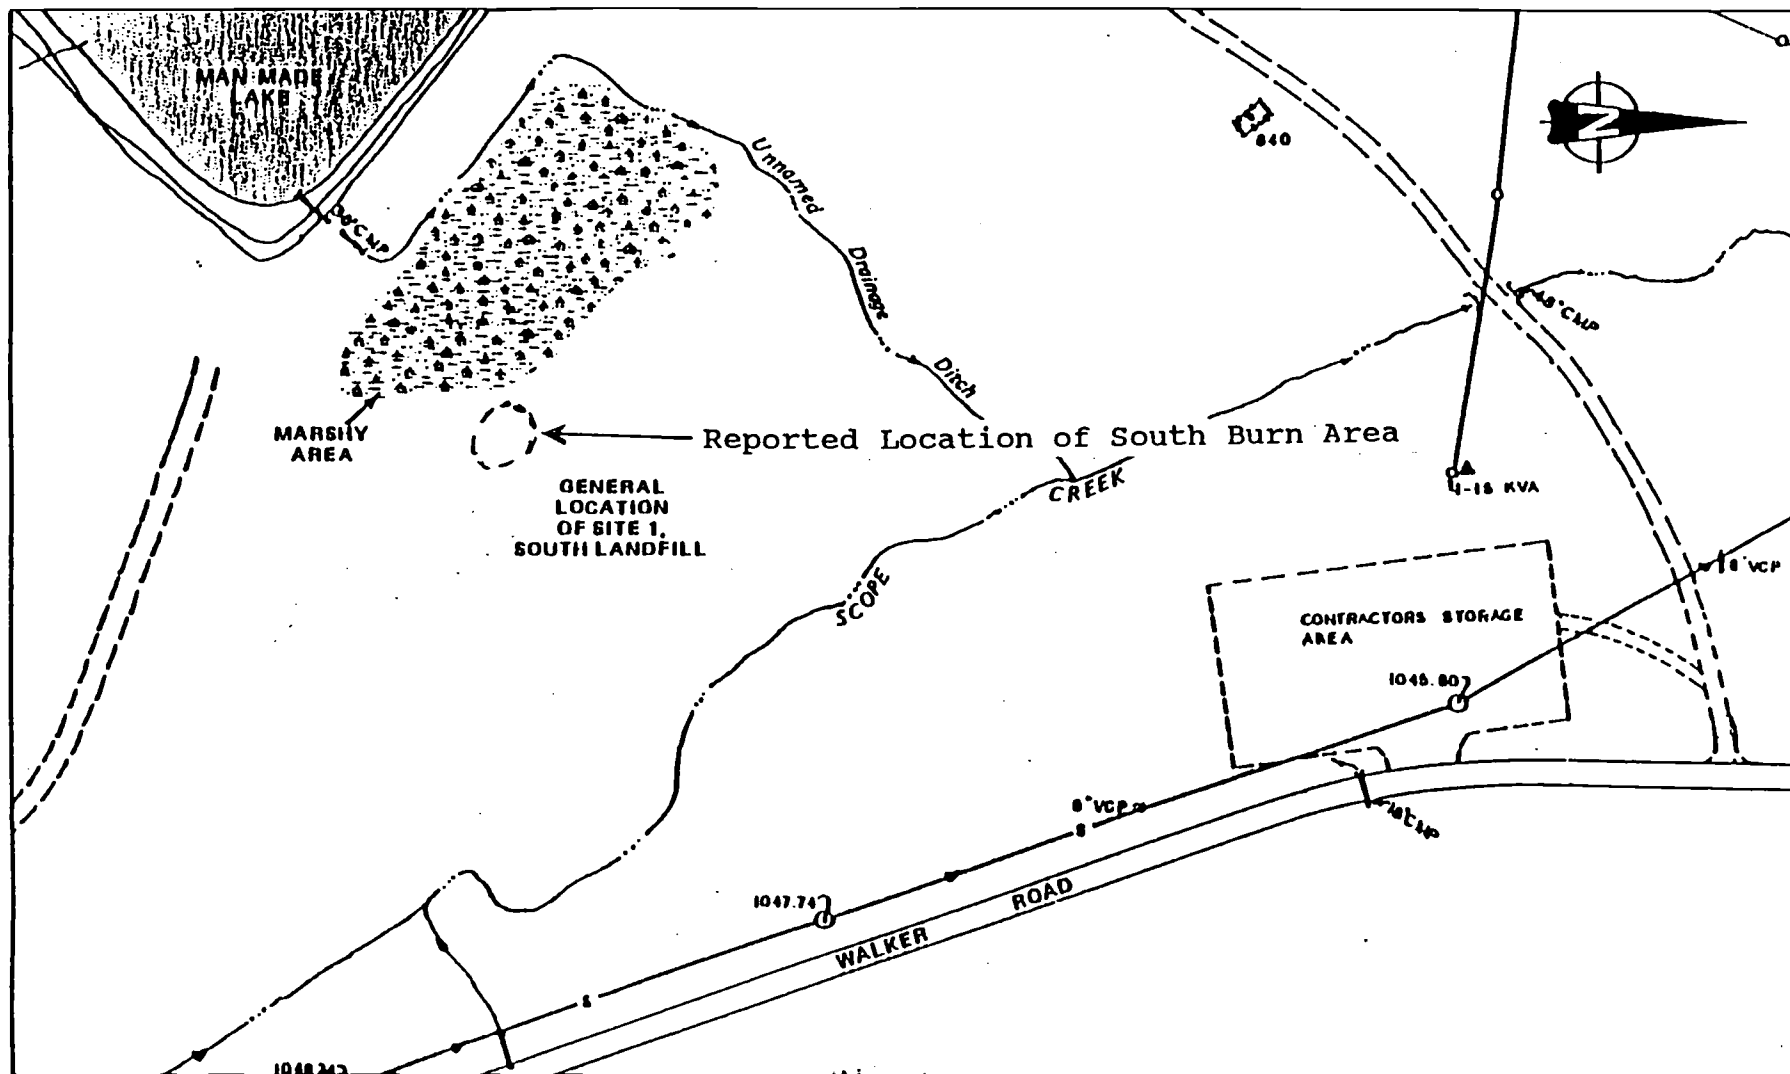
SOURCE: Department of the Air Force, Air Force Communications Service, August 1985, Detell Utility Map, Richards-Gebaur AFB, Missouri.

South Burn Area

Figure B-6 Adapted from Figure 1-9 in
Reference No. 4

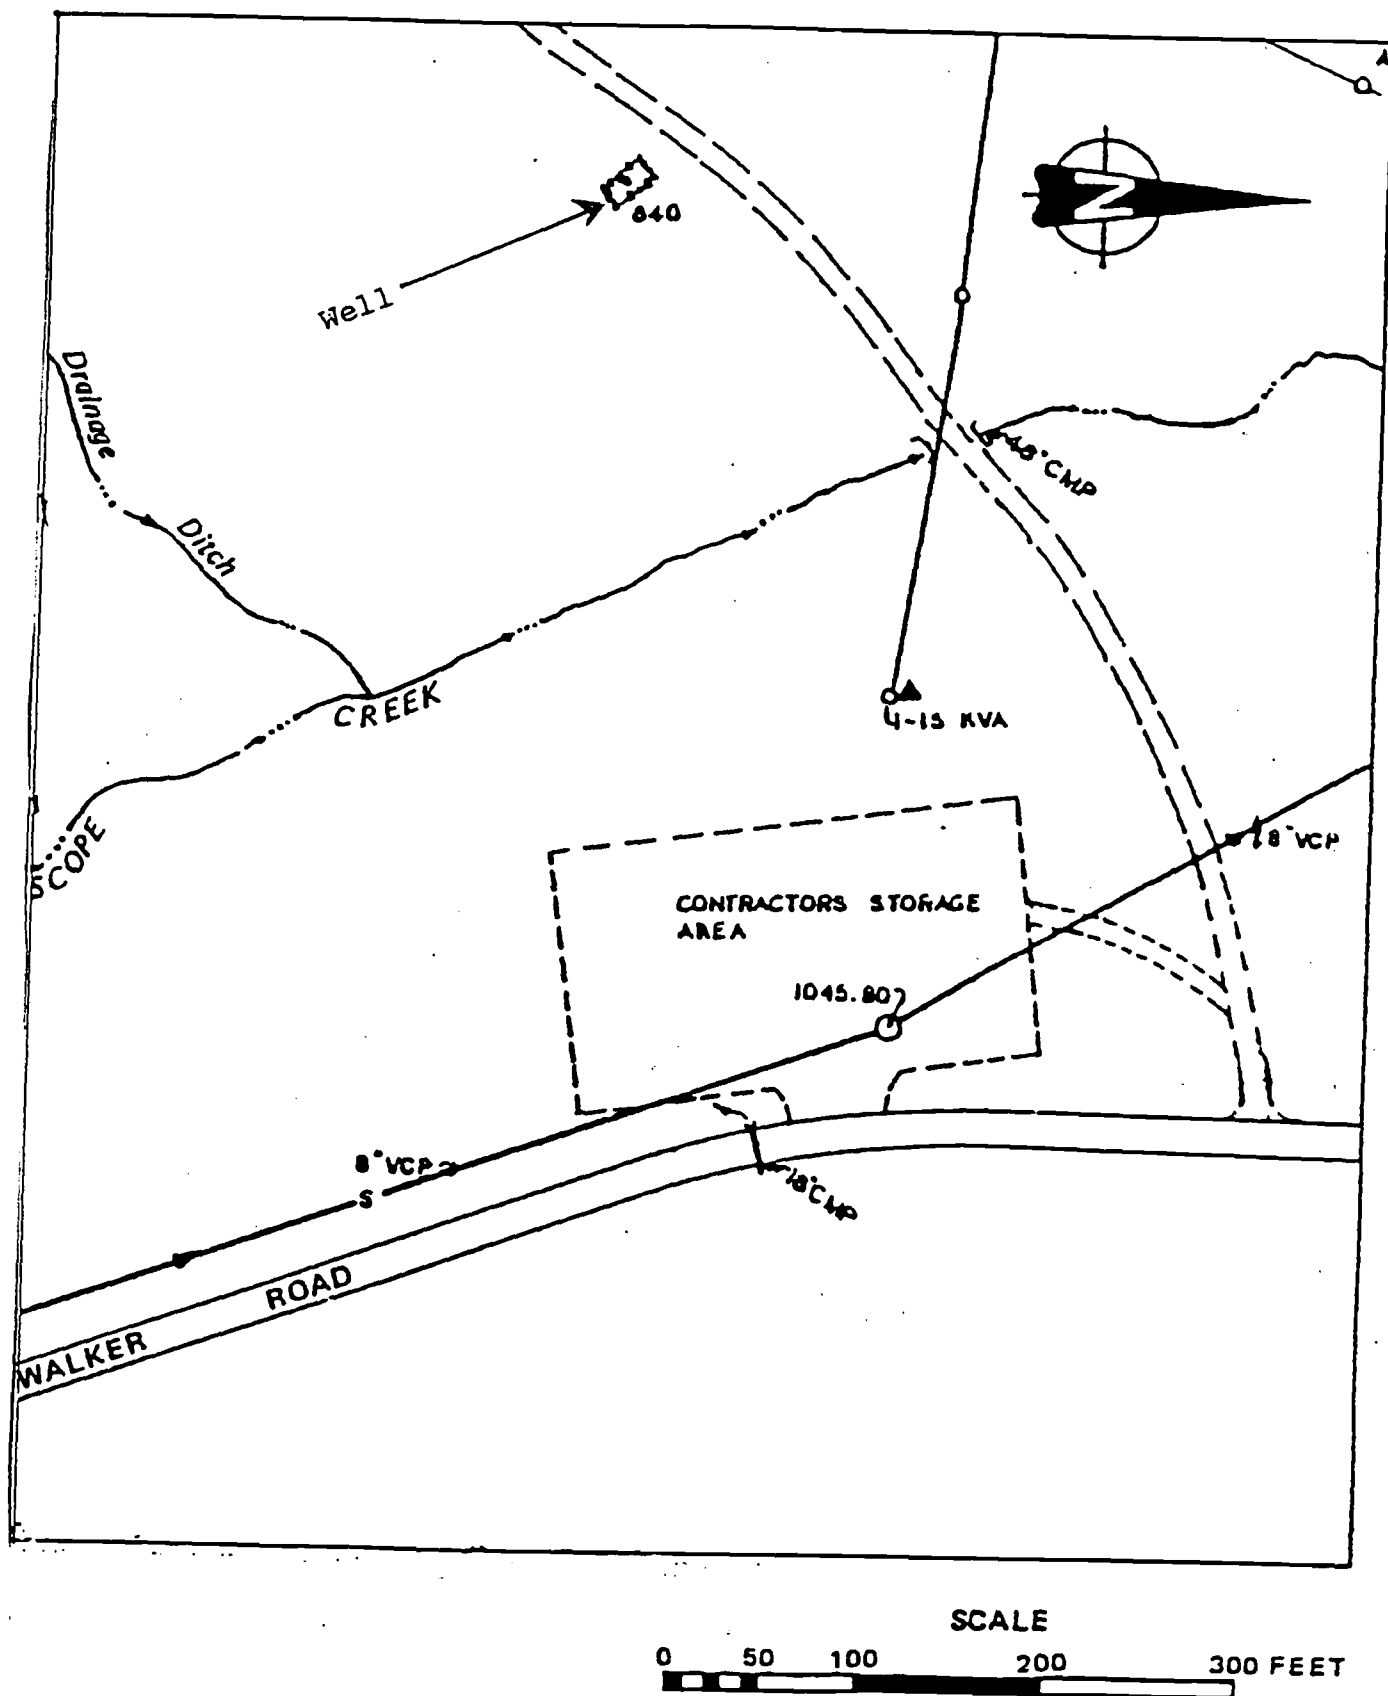
Figure B-7
Radioactive Disposal Well
Figure B-7 Adapted from Figure 1-9 in
Reference No. 4

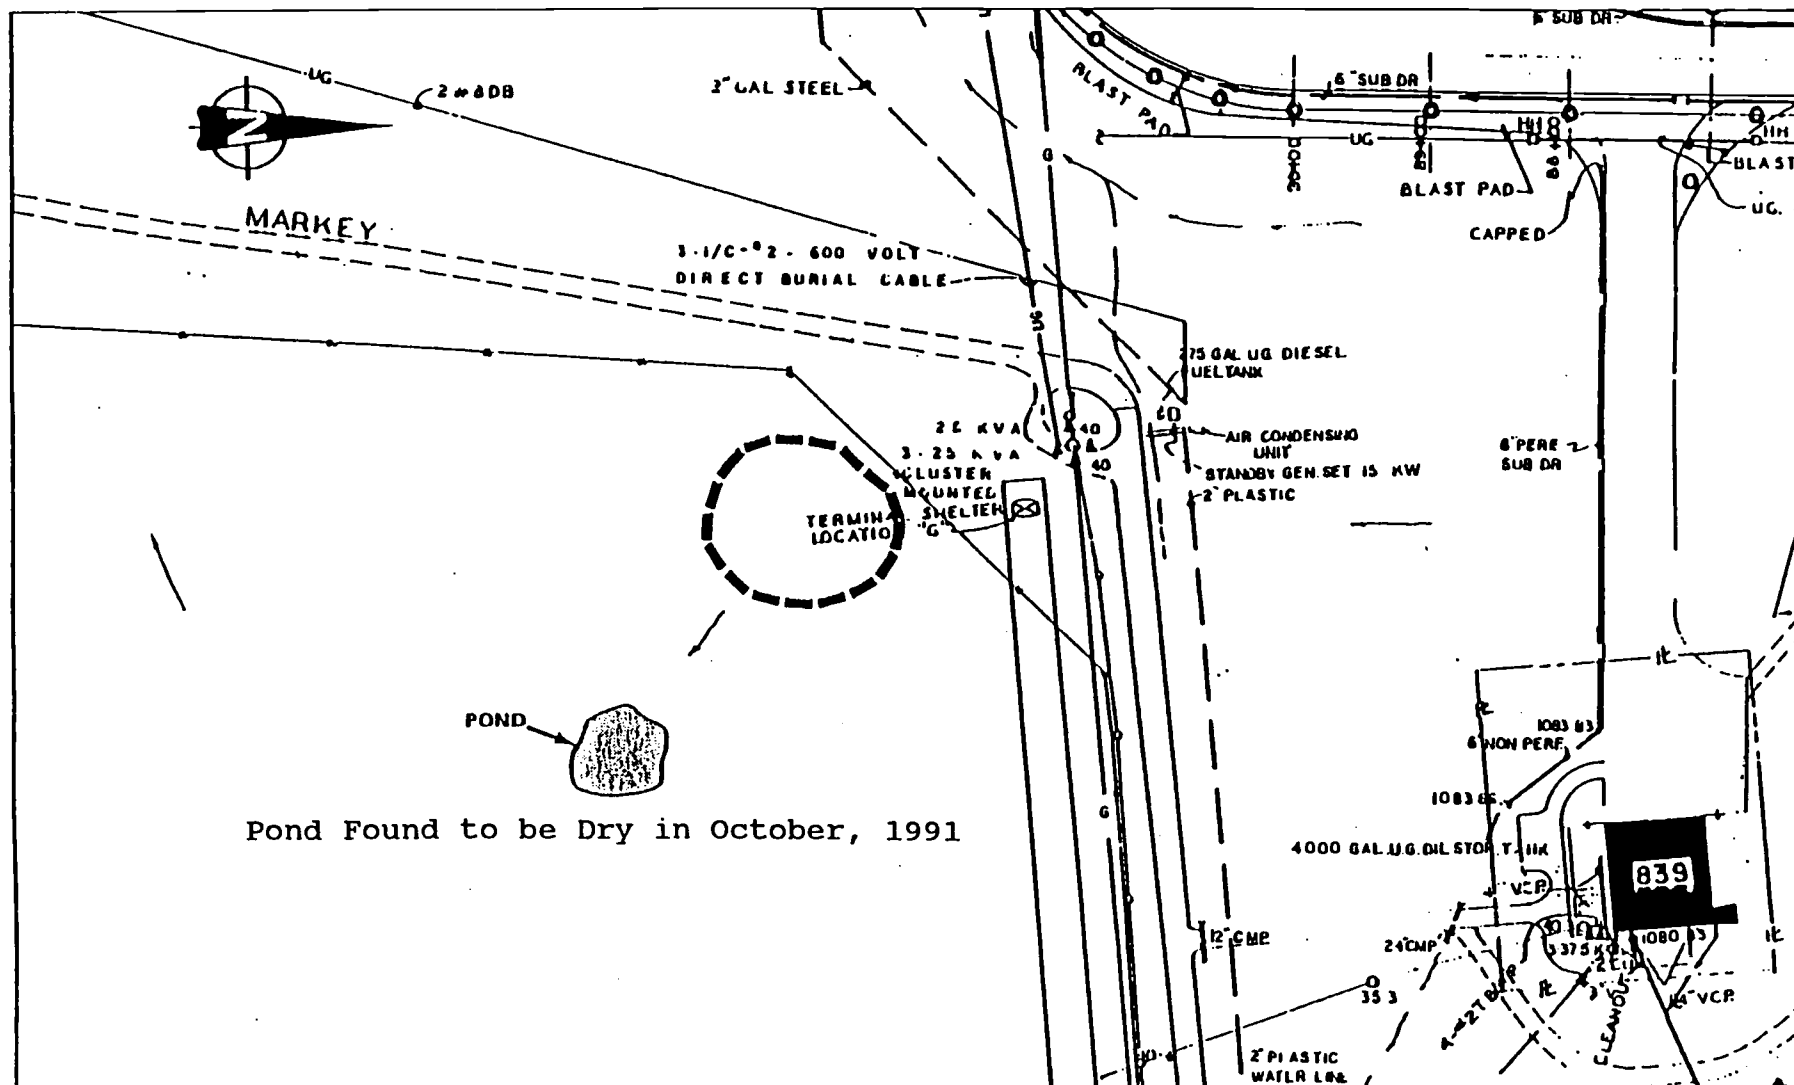
SOURCE: Department of the Air Force, Air Force Communications Service, August 1985, Detail Utility Map, Richards-Gebaur AFB, Missouri.

KEY: Site Boundary Surface Runoff Direction
(according to Ref. 4)

Figure B-8
Herbicide Burial Area

Figure B-8 Adapted from Figure 1-7 in
Reference No. 4
