# Test Report - VxScan Ballot Box Material Cold Storage

Pius Wong Aug 29, 2024

This is a basic test to see if the fabric and flexible materials used in the VxScan v4.0 ballot box LP1 and LP2 prototypes can withstand a cold storage test similar to that defined in VVSG requirements. This test could help evaluate if these parts would become brittle and crack in cold storage, especially if they are under stress and strain.

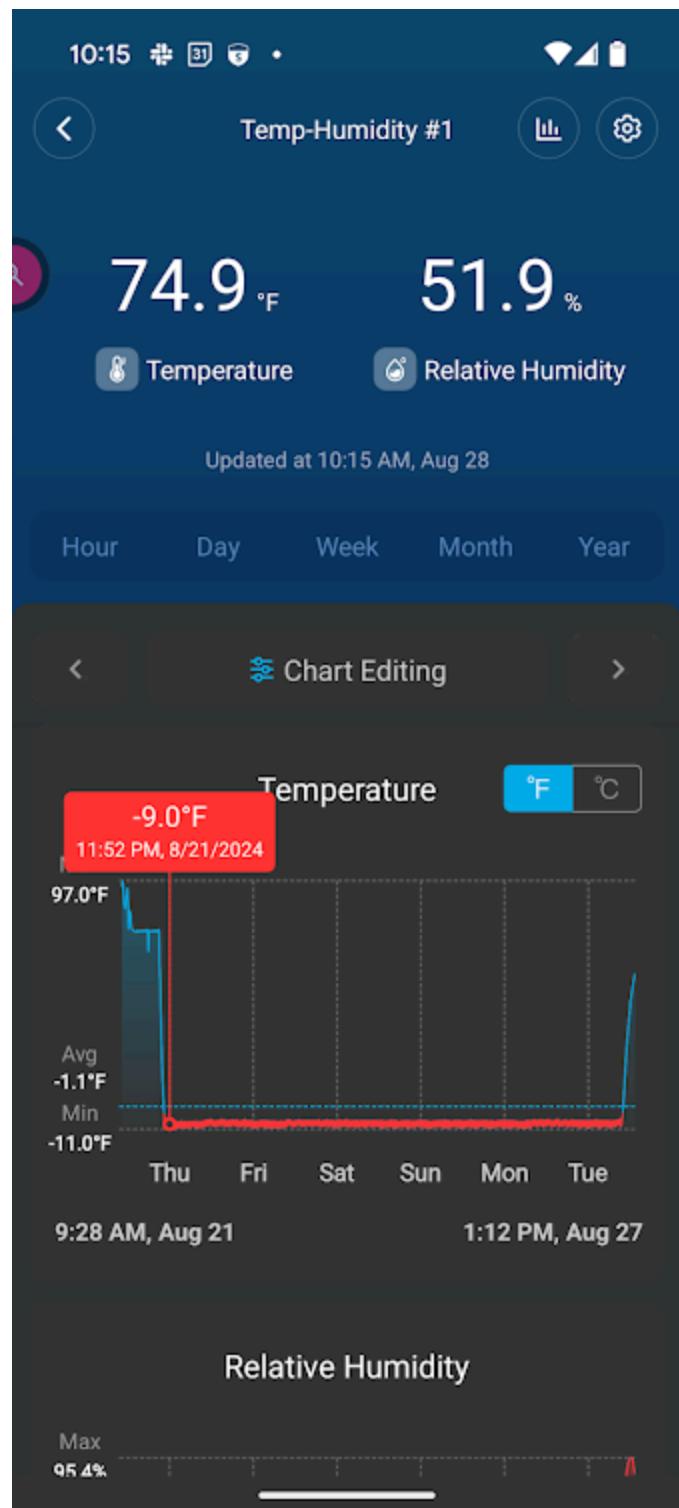
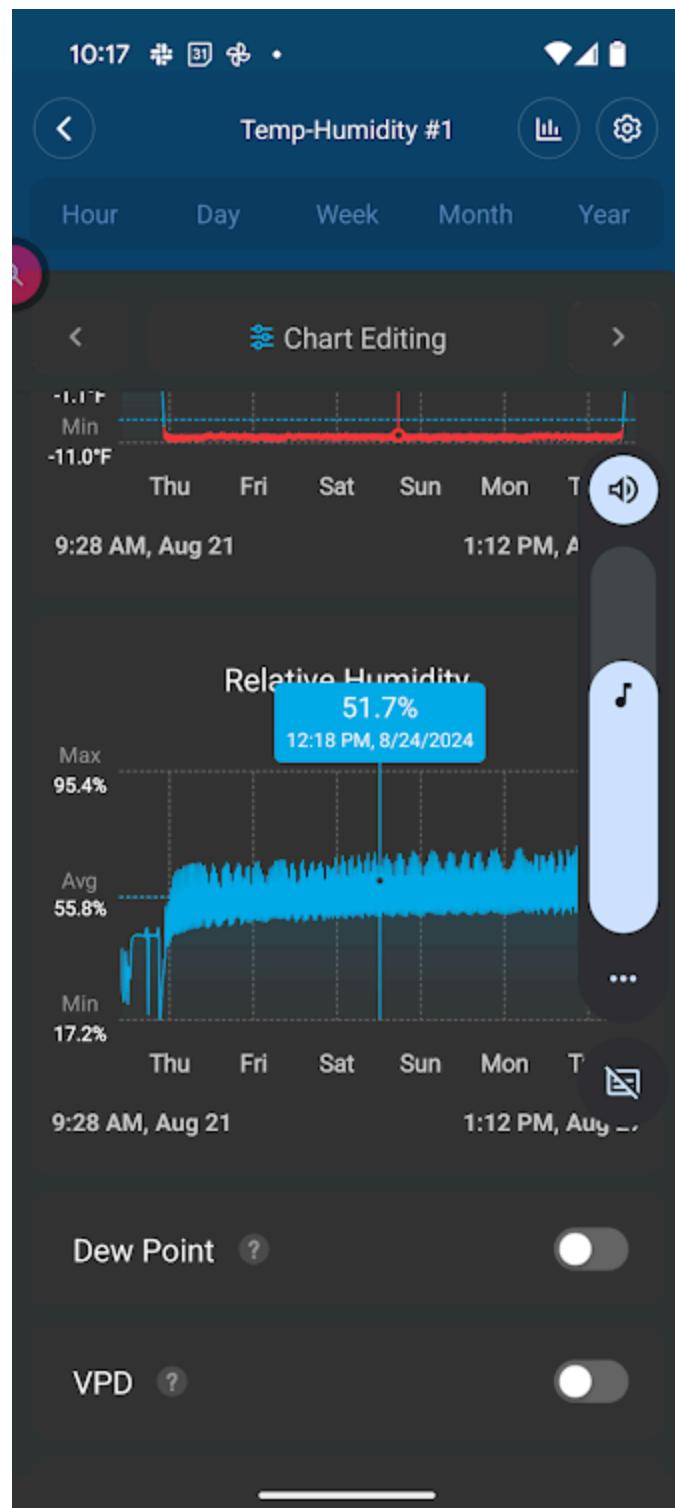
- a. The MCM was placed in the freezer on 8/21/24 at about 5:30pm, starting at a temperature of 75°F and 46%RH. (see photo below of setup)

- b. The freezer held a temperature between -8 to -11°F (digital thermometer reading), and humidity of 50-60%RH, from 8/22/24 at about 12AM to 8/27/24 at about 9am when it was unplugged. It held these conditions for a total of about 129 hours. (See sensor data below)
