Richards-Gebaur Memorial Airport

Draft Stormwater Permit Application

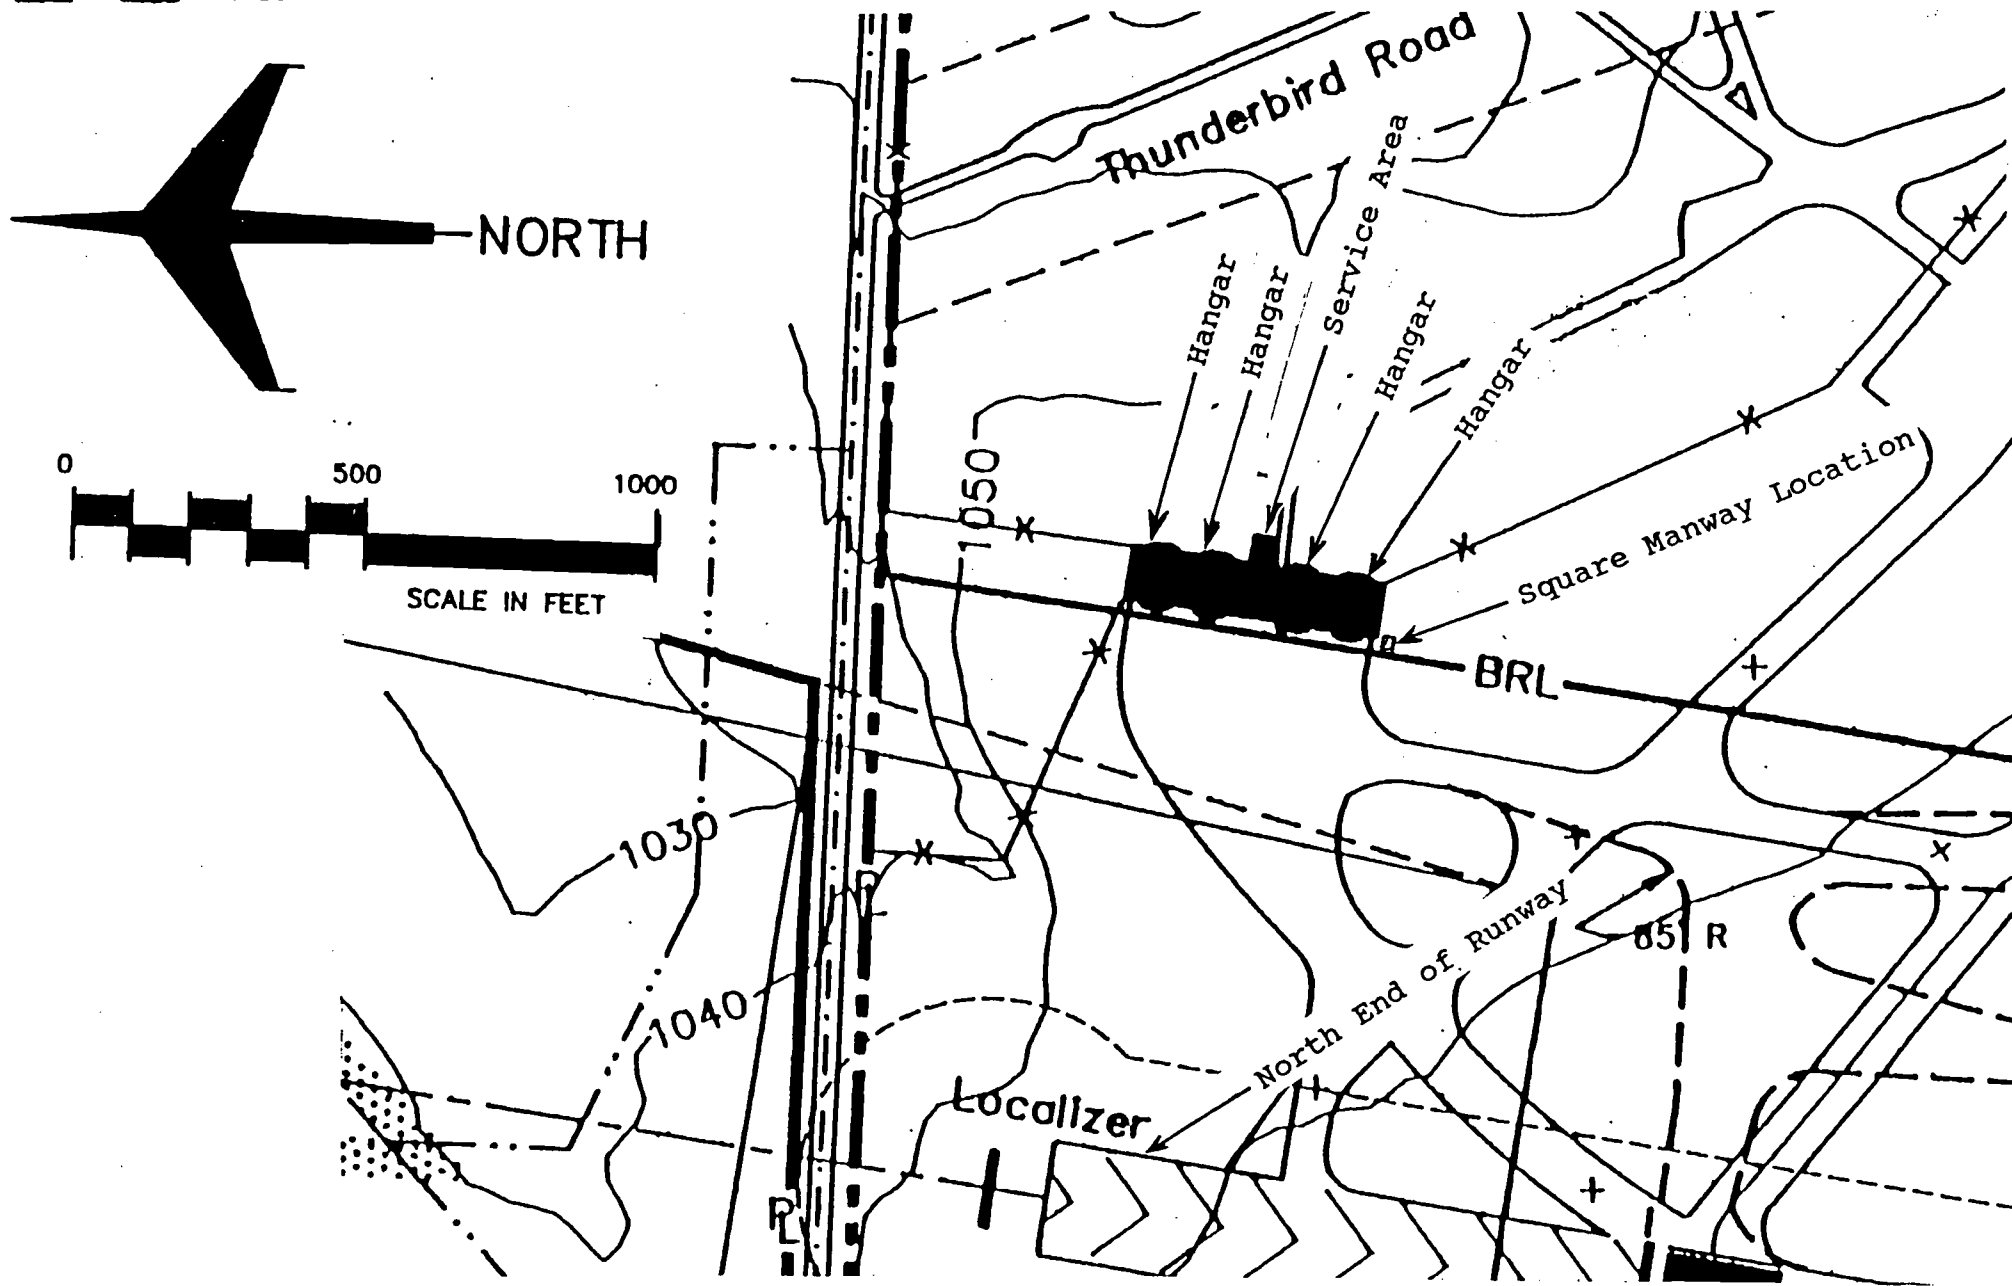
Figure B-9
Paint Stripper Hanger
Figure B-9 Adapted from Portion of
Reference No. 18

Still another individual⁷ recalled only the helicopter painting operation. He reported that the underground tank, provided with containment, was used for storing stripper and was located behind No. 3 and No. 4 hangars (the two to the south). Remaining material was pumped out by a hazardous waste disposal company following the one-year period in 1982 and 1983 when the operation was carried out. He said that disposal of the stripper presented no problem, since it was biodegradable. The only solvents used were those in the spray paint; no method of application other than spraying was employed.
