Test Report - VxMark Cold and Hot Storage of Goldenmate 1500VA/1000W UPS and HP4001dn Printer

Author: Pius Wong , created Apr 30, 2026 , updated Jun 3, 2026

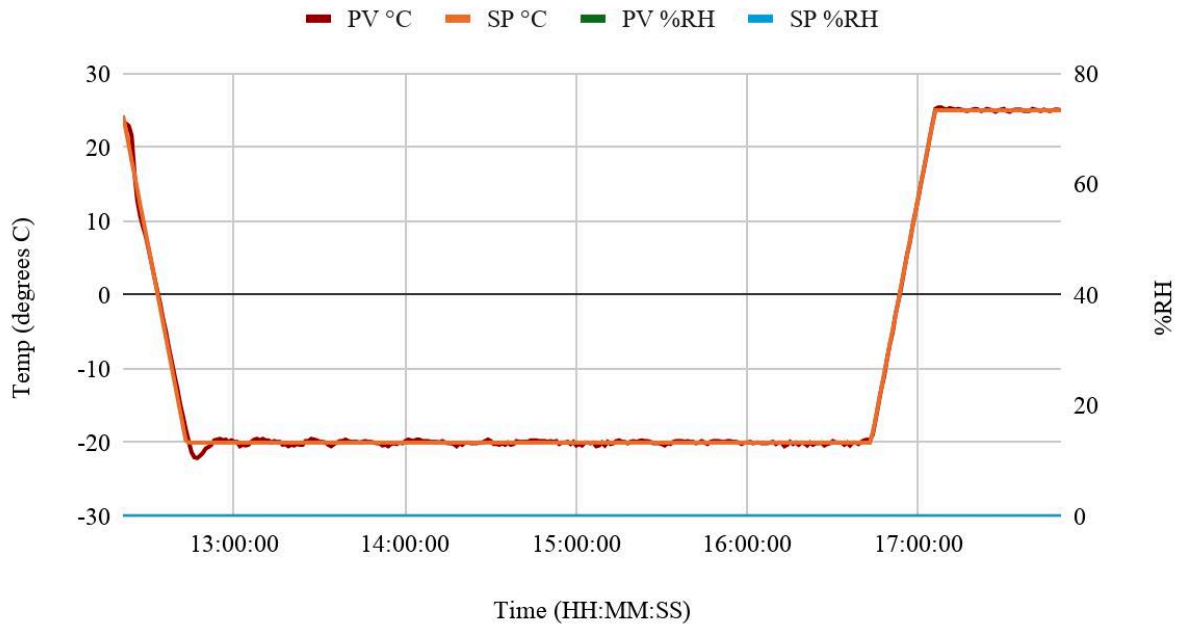
Temperature & %RH vs. Time, Cold Storage

- b. Test conditions followed the intended set point (SP) for the process variable (PV) of temperature, with humidity at 0%RH uncontrolled. This is shown in the graph below of the chamber data log:

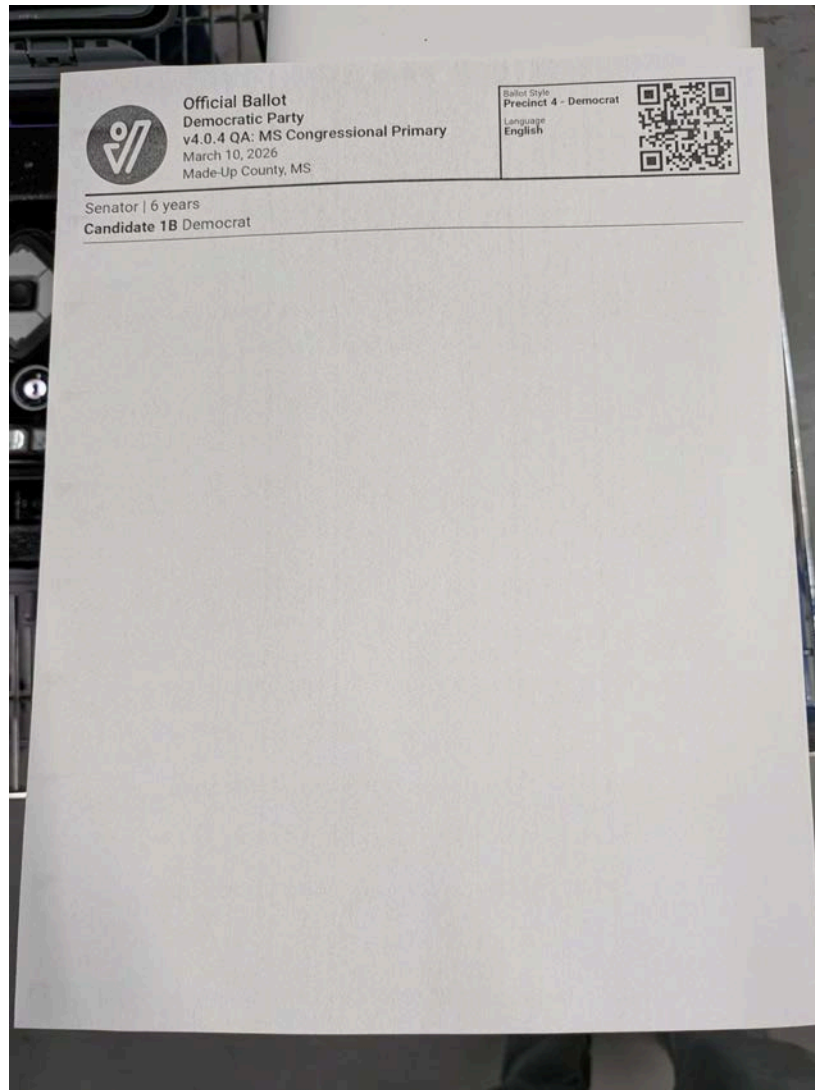
Temperature & %RH vs. Time, Cold Storage

5. Normal function was confirmed for the UPS and printer after cold storage, if toner was replaced.

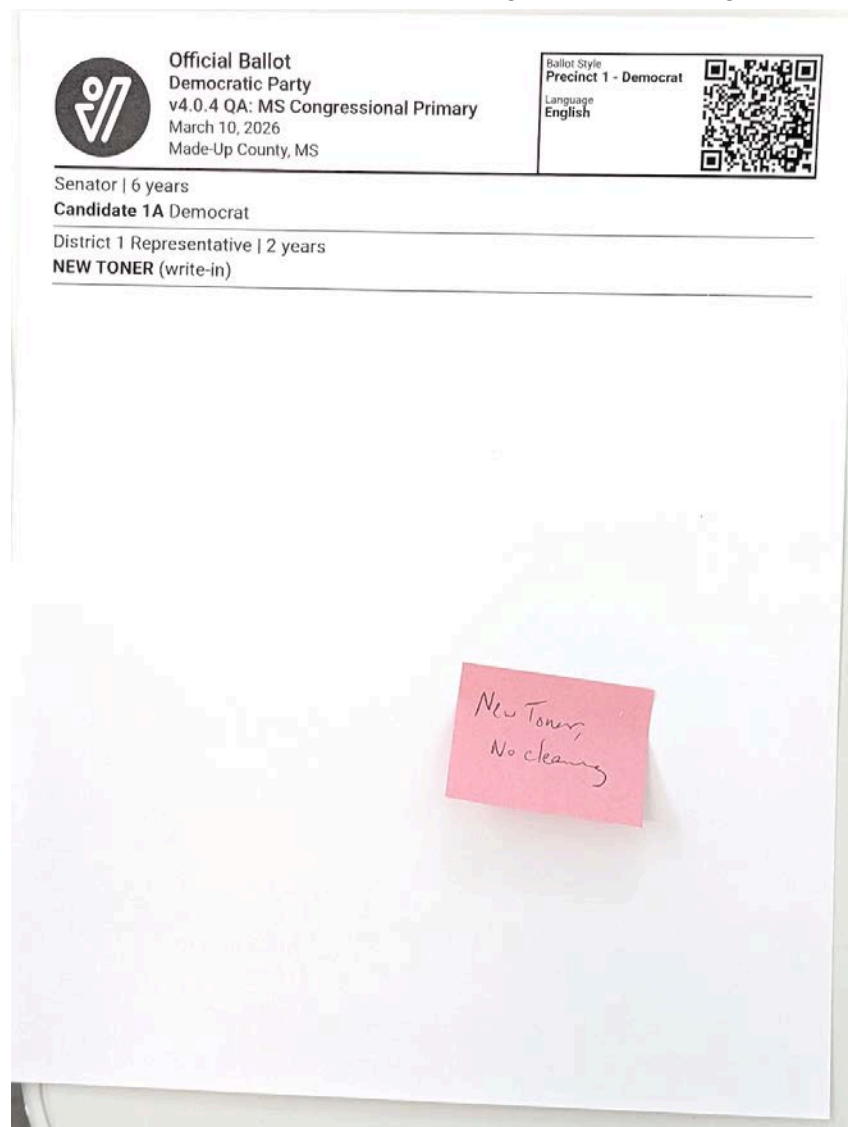
- c. All essential UPS functions worked as expected.
- d. Printer functions worked mostly as expected, with the exception of a gray layer of toner or ink over the printable area on the first several prints after hot storage. This did not appear previously nor after cold tests. This printing artifact did not prevent the printed ballots from being properly scanned, interpreted, or tabulated in VxScan, but were still very visible and not proper behavior. Additional test prints several hours later showed that the printer continued to print with artifacts that potentially could cause concern. See image below for an example test print with a layer of gray over the page:

- e. Replacing the HP148A toner with one that was properly stored eliminated the artifacts, as shown in the print below right after replacing the toner:

- User instruction and documentation should clarify that standard maintenance procedures for the HP4001dn include replacing the toner when the toner (or printer holding the toner) is stored at temperatures greater than 104°F (40°C).
