Passage of Native Cutthroat Trout Through Small Culverts On Steep Slopes: What Are The Limits?

Jeffrey T. Light¹, N. Phil Peterson², & Ryan K. Simmons²

Society of American Foresters
March 14, 2013

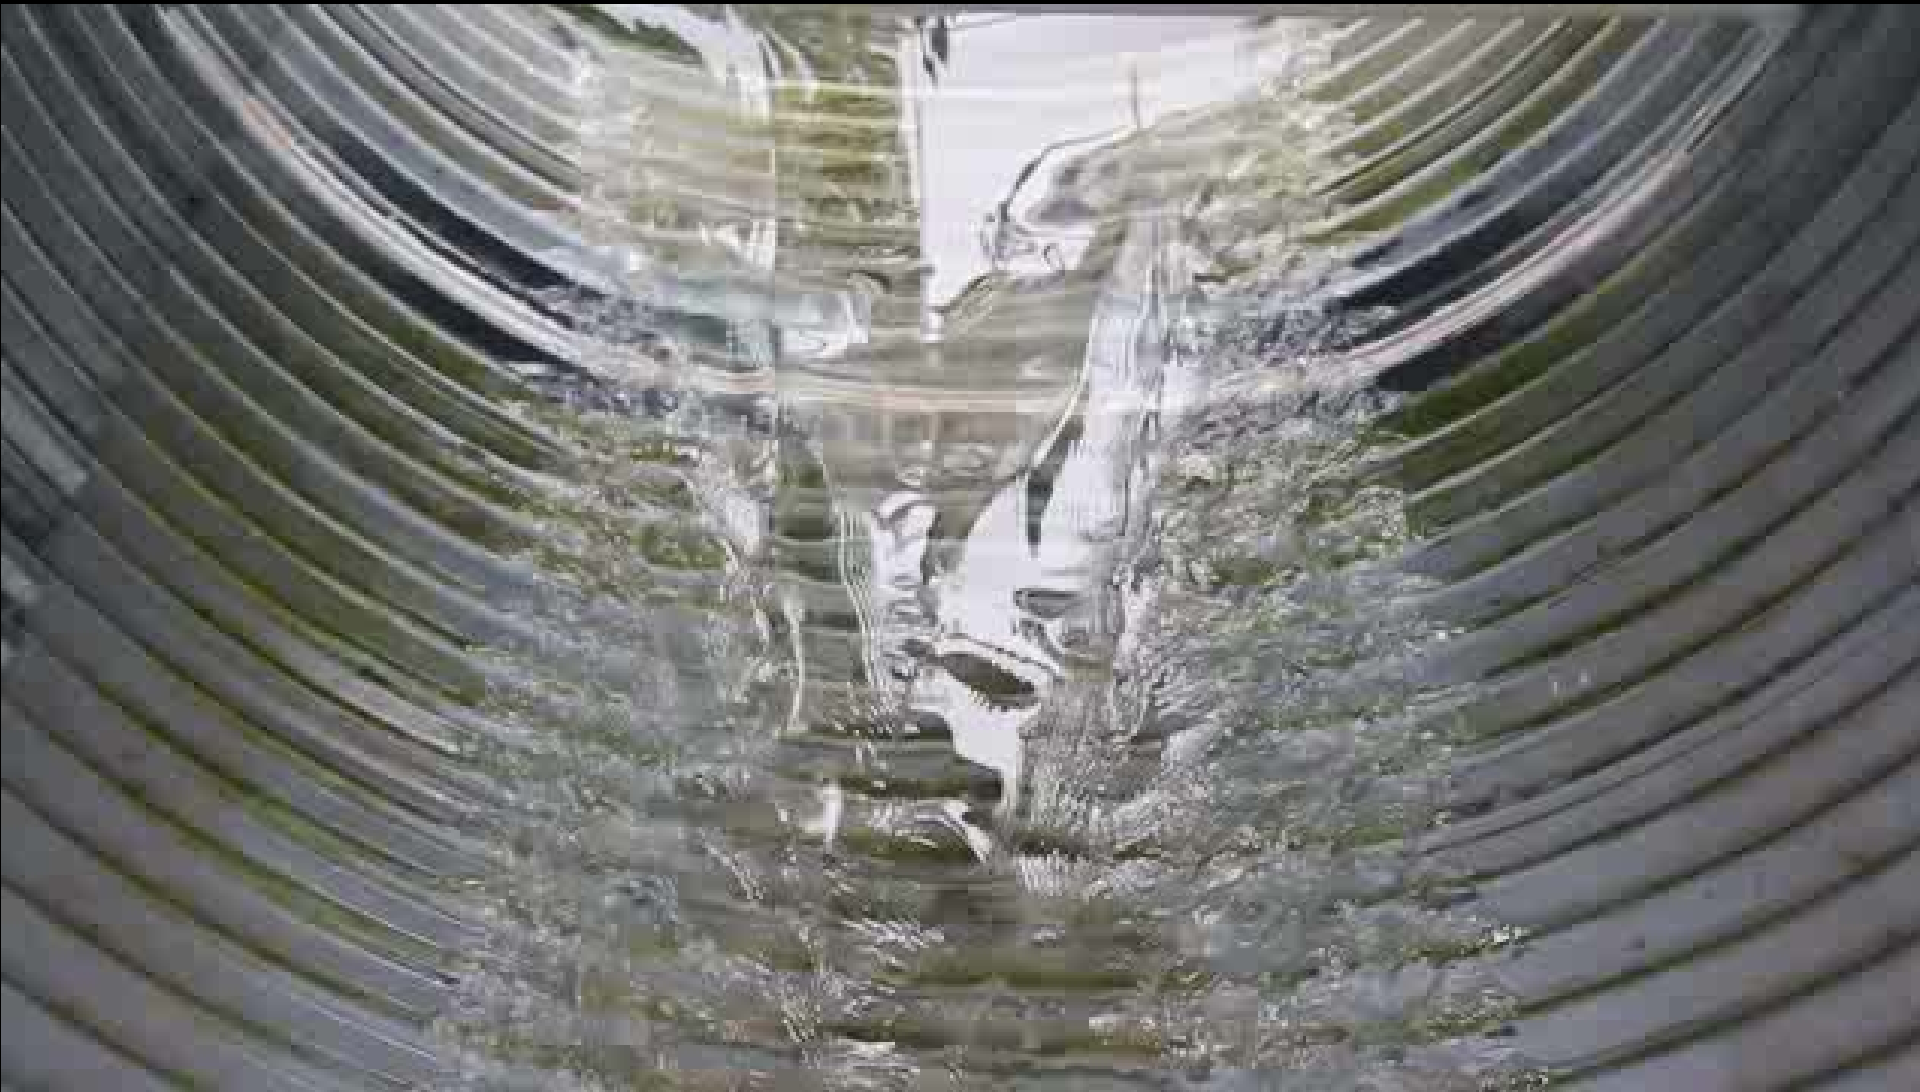
Flow: 8 cubic feet/sec

Pipe Slope: 8.6%

Velocity: 7 ft/sec

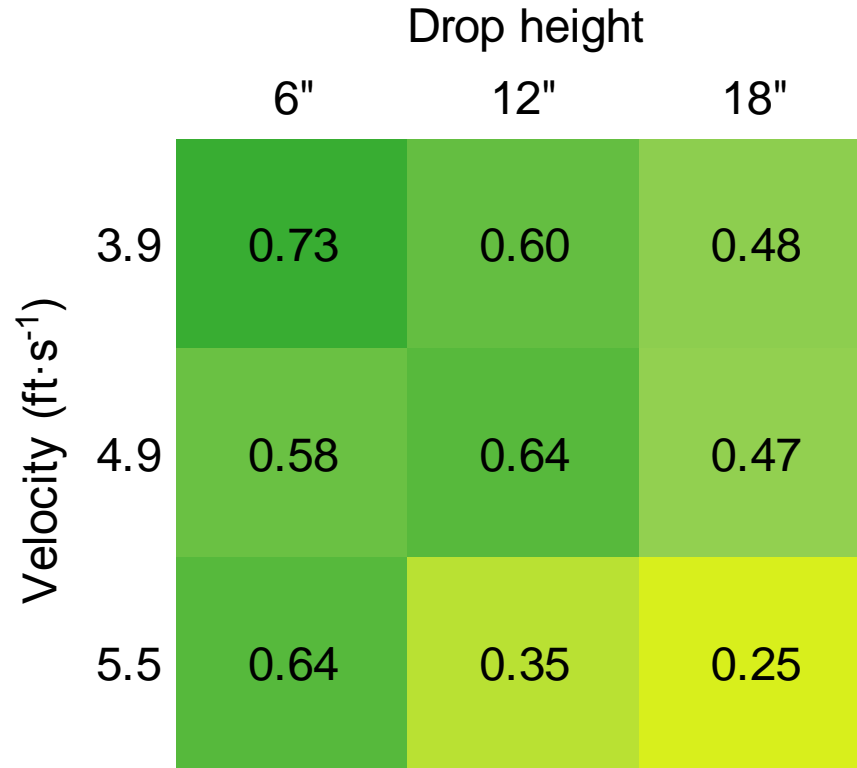
Passage performance by distance through culvert

Movement up lower quarter of culvert
