B1GMB42 Motherboard Slot & Port Inventory

Machine: Dell Precision Tower 5810

Serial: B1GMB42 (same chassis; DMI serial blank until SMBIOS repopulated)

Motherboard: Dell 0K240Y (BIOS **A34**)

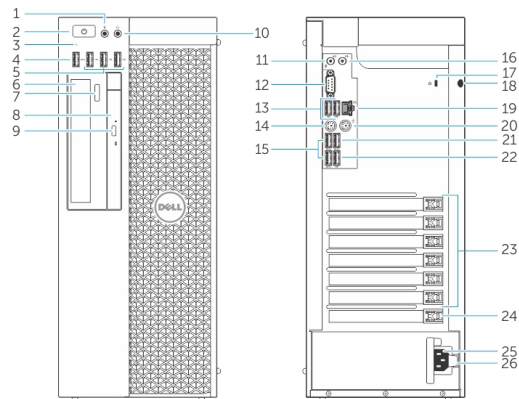
Figure 1 — Front & Rear I/O

B1GMB42: 12 mini-DP on 3 FirePro; Intel I217-LM RJ-45.

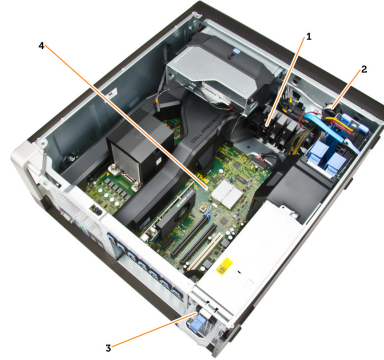
Figure 2 — Inside (top view)

B1GMB42: Hitachi rpool; TEAM special; Seagate Windows.

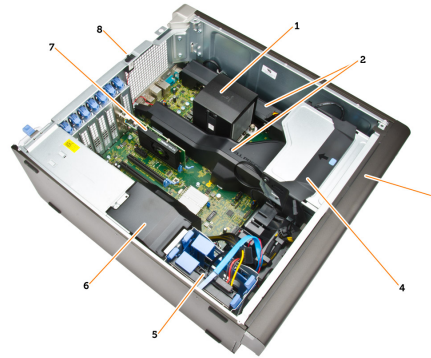
Figure 3 — Inside (PSU side)

PERC H710 in Slot5.

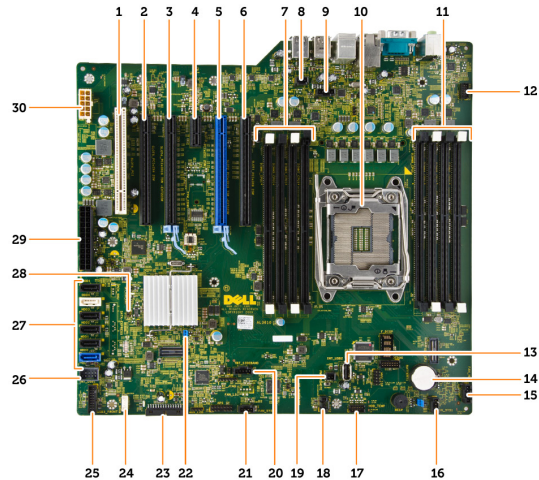
Figure 4 — System board labels (1–30)

Slots	1 W5000, 2 W5100, 4 W5000, 5 PERC H710, 3 empty
SATA 27	Hitachi rpool, Seagate Windows, TEAM special
Power	29 ATX + 30 CPU EPS from PSU shroud
Front	12 audio, 23 panel/LED/USB2, 25 USB3
Fans	9 CPU + 16/18/21 chassis
PCIe bus	01:00 / 02:00 / 03:00 GPUs; 07:00 PERC

Manual allows up to **two** full-height full-length PCIe x16 cards at 225 W each; B1GMB42 exceeds that count with three 75 W FirePro cards — confirm PSU label (**425 W** or **685 W**).

Item	Detail
Card	PERC H710 @ 07:00.0
Driver	megaraid_sas
Status	FAULT — FW in FAULT state, Fault code:0x40000
Disks exposed	None

1. **Apply video config** (if not done): cd ~/Documents/IndianaDell && sudo bin/apply-amdgpu then reboot.
 2. **RAM:** Upgrade to 32 GB+ when possible (currently 3x4 GB).
 3. **PERC H710:** Fix firmware fault or replace before using SAS bays.
 4. **PSU:** Confirm wattage on PSU label.
 5. **Do not re-enable ZFS encryption** until TPM + recovery strategy is documented.
 6. **FactoryDocs:** Re-grab any drivers that failed mid-download (GPU, audio, encryption zips).
-
