B1GMB42 Motherboard Slot & Port Inventory

Machine: Dell Precision Tower 5810

Serial: B1GMB42 (same chassis; DMI serial blank until SMBIOS repopulated)

Motherboard: Dell 0K240Y (BIOS **A34**)

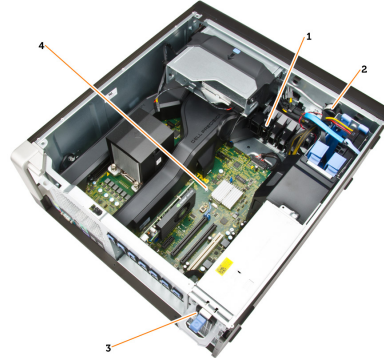
Figure 2 — Inside (top view)

B1GMB42: Hitachi rpool; TEAM special; Seagate Windows.

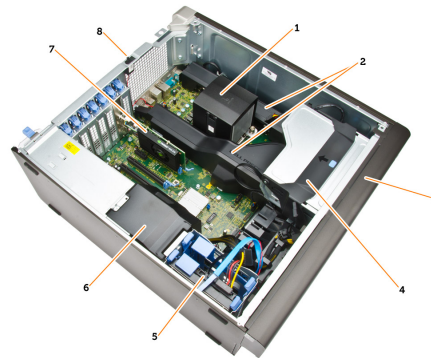
Figure 3 — Inside (PSU side)

PERC H710 in Slot5.
