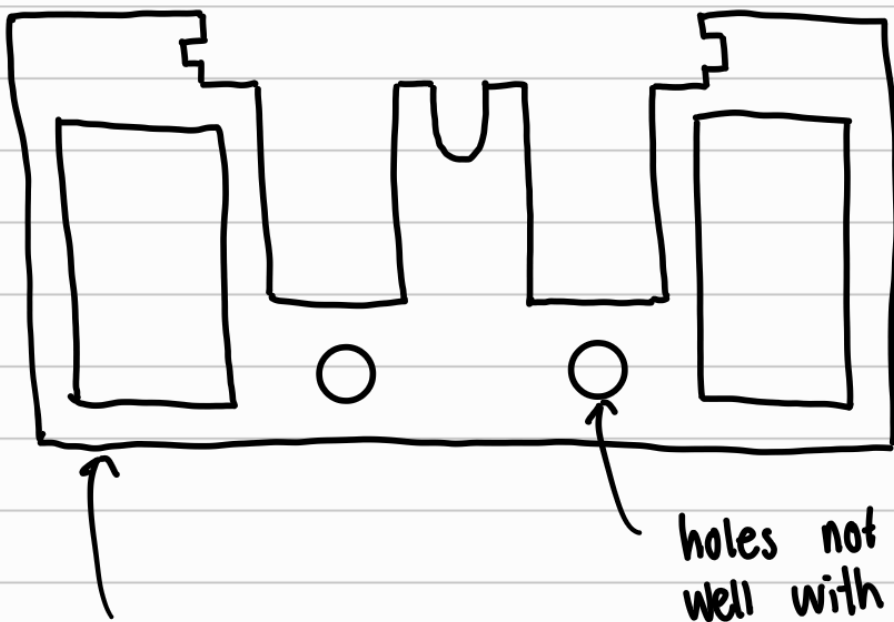
↓ Arduino gap should increase by 1-2 mm

Revise this structure for more strength

holes not aligned well with battery holder

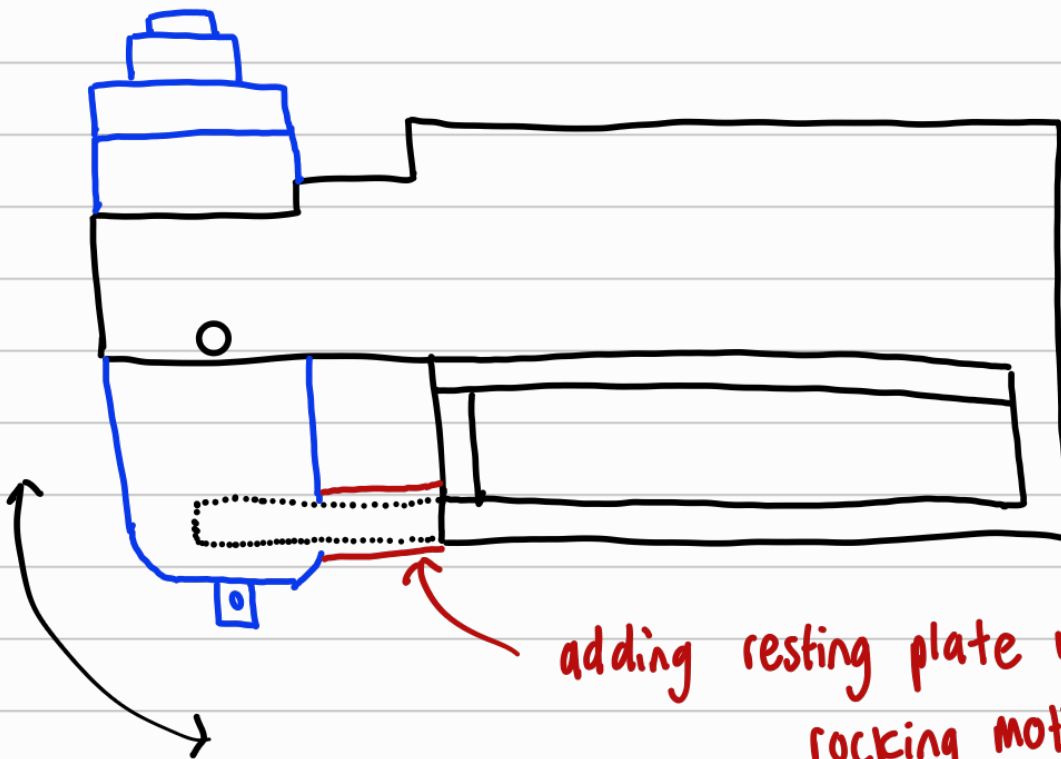
DC motor is locked in but rocks back and forth

- encoder does not lie completely flat, the soldering increases width by 1-2 mm.
- slot design and battery holder are perfect friction fits.
- encoder wheel is loose on the motor shaft.

adding resting plate will remove rocking motion
