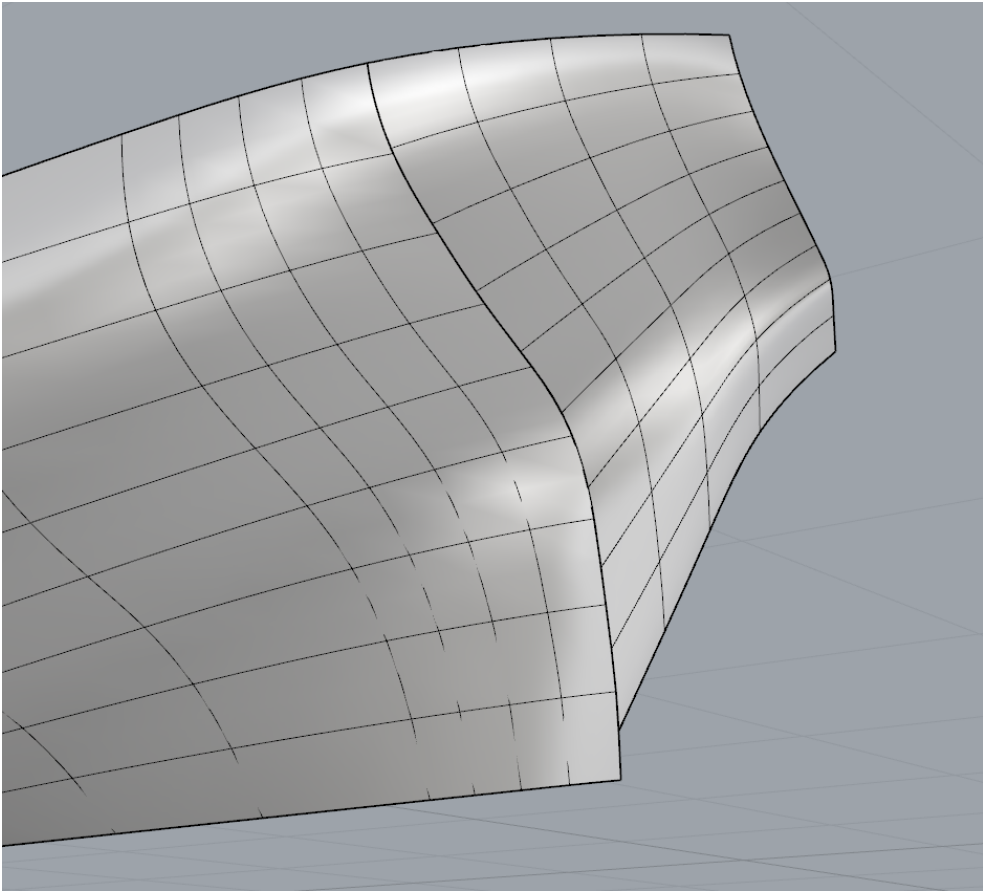
Below is the one patch of the hull that is non-continuous. Due to the centerboard of the ship taking a jog upwards to meet the rudder, there is a corner near the stern, which required a patch to complete the segment past the corner. The surfaces ended up being actually nearly continuous on the first try, and attempting to merge them changes the corner, as shown below (in green).

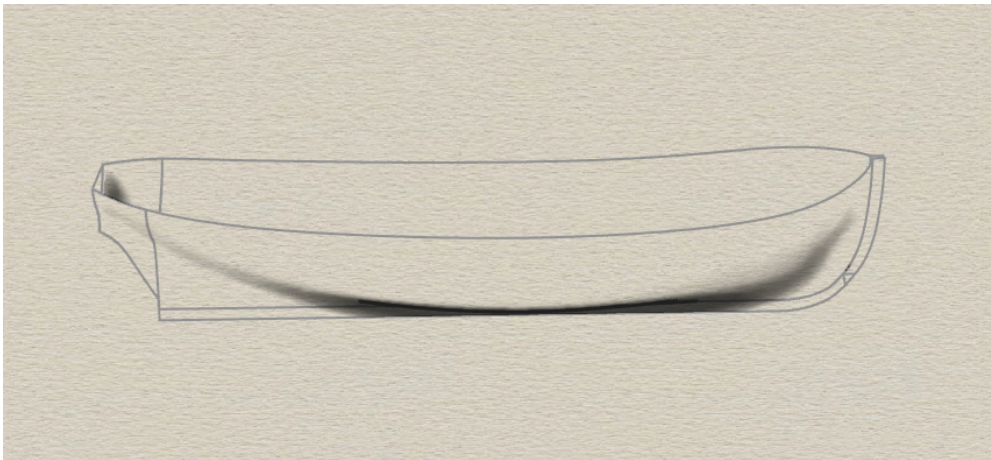
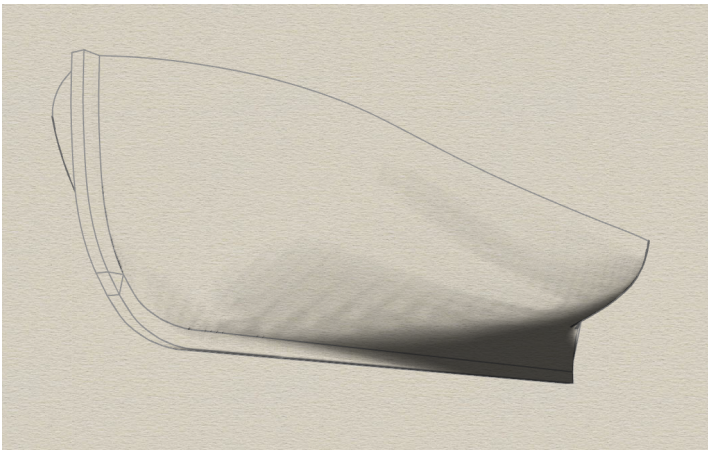
Above is the entire hull rendered in “artistic mode” in two perspective views to demonstrate the overall level of fairing achieved, which was all done on the first pass aside from the minor fixes and blemishes described below.

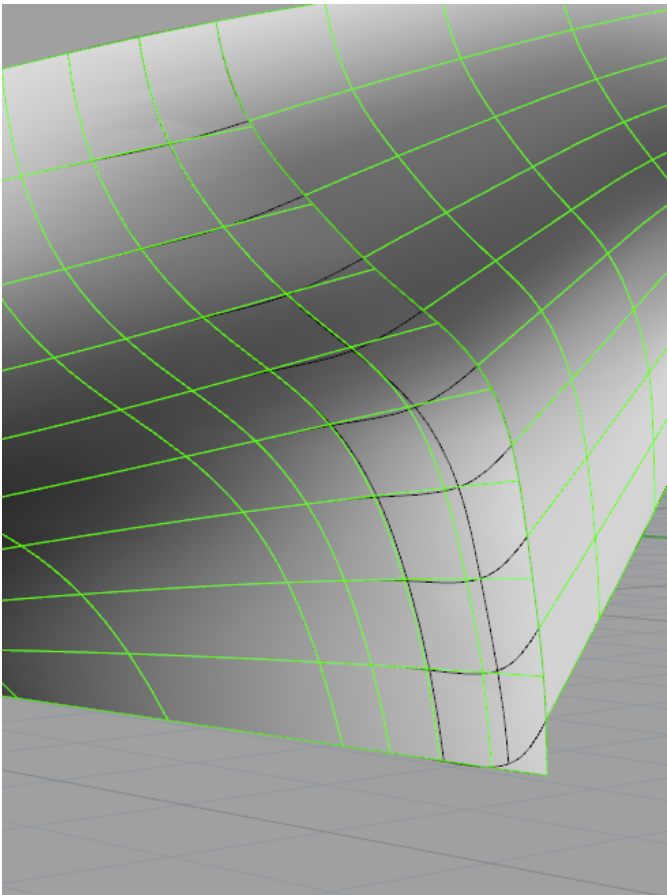
Here we can see a small knot in the surface, which is a result of the two edges of the curve network near the bow being tangentially continuous where they meet (this is expected as from the bowsprit to the tiller in the rear is a smooth curve). It is only visible in shaded or rendered mode, or with a high density wireframe. This means that when exporting just the geometry as a mesh - for instance an STL file - the knot is not captured.

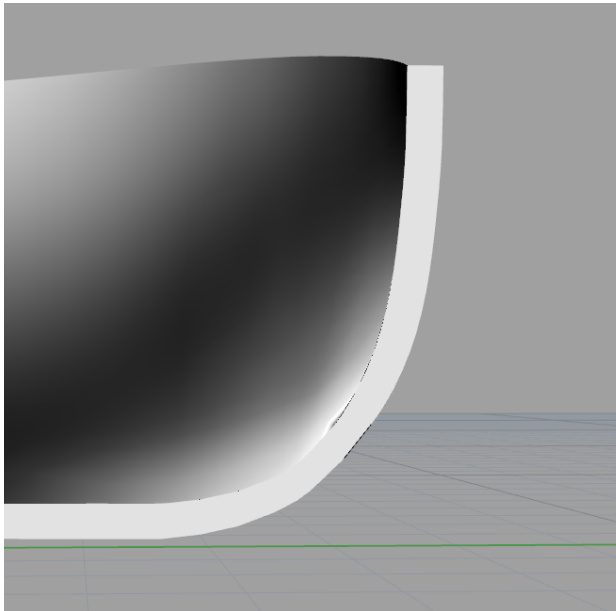
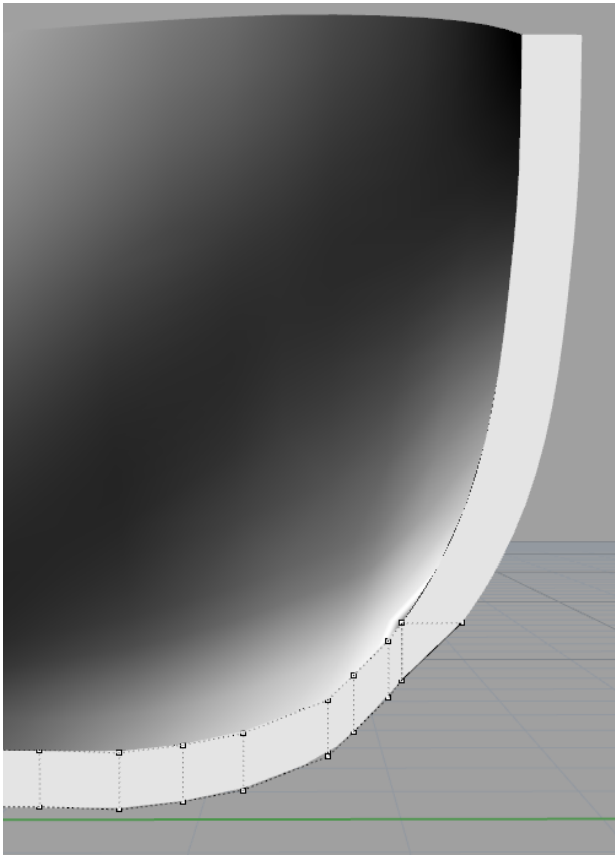
The two images below show the before and after of refining the centerbaord that protrudes like a spine along the bottom of the hull. There was a slight kink (corresponding to where the knot is as described in the lower left) which had to be ironed out using the surface control points.

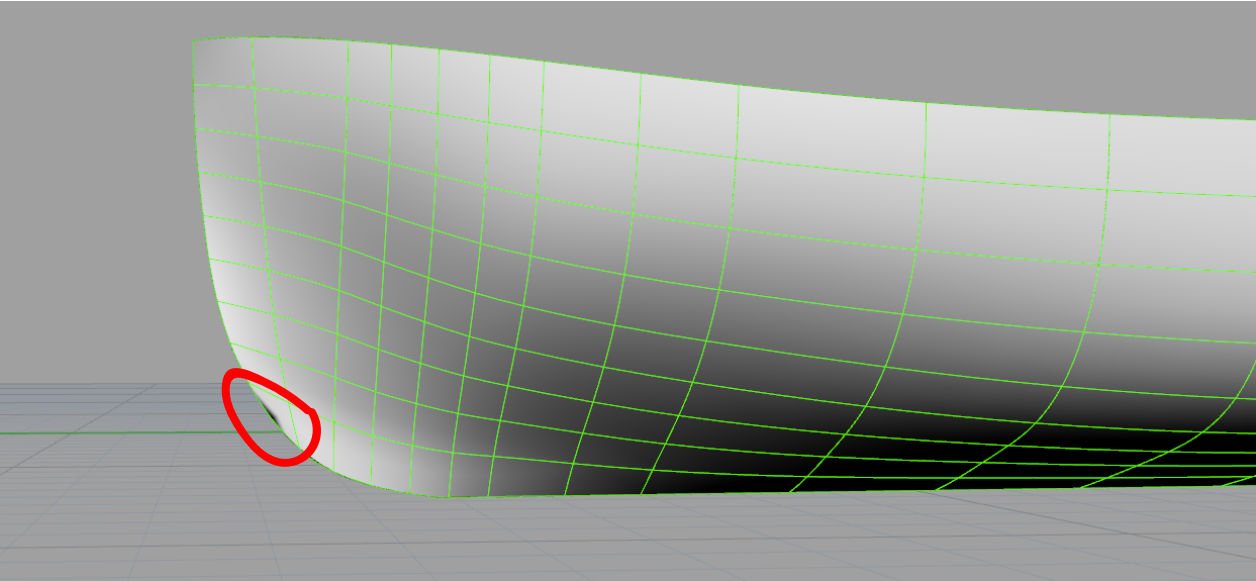
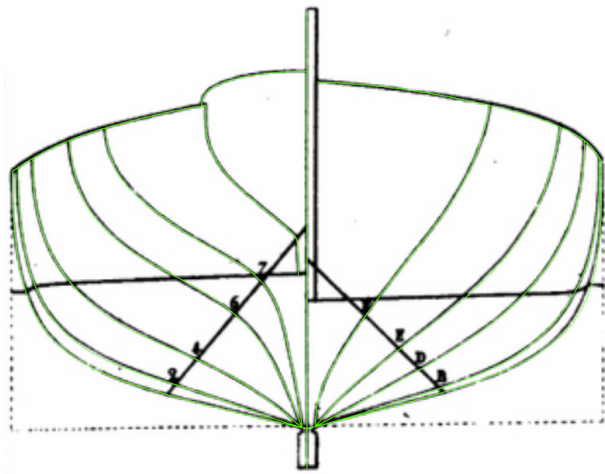
And finally, below we have the front/back split view of the splines in Rhino overlaid on the plans. This was the first and only iteration, as the resulting mesh worked out really well. The only fixes that had to be made were related to other things such as how the network was defined or the ccenterboard extruded.
