AV Controller Malfunction Recovery Procedure for Customer

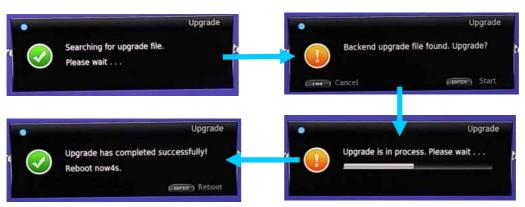
(Current Official Firmware)

"This player requires the firmware update to the latest version."

Step 5: Prepare the latest firmware officially released and copy "UPG" folder to USB flash drive. Before the copy, be sure to delete the recovery firmware file.

BD-S1067, BD-A1000, BD-A1010: Ver. 1.4912 BD-S671: Ver. 1.2505 (as of June 27, 2012)
