NO-DIG INSPECTION TECHNOLOGIES FOR UNDERGROUND PIPELINES

Ming-Der Yang¹, Tung-Ching Su², Tung-Yen Wu³, and Kai-Siang Huang³

Key words: No-dig inspection, diagnosis of sewer pipe defects, CCTV image quality assessment, radial basis network (RBN).

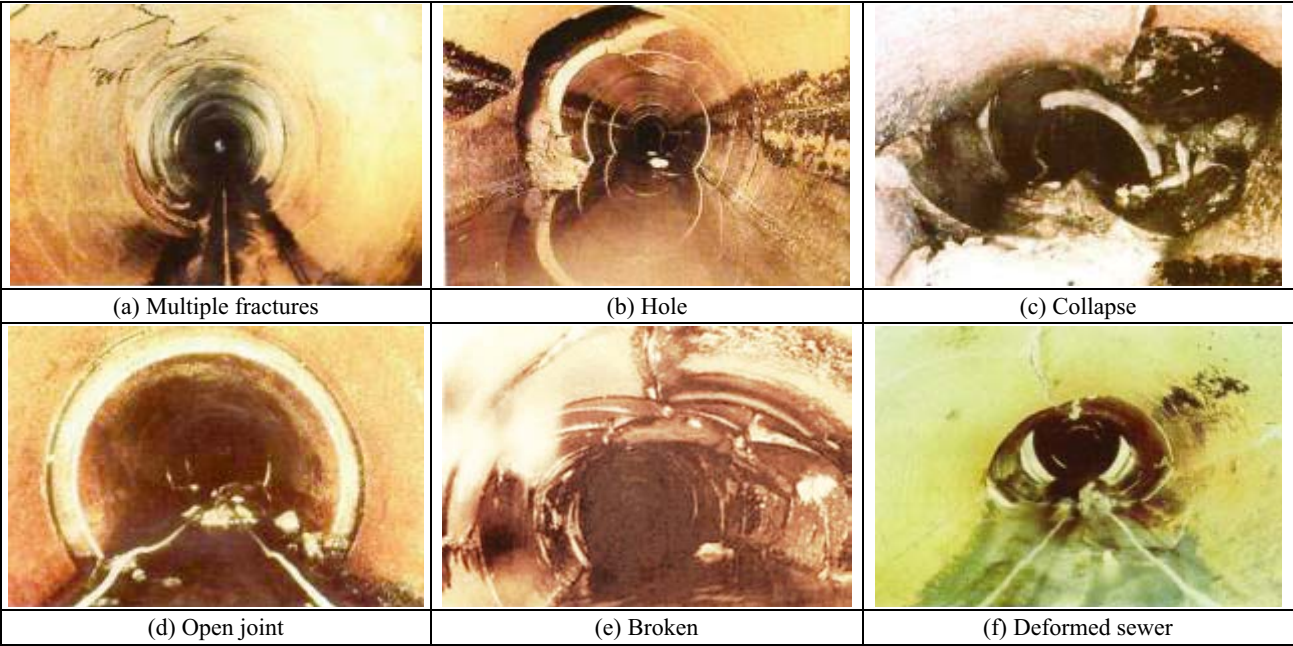
Fig. 3 Reference CCTV images

In this paper, the inspection images within each CCTV inspection video stream were assessed against the six specific reference images as Fig. 3 (UK water industry engineering and operations committee 1994). Table 2 is the statistic of the inspection image quality analysis for the four video streams. Most CCTV video streams have great quality with a mean image quality index of above 0.85, except for Video II provided by project 31 with a mean image quality index of only 0.7. The quality assessment of the tested CCTV images varying with defect patterns is listed on Table 2 that illustrates “Crack” images have the least similarity against the ideal image. Also, according to the variation analysis of image quality including maximum, minimum, and mean values, in Fig. 4, Video III provided by project 32 has a significant quality variation in all six patterns of pipe defects, while Video I has the steadiest quality. Table 3 and Fig 5 show the distribution of image quality indices for all four video streams. Figure 6 also shows that the CCTV images of about 20% have an image quality index less than 0.6 for video II that may consider to be abandoned. As to the other CCTV images in the video stream II with an image quality below the average needs to be improved. Noticeably, the video stream III has the highest image quality identified by 48.9% CCTV images with an image quality index of above 0.9. According to this result, it is suggested that a CCTV video stream with a mean quality index of above 0.8 approximately can be considered acceptable. Those CCTV images with a quality index of below 0.7 needs to be enhanced and less than 0.6 should be abandoned.

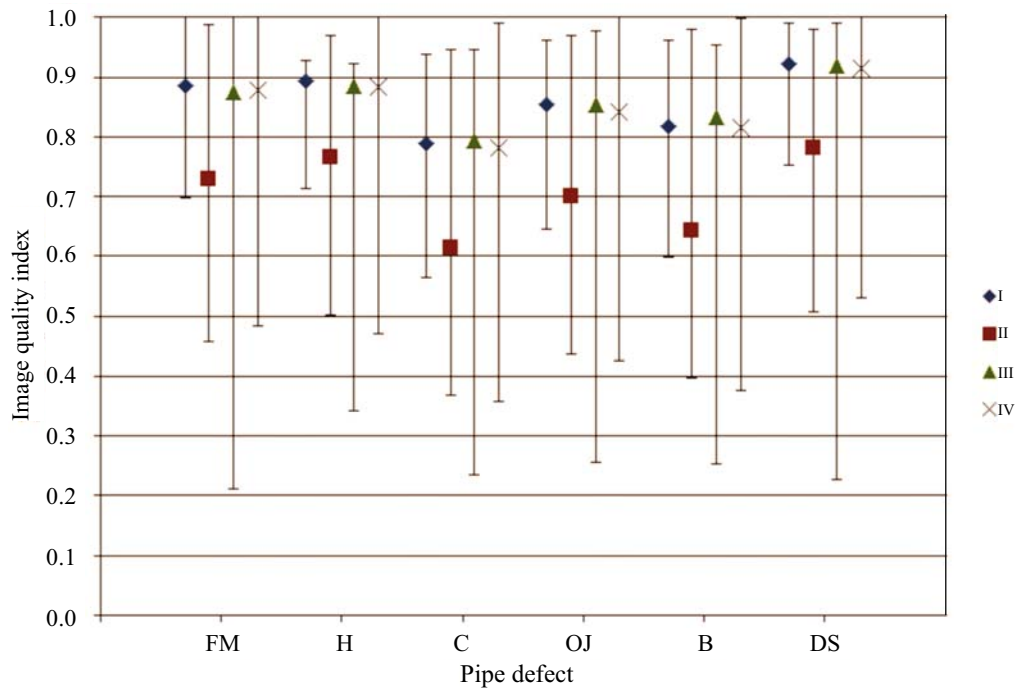
Fig. 4 Variation of CCTV image quality index versus pipe defect

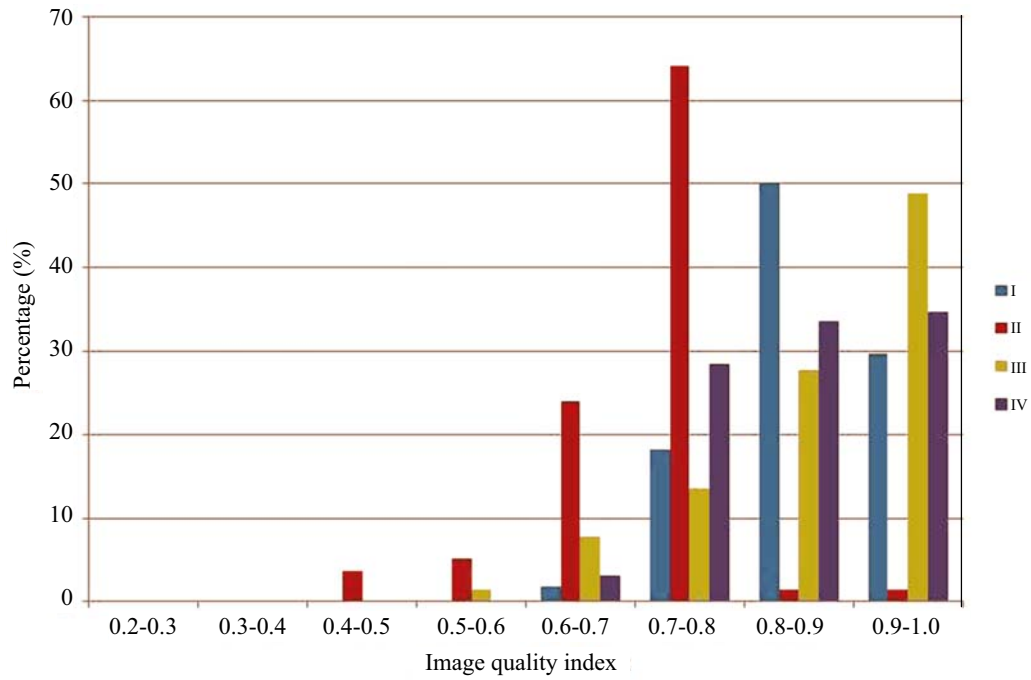
Fig. 5 Distribution of CCTV image quality index for the tested video streams

distortion and contrast distortion is employed to effectively assess inspection image quality by giving a value range between 0 and 1. According to the image quality analysis, a CCTV video stream with a mean quality index of above 0.8 approximately can be acceptable. For the accepted inspection images, a combination of opening operation and Otsu's technique was used for segmenting the morphologies of pipe defects. For the successfully segmented pipe defects including broken pipe, cracks, and open joint, their morphological features were measured and used to classify the pipe defects by the RBN-based automated diagnosis system with an overall accuracy of 95.0%.

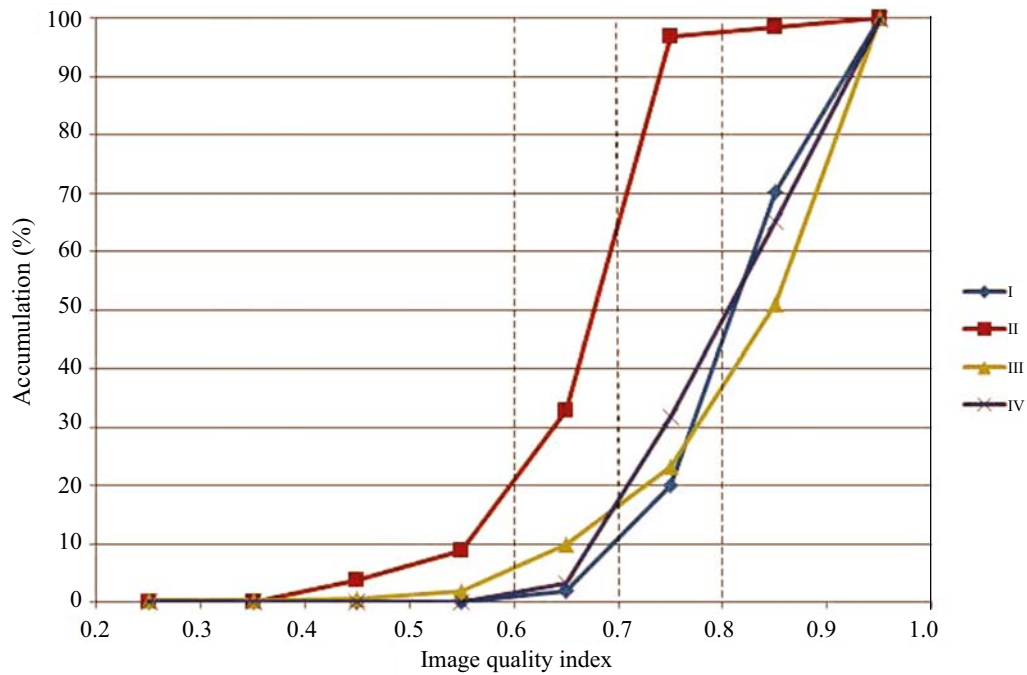
Fig. 6 Accumulation of CCTV image quality index for the tested video streams
