Comparison of Studies

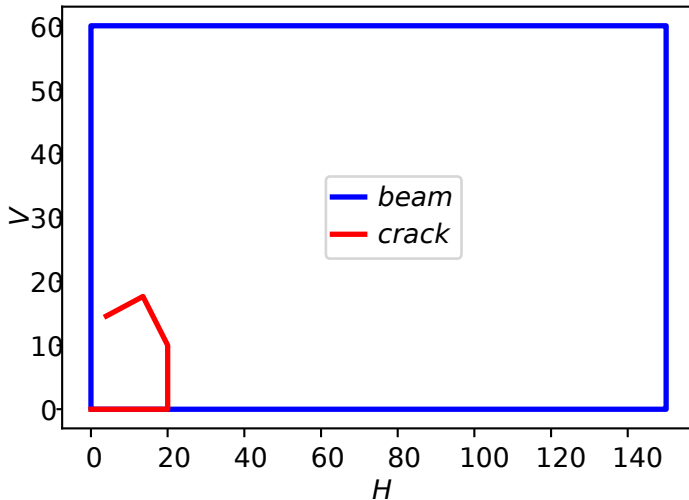
Observation:

By flipping the curve it is visualized that the crack bends down on the left side and furthermore, it keeps moving down which is realistically not possible.

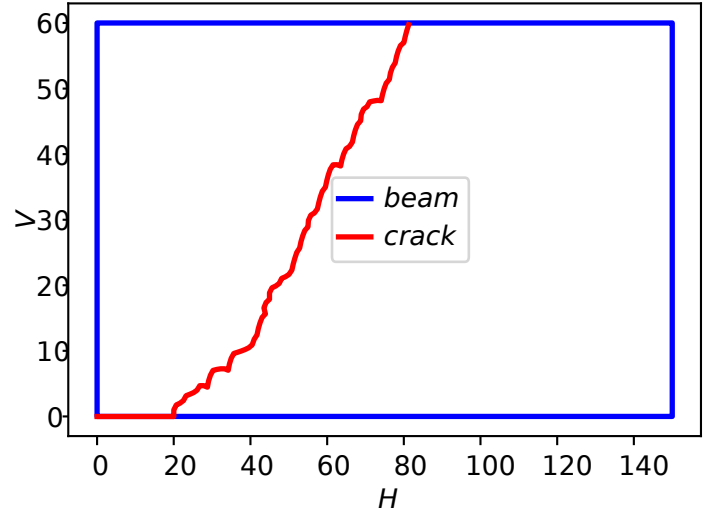
Observation:

Following this layout of crack propagation angle with inclination angle it is visualized that the crack can propagate in quite acceptable way. However, a slight assumption is made that when the angle of propagation increases more than 90 degrees then an assumption is made to propagate the crack upwards.

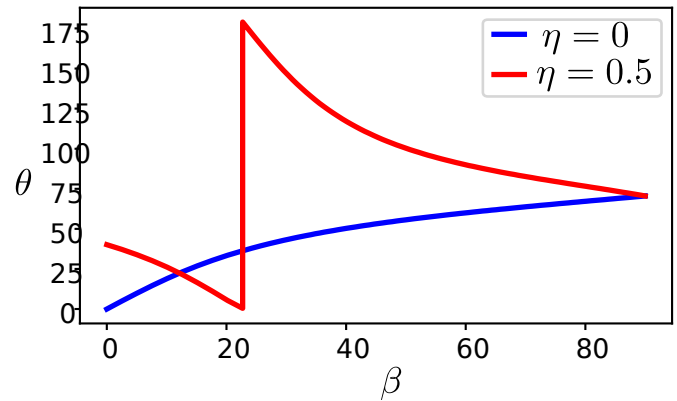
Observation:

If the curve is flipped after the point crack propagation reaches zero then it is observed that the crack propagation will yield constant growth possessing almost same angles which seems realistic because the far field condition is fixed.

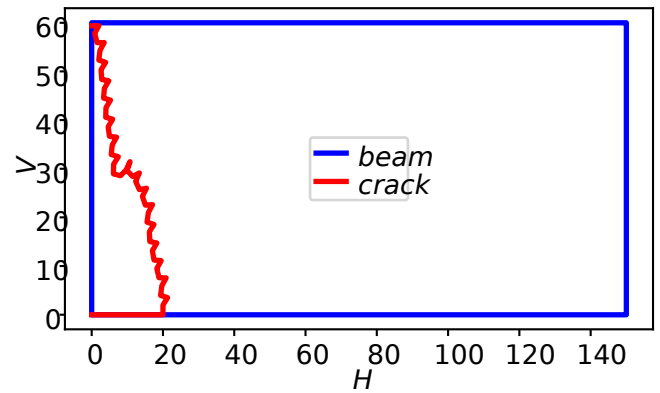
Observation:

By changing the root when crack propagation reach 0 degrees shows that crack will propagate in the manner depicted above which seems quite unrealistic due to the fact that the crack bends downward after alternate steps and seems unrealistic.
