Article No.: TCTIP-04-08

Author: Ed Lee

Ins & outs of impeller vanes and weld gaps

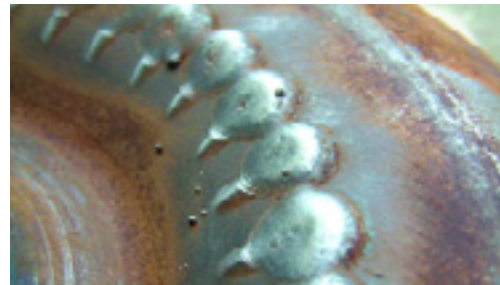
Figure 1

reinforce their converters. The GM 13" converters found in the LT 1 Corvettes and V12 XJS Jaguars were reinforced by welding the impeller vanes to the impeller (see Figure 1). This process was unique because it was done from the outside of the impeller. During the weld process the dimple melted down, fusing the impeller to the vane. This process worked particularly well because it didn't obstruct oil flow nor did it overheat the vane at the point of the weld. Some converter shops still reinforce their converters in a similar manner by utilizing a TIG weld on the outside of the dimple area (see Figure 2).

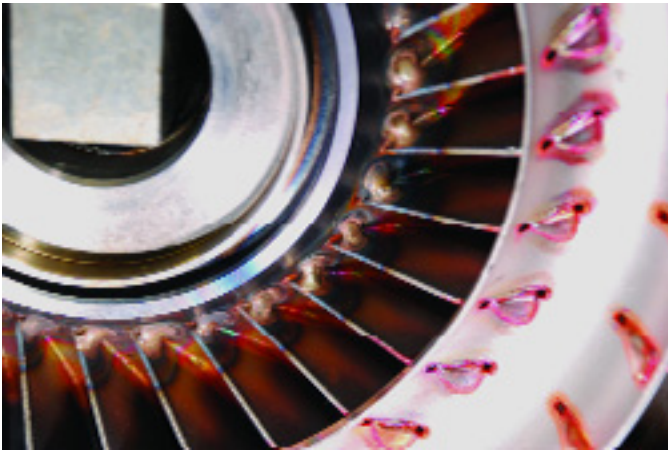
Today, most OEMs and some rebuilders reinforce the impellers by a furnace brazing process. In the aftermarket, numerous other methods can also be found. Some rebuilders are brazing the ends of the vanes to the impellers by hand (see Figure 3). Some rebuilders are using a continuous MIG weld to reinforce the vanes, while others are using a MIG spot weld (see Figures 4 and 5).

Figure 3 shows both hand and furnace brazed.

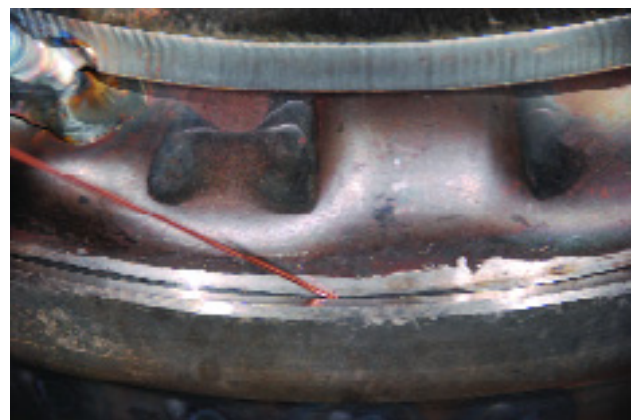
Figure 6

measuring the diameter of the converter before and after it is cut apart. You will see that the diameter of the converter next to the weld is up to .020" larger after it is cut apart. This natural ballooning, plus the clean-up machine work necessary to dress the mating parts, accounts for the wider gap. Keeping the weld gap to .020" or less would be ideal, but most shops allow up to a .035" gap. Many shops will use a short length of .035" welding wire as a "go, no-go" gauge (see Figure 6).
