TROUBLESHOOTING CONVERTERS HAS TWISTS AND TURNS

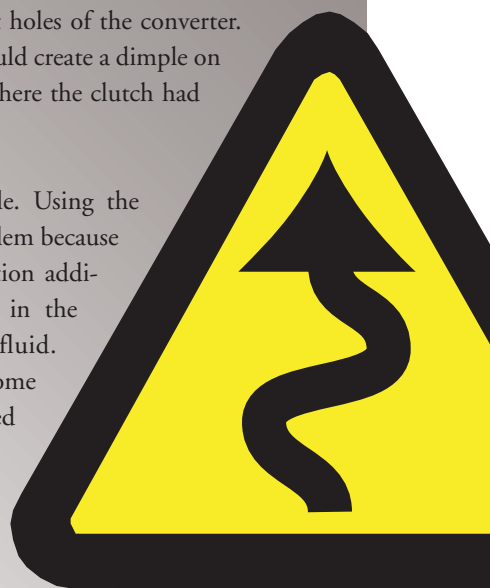
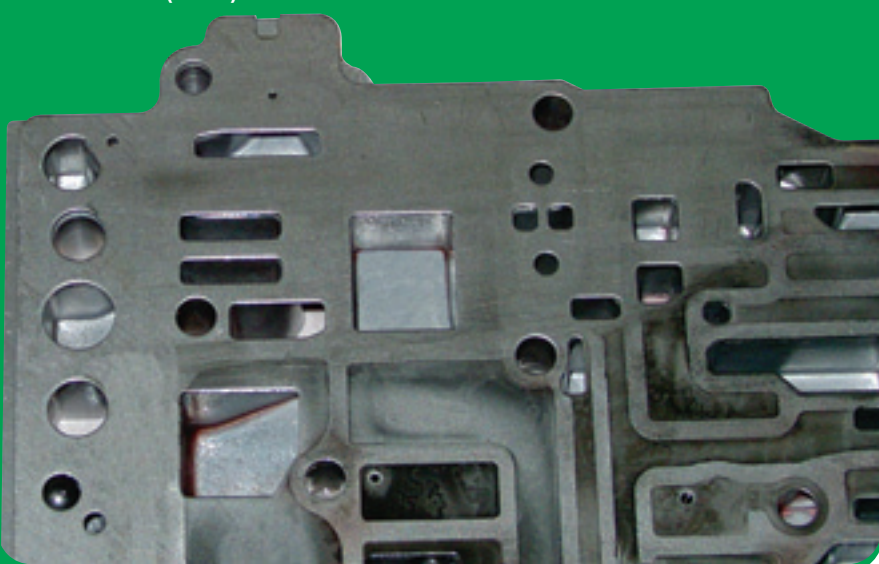
Figure 1

Switch Valve
Control Orifice (notch)

Since lockup apply oil is line pressure and it is only controlled by the pressure regulator valve, lockup apply feel is controlled by an orifice at the switch valve. The oil in front of the lockup plate must pass through this orifice when it exits the converter. If this orifice is too small, the oil will not exit quickly enough and you will have a lockup shudder. (The orifice is located above the end of the switch valve. It is a notch in the valve body spacer plate that is sandwiched between the two halves of the valve body (see *Figure 1*).

Technicians were being told by some smart technical support people that increasing the size of this orifice would allow the clutch to apply faster, because the release oil would exit faster. The faster release did eliminate a lot of shudder concerns and this practice is still in use today, more than two decades later.
