Soft shift and low accumulator pressure

Oversized Accumulator Control Valve Kit

34994-22K

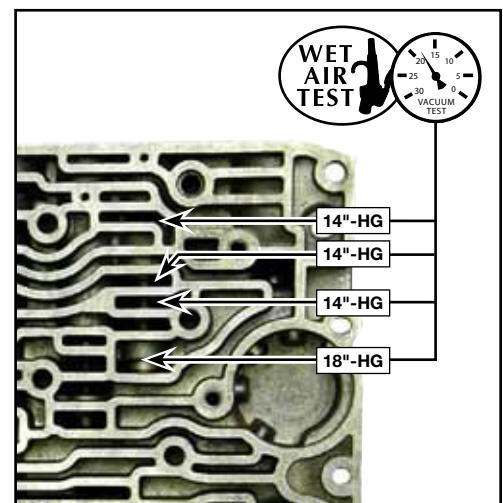
A vacuum test fails to yield the indicated 14 or 18 in-hg or greater, depending on the port tested as shown, or if visual wear is detected.
