6L80 & 6L90

GM 6-Speed Automatic Transmission

INSTALLATION GUIDE

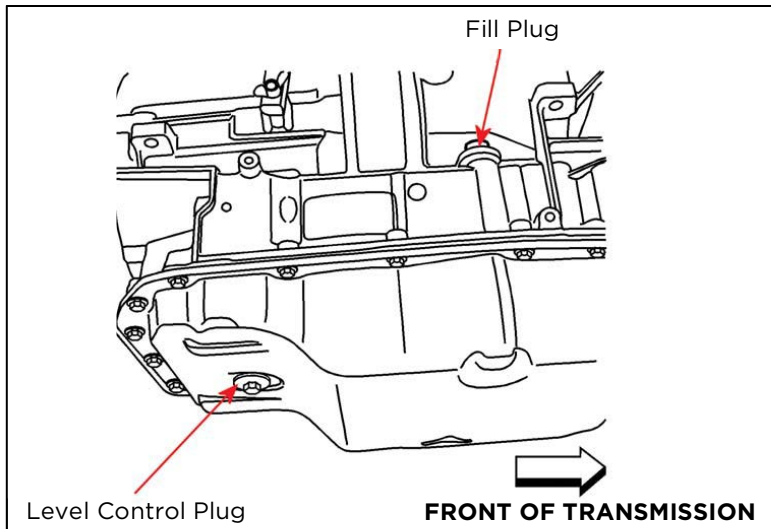
6L80 / 6L90 transmissions do not typically use a dipstick. Proper fluid level is achieved when fluid begins to drip from the Level Control Plug opening.
