# 6T70 & 6T75

## GM 6-Speed Automatic Transmission

### INSTALLATION GUIDE

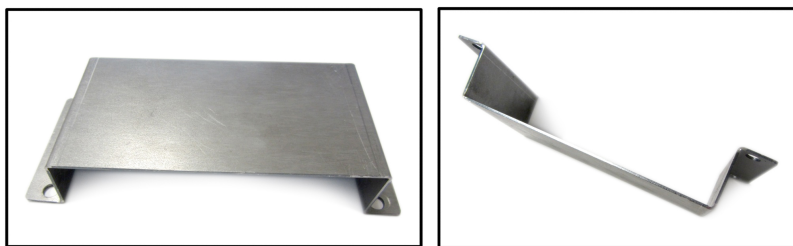
Also, any core transmission being returned to ETE must have the TCM connector cover installed during the return shipment process.

Top and front view of connector cover.

The Transmission Control Module (TCM) connectors on GM 6T70 / 6T75 transmissions are prone to damage during shipment and handling. Since the connector is integral to the TCM, a damaged connector will render the TCM useless.

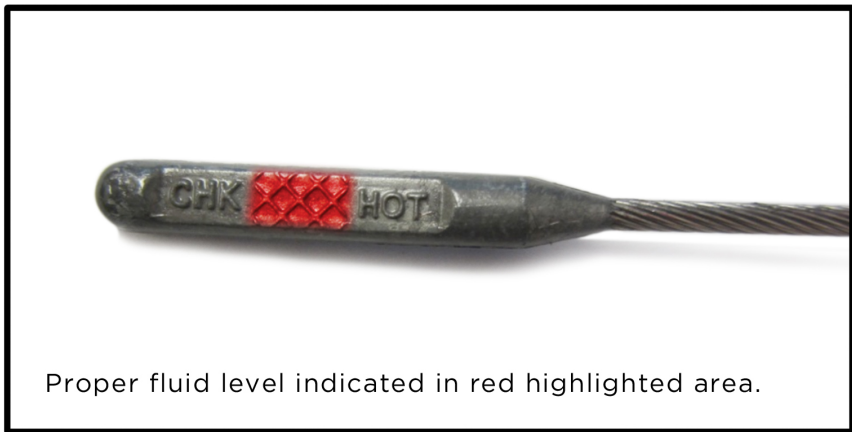
Proper fluid level for 6T70/6T75 transmissions is indicated in the cross-hatched area of the dipstick.
