ERRATA SHEET

Date: September 04, 2002
Document Release: Version 1.0
Devices Affected: P89C51RA2 /01, P89C51RB2 /01, P89C51RC2 /01,
P89C51RD2 /01
(referenced to as P89C51Rx2 /01 in this document)

On-chip Flash 8-bit microcontroller

P89C51Rx2 /01**IDENTIFICATION:**

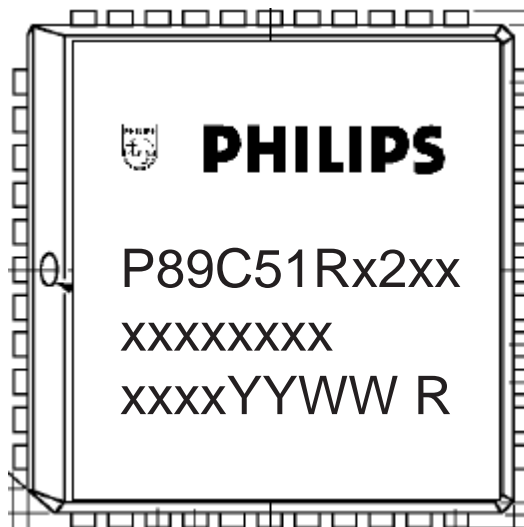
The P89C51Rx2 /01 devices have the following top-side marking (PLCC44 package shown):

The last letter in the third line (field 'R') will identify the device revision. This Errata Sheet covers the following revisions of the P89C51Rx2 /01:

Field 'YY' states the year the device was manufactured. Field 'WW' states the week the device was manufactured during that same year.

Revision Identifier (R)	Comment
'B'	Initial release
