**EXPERION PKS**

**RELEASE 511.1**

## Software Change Notice

EPDOC-X166-en-5111E

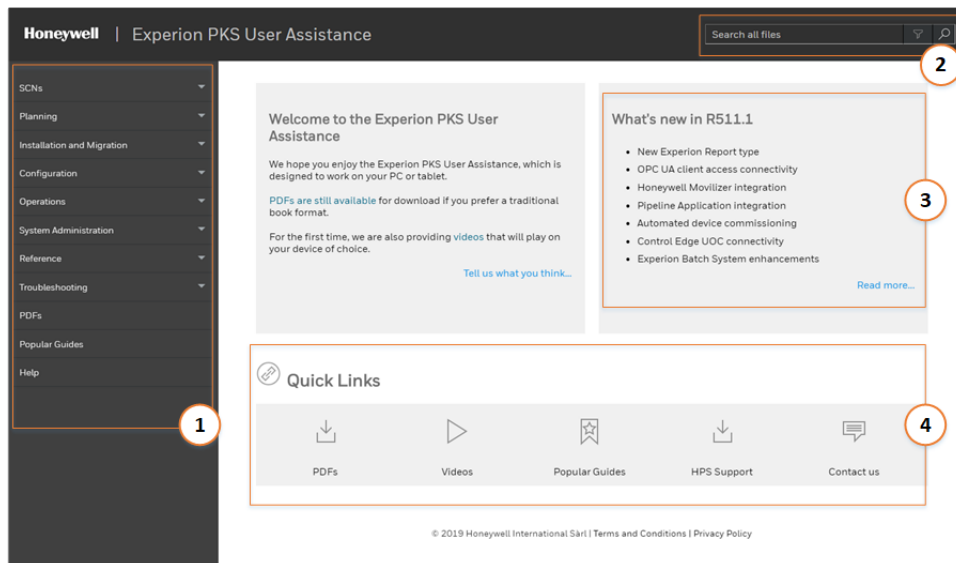
1. From the Start menu, navigate to **Honeywell Experion > Experion User Assistance**. The User Assistance appears.

Item	Description
1	<i>Navigation Pane:</i> Lists of documents organized by task category.
2	<i>Search Field:</i> Enter words or phrases and select the <b>Filter</b> icon to minimize your search results to one of the available task categories.  Click <b>Help</b> in the Navigation Pane for more tips on searching.
3	<i>What's new:</i> Lists new features for this release, and provides links to more information about each.
4	<i>Quick Links:</i> Easy access to PDF versions of the documents, sample Videos, the most often used guides, the Support page on Honeywell Process.com, and Contact methods for providing feedback or suggestions about this User Assistance.

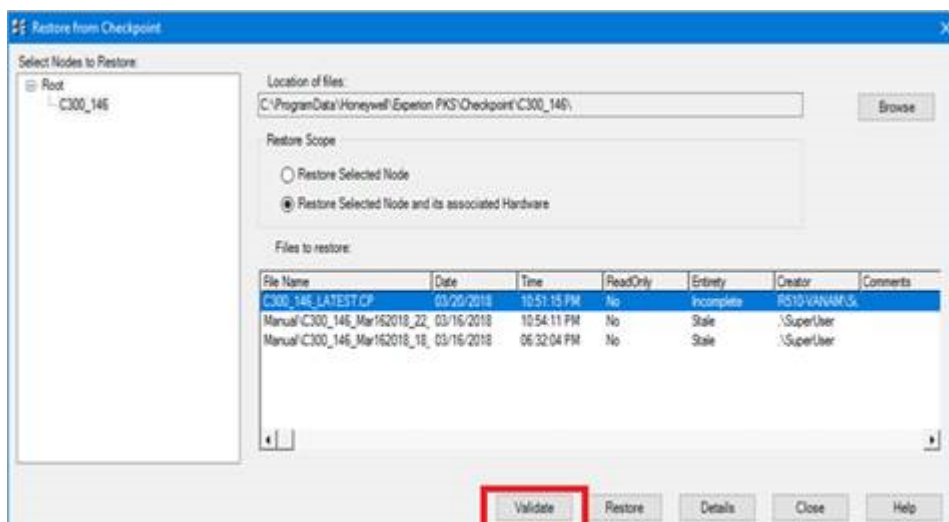
A new option is introduced to perform checkpoint file validation from Station or Control Builder. This enhancement provides a new button “Validate” on the Restore from Checkpoint dialog box to validate a checkpoint file.

1. Click **Validate**.  
Checkpoint file validation is initiated, a **Validation Progress** dialog is displayed. If any errors are identified during the validation, it is displayed on the **Validation Progress** dialog.
2. Depending on the errors reported, take appropriate corrective actions.
3. After taking a corrective action, click **Validate** to re-validate the checkpoint file to make sure it passes all validation checks.

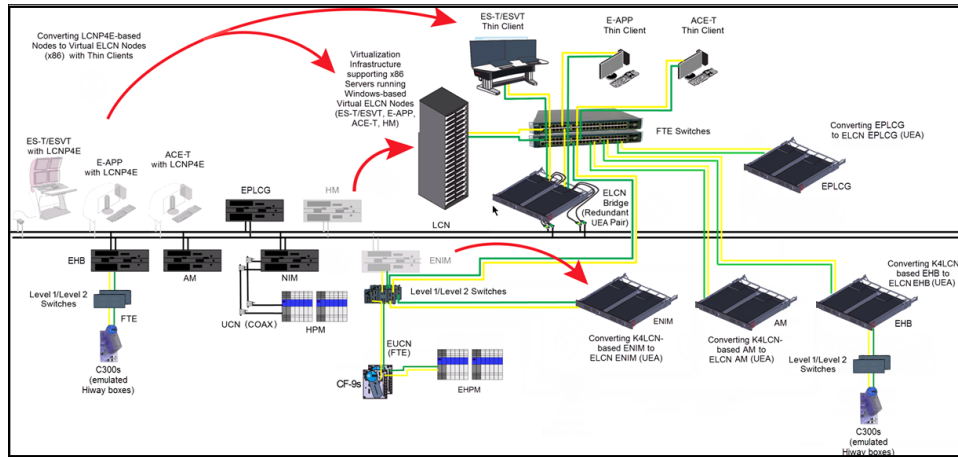
The following figure illustrates a simple architecture of ELCN.

There are two general categories of ELCN Nodes: TPS Nodes and Appliance Nodes. ELCN TPS Nodes are Experion nodes deployed on a physical Microsoft Windows-based platform or as a virtual machine. You migrate legacy LCN user interface nodes (US, UxS, and GUS) to the ELCN as TPS Nodes. You also deploy the ELCN History Module as a TPS node. You migrate LCN data owner nodes (such as the ENIM, AM, EPLCG, and EHB) as ELCN Appliance Nodes or ELCN Virtual Appliance Nodes. ELCN Appliance Nodes use the Honeywell Universal Embedded Appliance (UEA) hardware platform, as does the ELCN Bridge.
