# 接口故障处理步骤

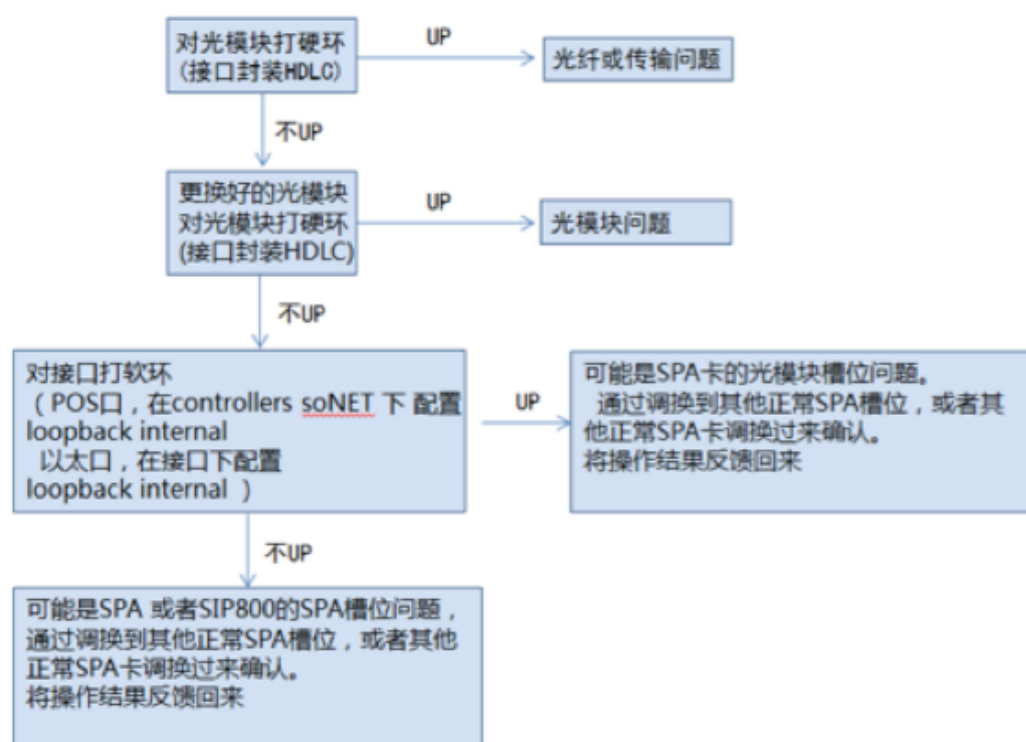
端口打环流程：

做硬环测试时，检查接口是否 UP/UP，ping 本地 IP 地址是否有丢包，并 show interface TenGigE x/x/x/x 检查接口下 input error 和 CRC 是否有增长。如果有增长说明光模块或硬环尾纤有问题，先更换打硬环的尾纤，再做 ping 测试和接口 input error 和 CRC 是否增长的检查。如果仍然有增长，可以确认是光模块故障。
