<p align="center">The Industry Association of Building and Property Inspectors in WA Inc – Inspect WA</p>	
<p align="center">Position Paper 12. February 2020 Title: Recessed Downlights & Insulation</p>	
Subject	Recessed Downlights and Insulation
Association Position	<p>Given the generally recognised concerns in regard to fire and safety this paper identifies the need for Building Inspectors to consider the need to report and or comment on perceived hazards associated with the proximity of insulation to recessed lighting.</p> <p>The Association recommends that the clearance between an Incandescent/Halogen Globe and Insulation and or timber associated with ceiling frames or roof frames be a minimum of 200 mm. Further the Association recommends that the clearance between an LED lights and Insulation and or timber associated with ceiling frames or roof frames be a minimum of 50 mm.</p> <p>Where the clearance distance can be visually identified as less than the minimum, Building Inspectors should consider if the issue should be reported as a safety issue.</p> <p>A standard note as advice when considered by the inspector should suffice in most cases.</p> <p>Whether or not the issue is in

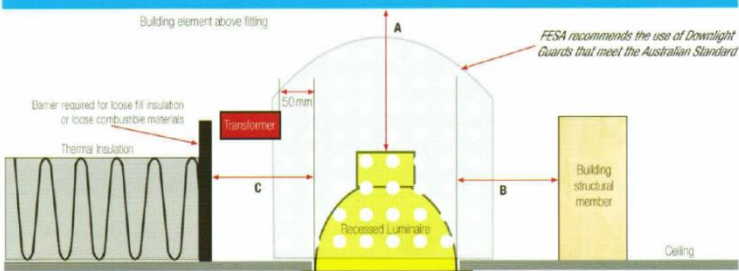
<p>DEFAULT MINIMUM CLEARANCES FOR RECESSED LUMINAIRES</p>

<table><tr><th>Dimension</th><th>Incandescent lamp</th><th>Halogen lamp</th></tr><tr><td>A - Clearance above luminaire</td><td>50 mm</td><td>200 mm</td></tr><tr><td>B - Side clearance to structural member</td><td>100 mm</td><td>200 mm</td></tr><tr><td>C - Clearance to thermal insulation</td><td>50 mm</td><td>200 mm</td></tr><tr><td>D - Clearance to supply transformer</td><td>50 mm</td><td></td></tr></table>

1. Recessed lighting of all types within residential properties should be kept well clear of insulation and timbers associated with ceiling and roof frame.
2. As a general the Association recommends that a clearance between an Incandescent/Halogen Globes and Insulation and or timber associated with a ceiling frame or roof frame should be a minimum of 200mm. Further the Association recommends that a clearance between an LED lights and Insulation or with a ceiling frame or roof frame should minimum of 50 mm.

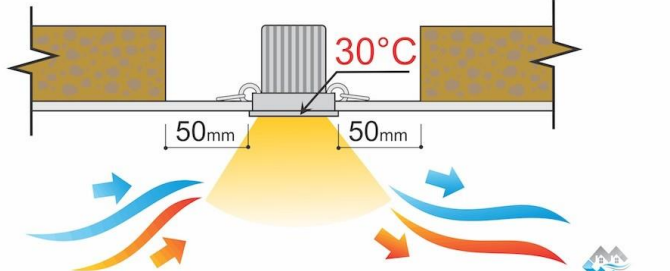
<p>LED Light</p>
